HAYLE TIMBER REPORT

C.I.S.M.A.S.

Luke Randall

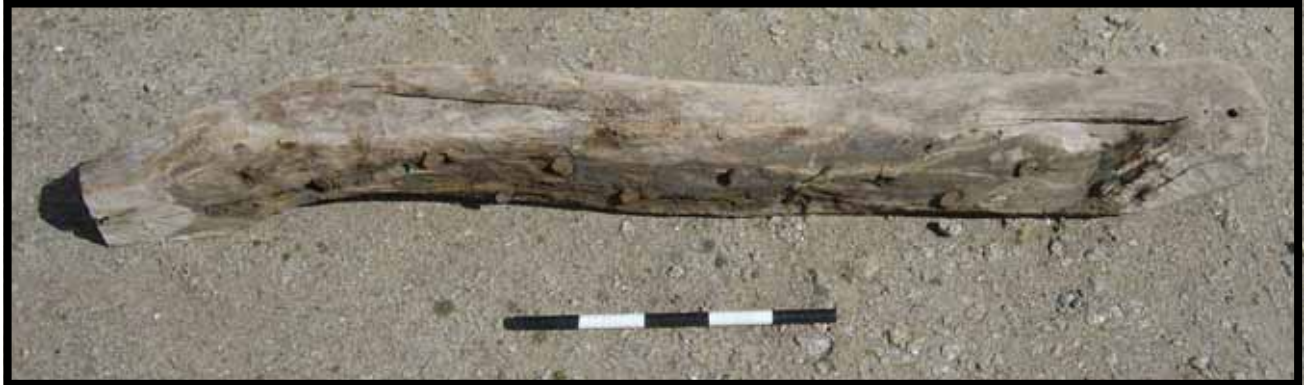
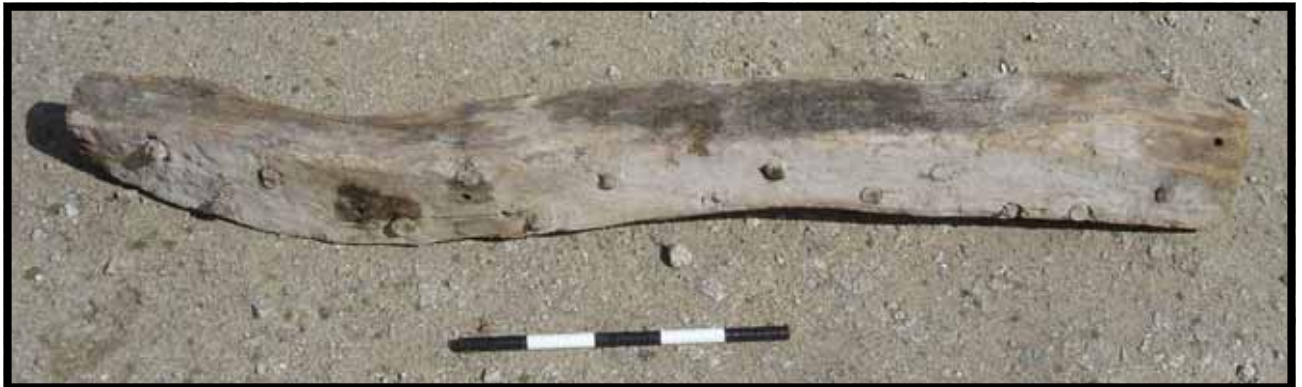
TIMBER I

ABOVE: Inboard Face (lower) and Face B (uppermost) of Timber I.
BELOW: Outboard Face (lower) and Face D (uppermost) of Timber I.

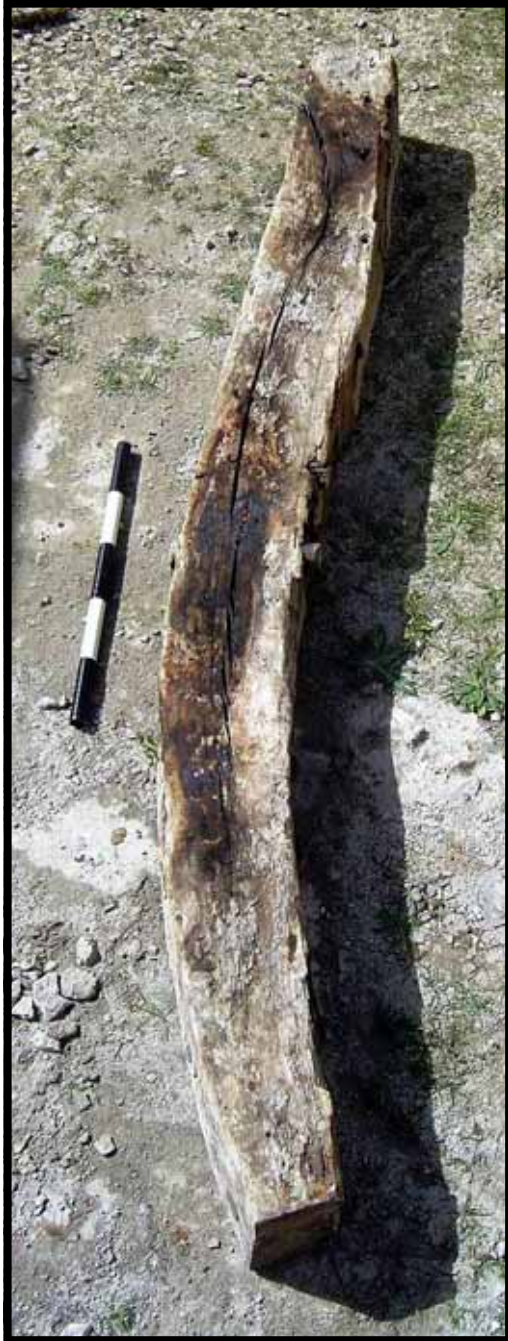
Timber II
Face D

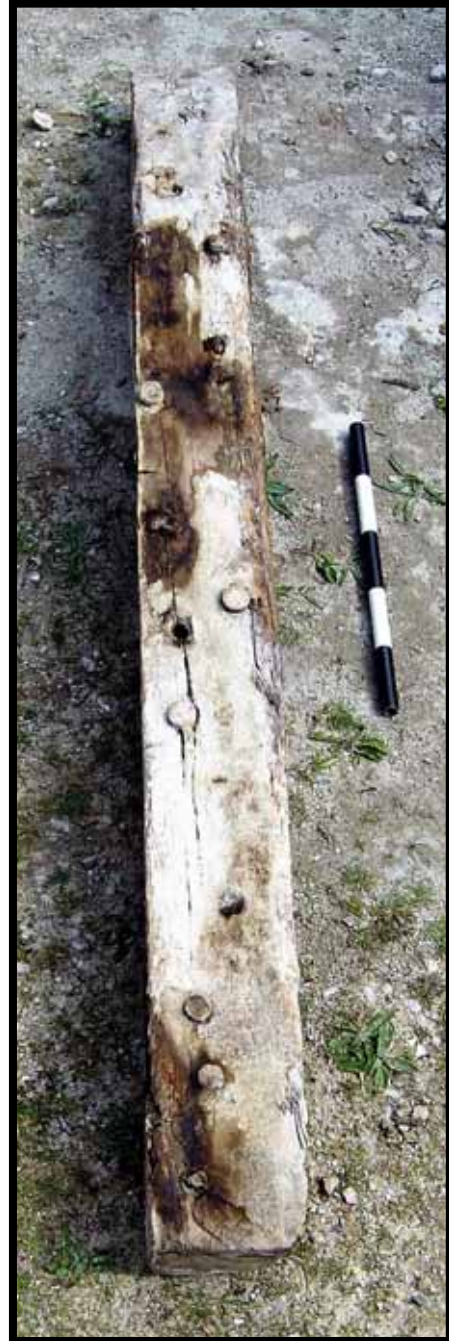
Timber II
Outboard face

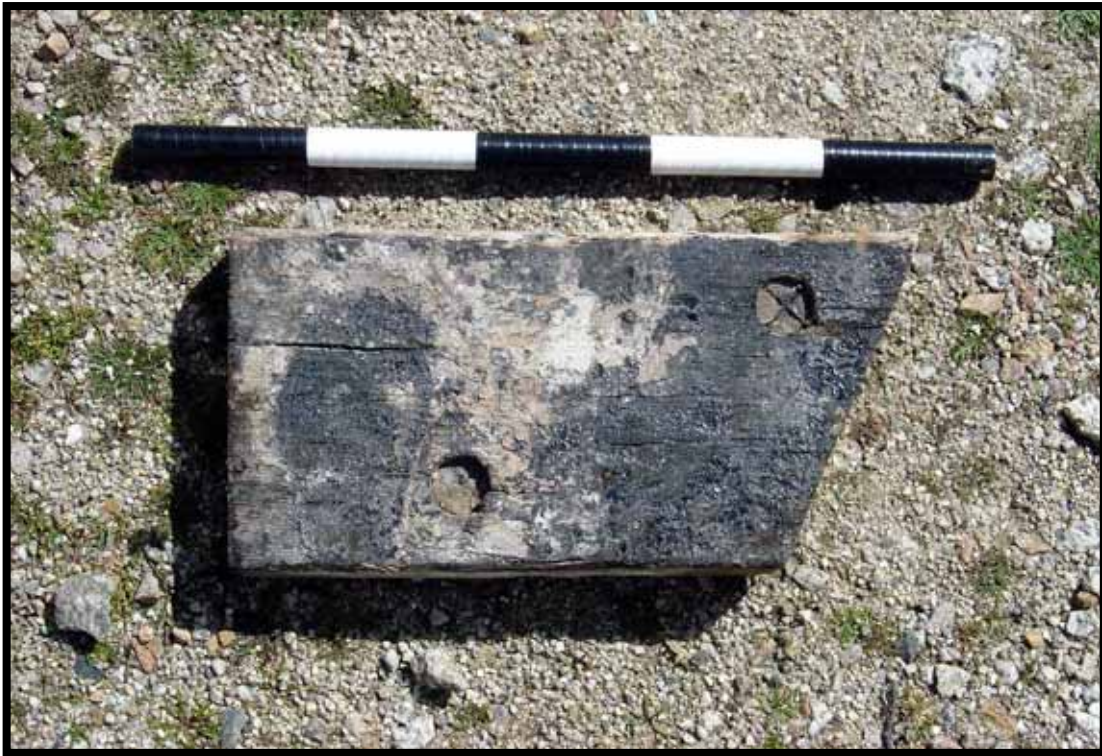
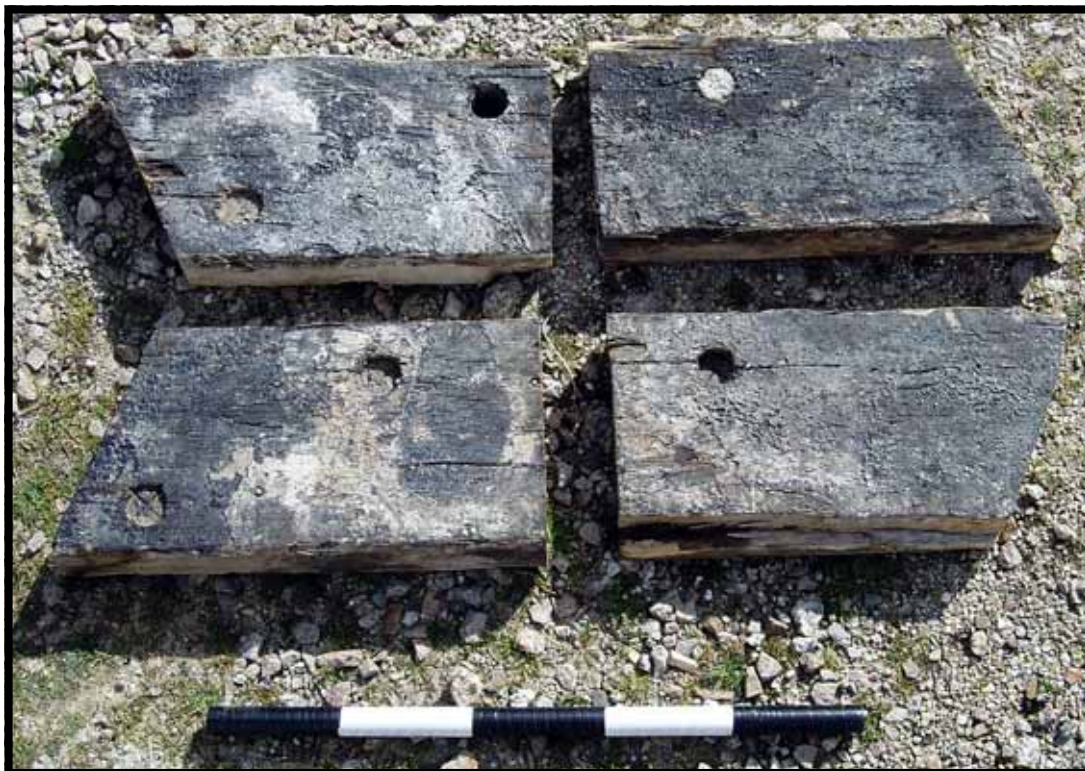
TIMBERS III - VI

Timber III

Top right to bottom right clockwise - Timber IV, Timber VI,
Timber V, Timber III.
