HMS Colossus

Wrecking Project 2017

Project Report

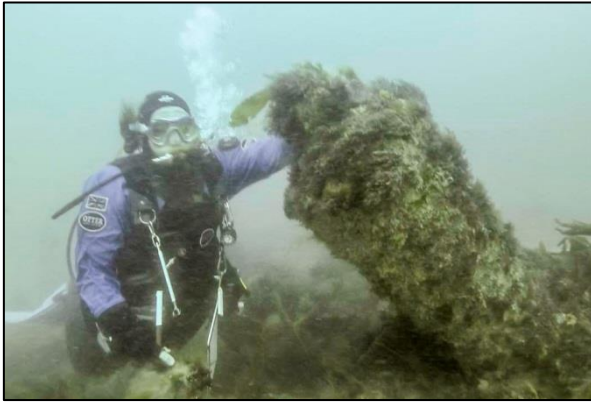
Fig 5

One of the upper gun-deck 'upstanding' guns on the stern site. These are 18lb guns which are 9 feet (2.75m) long; roughly half the length of the gun is buried in the seabed.

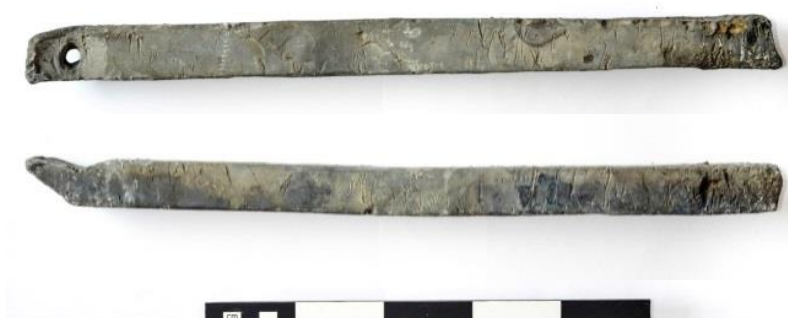
Fig 6

Two views of one of the lead sash weights found on the seabed to the east of the stern.

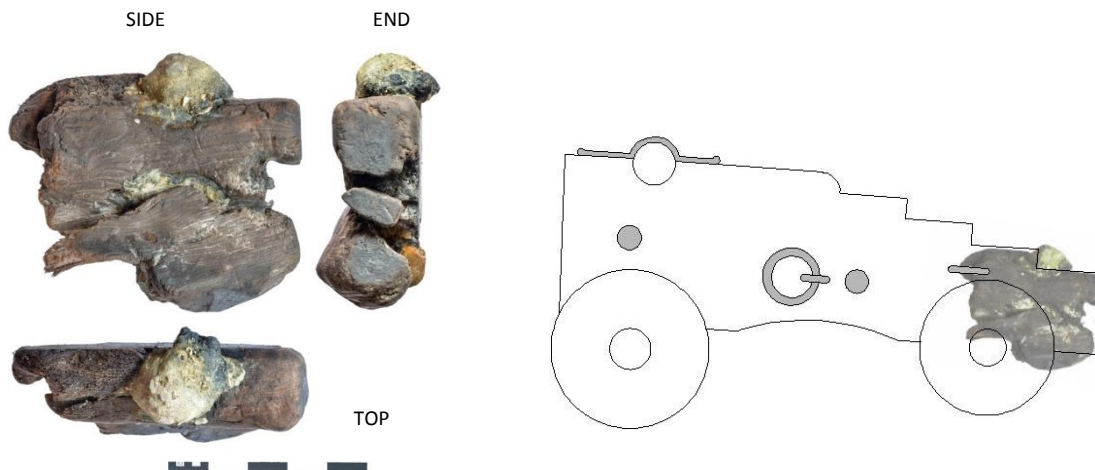
Fig 8

Several fragments of 9lb gun carriage were also located (one of which was inscribed 'COLOSSUS'). All of the recovered fragments of gun carriage exhibited extraordinary damage. They were broken and split extensively – far more than it would seem reasonable to expect from the carriage and gun falling from the deck of *Colossus* into the sea, even if the gun was still attached to the carriage when it landed on the seabed. What could account for this 'crushing' of the gun carriage?

One of the damaged gun carriage fragments (left) and shown in position on a gun-carriage outline (right)

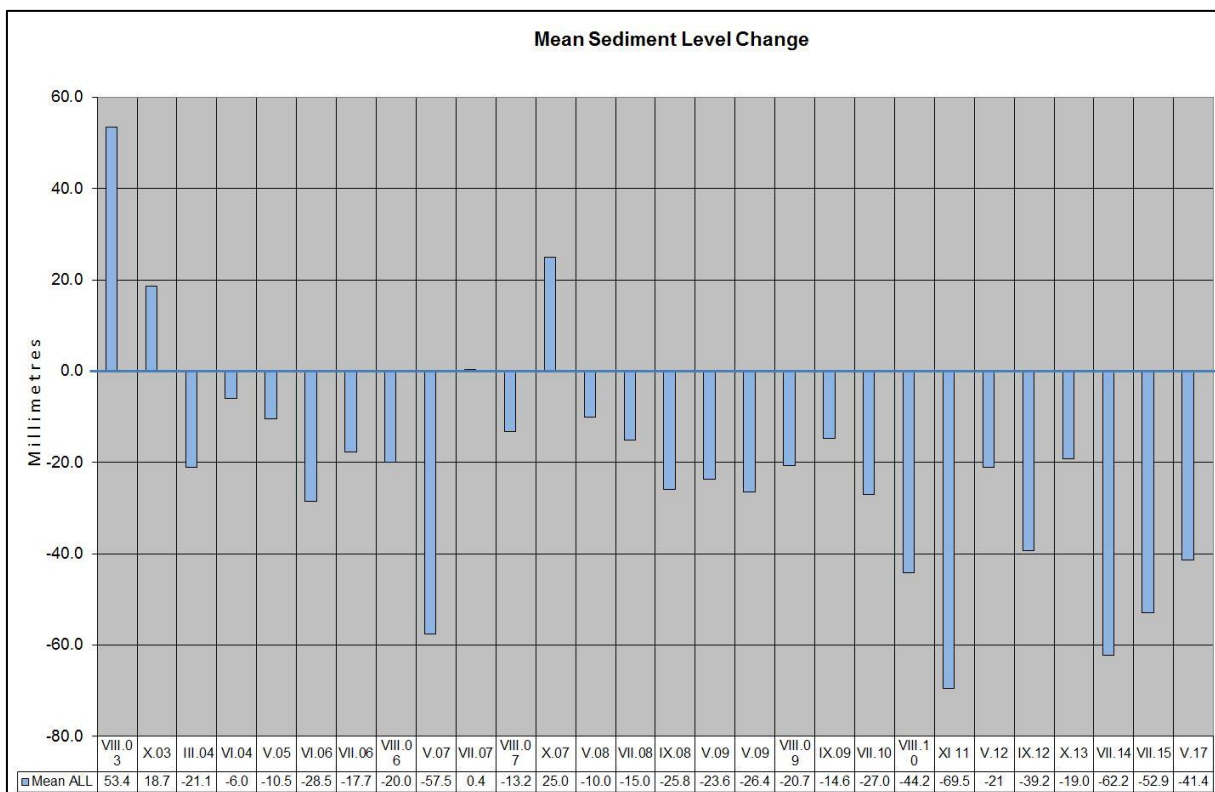
Fig 17

The sediment levels on the site have been monitored since 2003. This has been accomplished by means of 14 fixed survey pins driven into the seabed at various locations around the site. The results of the sediment monitoring have been reported every year in the annual licensees' report submitted to English Heritage (and now to Historic England). The sediment monitoring points were renewed in July 2014. It was while this work was in progress that the newly exposed material to the east of the wreck was first noticed (Camidge, 2014).

Chart showing the mean sediment level change on the site relative to the sediment levels in 2003 when monitoring began – this is represented by the horizontal zero line in the centre of the chart. These values are the average readings for all 14 monitoring points.

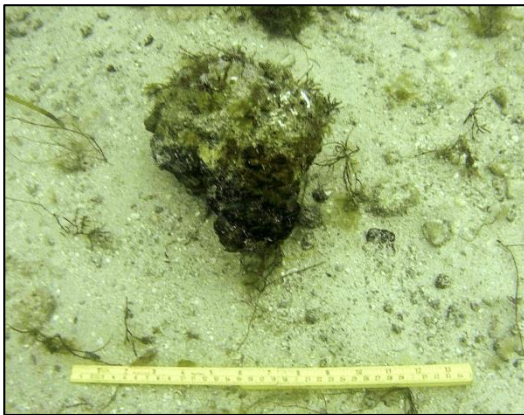
Fig 19
Concreted iron round shot N2.1

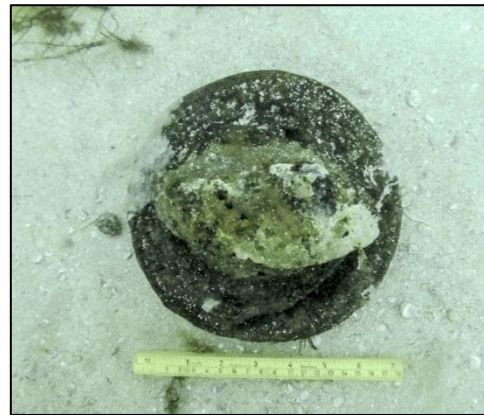
Fig 20
Wooden sheave N6.2

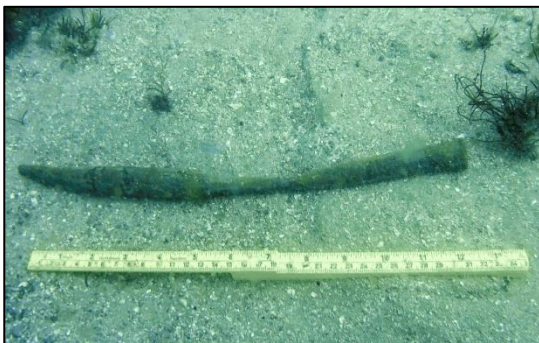
Fig 21
Copper fastening bolt N6.5

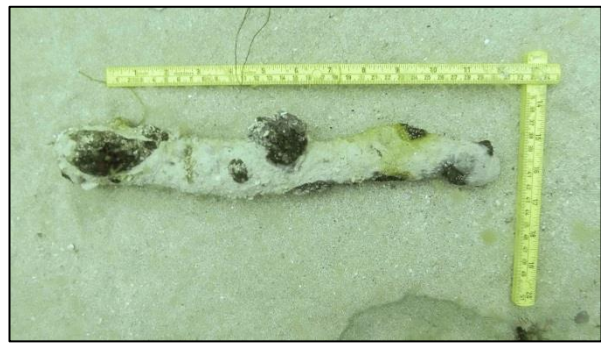
Fig 22
Iron concretion N6.4

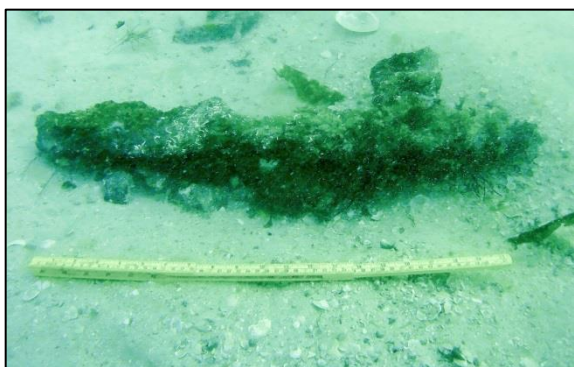
Fig 23
An iron concretion S1.1

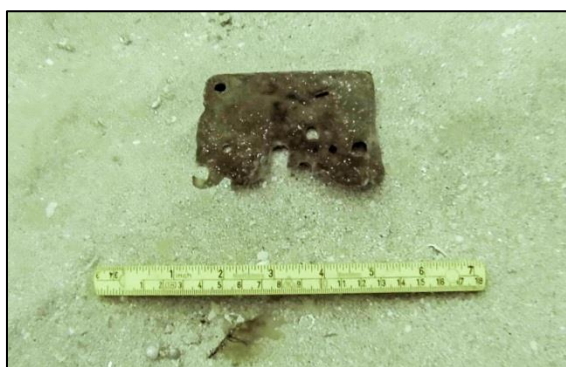
Fig 24
Copper alloy object (part of a box lock?) S4.2

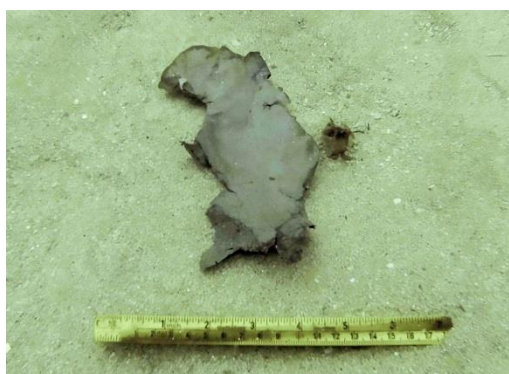
Fig 25
Copper sheet fragment S3.1

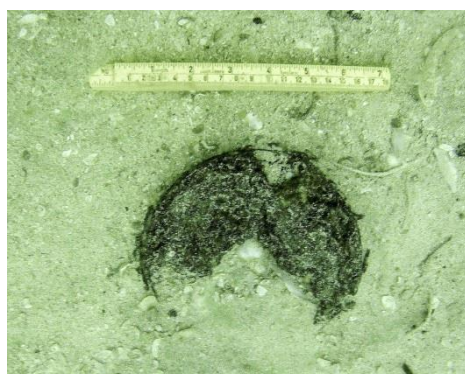
Fig 26
Iron object S5.1

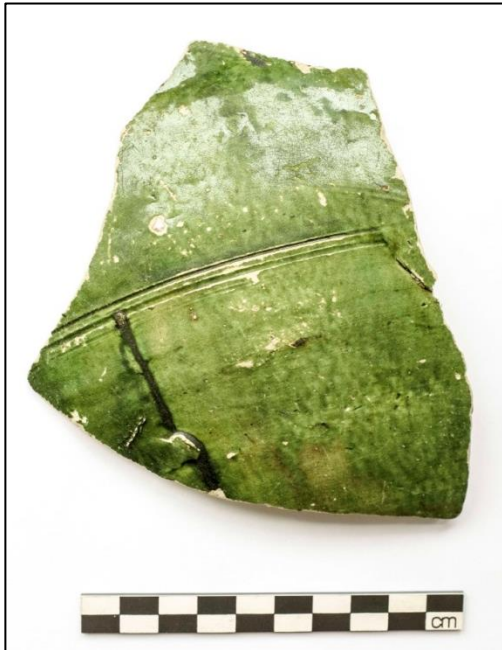
Fig 28
A fragment of medieval pottery C1.3 found to the east of gun 10 in search area C1. Probably Saintonge 1280-1320.

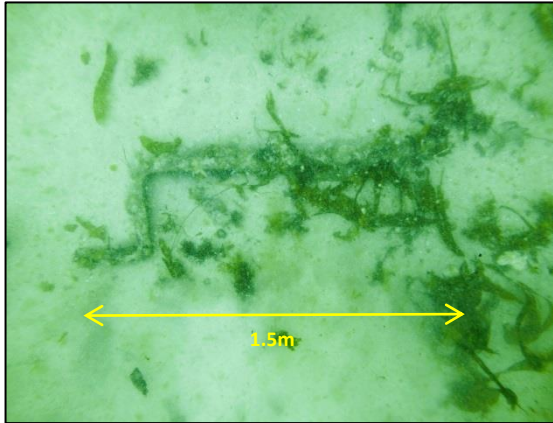
A number of larger, complex iron objects were found. Perhaps the easiest to identify was C6.19 which was an iron crank (fig 29) – probably part of the mechanism by which the crew powered the chain pump (fig 31), which would certainly have seen some action during the final hours of *Colossus*! Close by (8m to the south east), was found a similar complex iron object C6.20. This is probably the handle from a portable ‘fire’ pump of the period (figs 30 and 32) – doubtless also put to use as *Colossus* began taking on water.

Fig 29
Iron object C6.19 probably a chain-pump handle

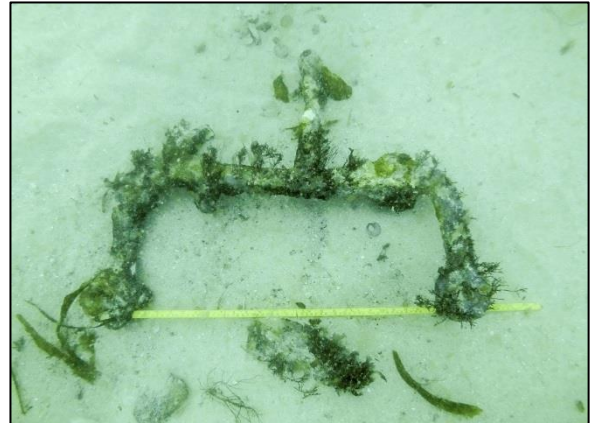
Fig 30
Iron object C6.20 possibly a portable pump handle

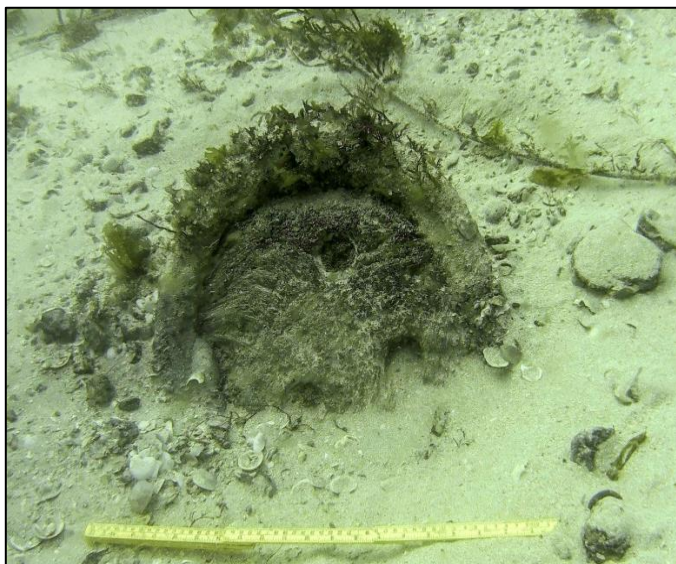
One of the largest iron items located was a wood lower deadeye complete with iron chains C10.1. The chains are the iron straps used to fasten the lower deadeye to the outside of the hull of the ship. This deadeye is very similar to another (F1355) found in 2015 some 7m to the east (Camidge, 2015). The diameter of the deadeye (440mm) is such that this would have been one of the main or foremast deadeyes – the mizzen deadeyes were smaller. It was partly buried within the seabed and lies on its edge rather than flat on the seabed. This brings the total of deadeyes and chains found to the east of the stern site to five (shown as yellow triangles on fig 27) – this is significant, as they potentially denote areas the hull has passed over during the wrecking process. What is more, at least three of these are attributable to the main or foremasts – so must be from amidships or the forward part of the hull. This deadeye lies right next to the dive trail around the site, but remained unrecognised until the survey undertaken this year. It should be noted that the port mizzen chains lie on the seabed in exactly the right place on the stern site (these were identified by the ADU in 2002).

Fig 33
Timber lower deadeye and iron chain band
C10.1

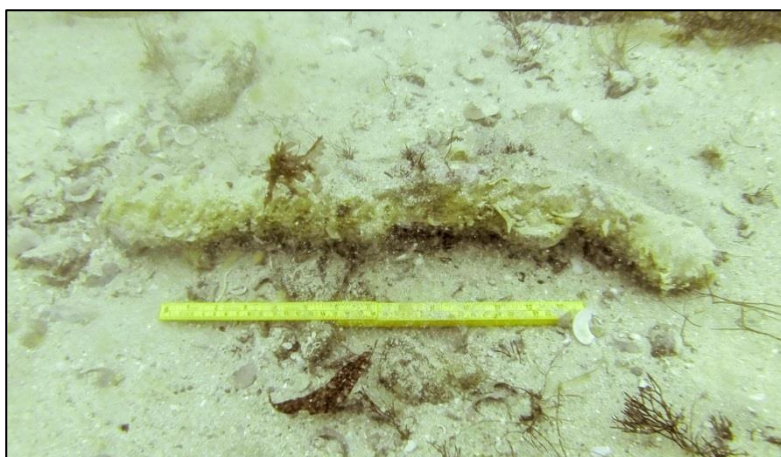
There is a scatter of ten muskets to the south east of the stern site; these have been recorded during previous projects (Camidge, 2014). However a pistol was located during the present search C10.9 – only one pistol has been found on the site previously (recovered by the previous licensee in 2002). The pistol appears to be in very good condition with all its parts still in place.

Fig 34
A pistol C10.9 found in search area
10. Note the trigger guard and
flintlock mechanism are still in
place.

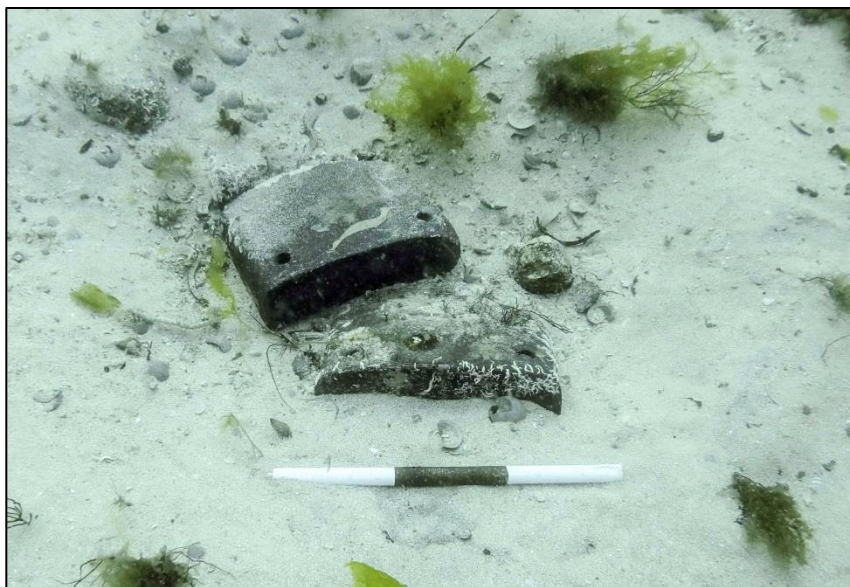
Two lead weights C10.15 were located in search area 10, just over 7m to the east of the seabed sign (close to the bottom line leading to the site from the mooring – again demonstrating that quite large objects can be overlooked by passing divers). The weights are rectangular, slightly curved and each has two holes 14mm in diameter, presumably for attachment. From the dimensions (see finds record appendix I) it has been calculated that each weight would be approximately 25kg in air. We have no idea what they were used for, and to date no concordances have been identified from similar sites. As they are in very good condition, it may be worth considering recovery of these objects to enable further study and possible identification.

*Fig 35
Two lead weights C10.15 found
to the east of the stern site.
Scale = 0.30m*
