HMS Colossus Monitoring Survey

Project Report 2010

Colossus Monitoring Survey

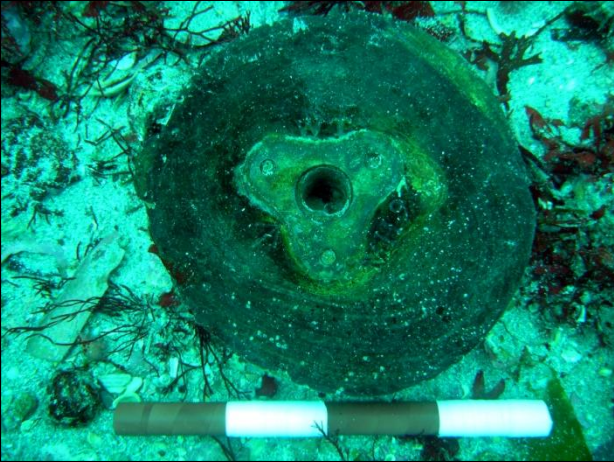
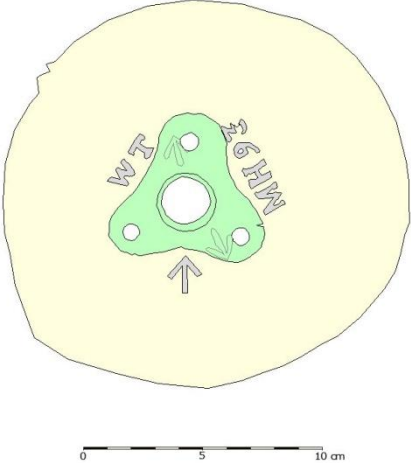
523 Sheave

The markings on this block sheave survive very well – WT denotes the manufacturer, Walter Taylor, who made blocks for the Navy under contract in Southampton in the late 18th century. MH93 denotes the date of manufacture, March 1793 (Bingeman, 2010).

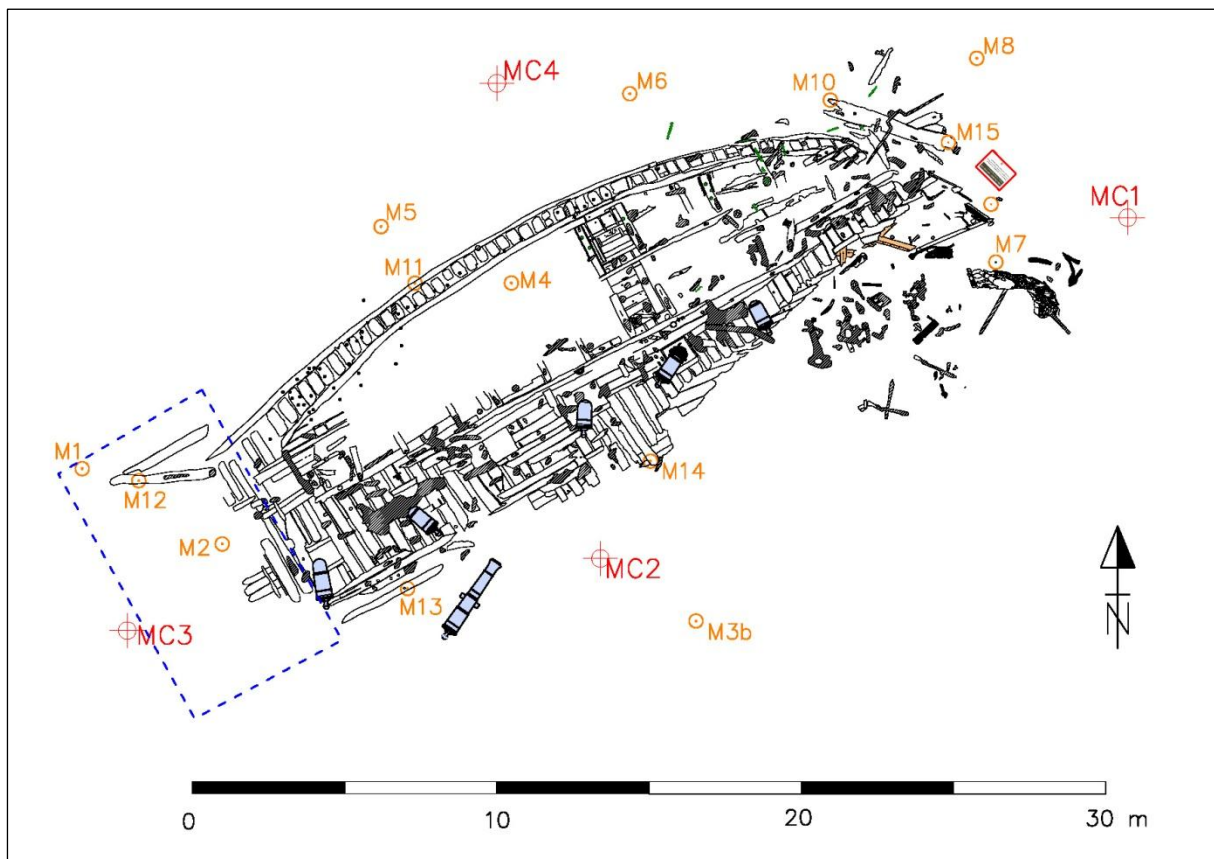
Approximately 15 square metres of newly-exposed timber was noticed at the western edge of the wreck during routine site monitoring in September 2009 (fig 5). As part of this project the newly-exposed timbers at the western end of the site were recorded by a planning frame survey and the results added to the existing site plan. The planning frame survey was undertaken using 1 x 1m planning frames positioned along baselines. These baselines were fixed by reference to the existing control points on the site. The site drawings were made on A3 mylar sheets at a scale of 1:10 and were then scanned and imported to AutoCAD. As well as recording the newly-exposed timber, a 2m strip of the already-recorded timbers was drawn, allowing an assessment of the deterioration of the wreck since this part of the site was last drawn in 2002.

Fig 5 The approximate outline of the area of newly-exposed timber which was recorded as part of this project.

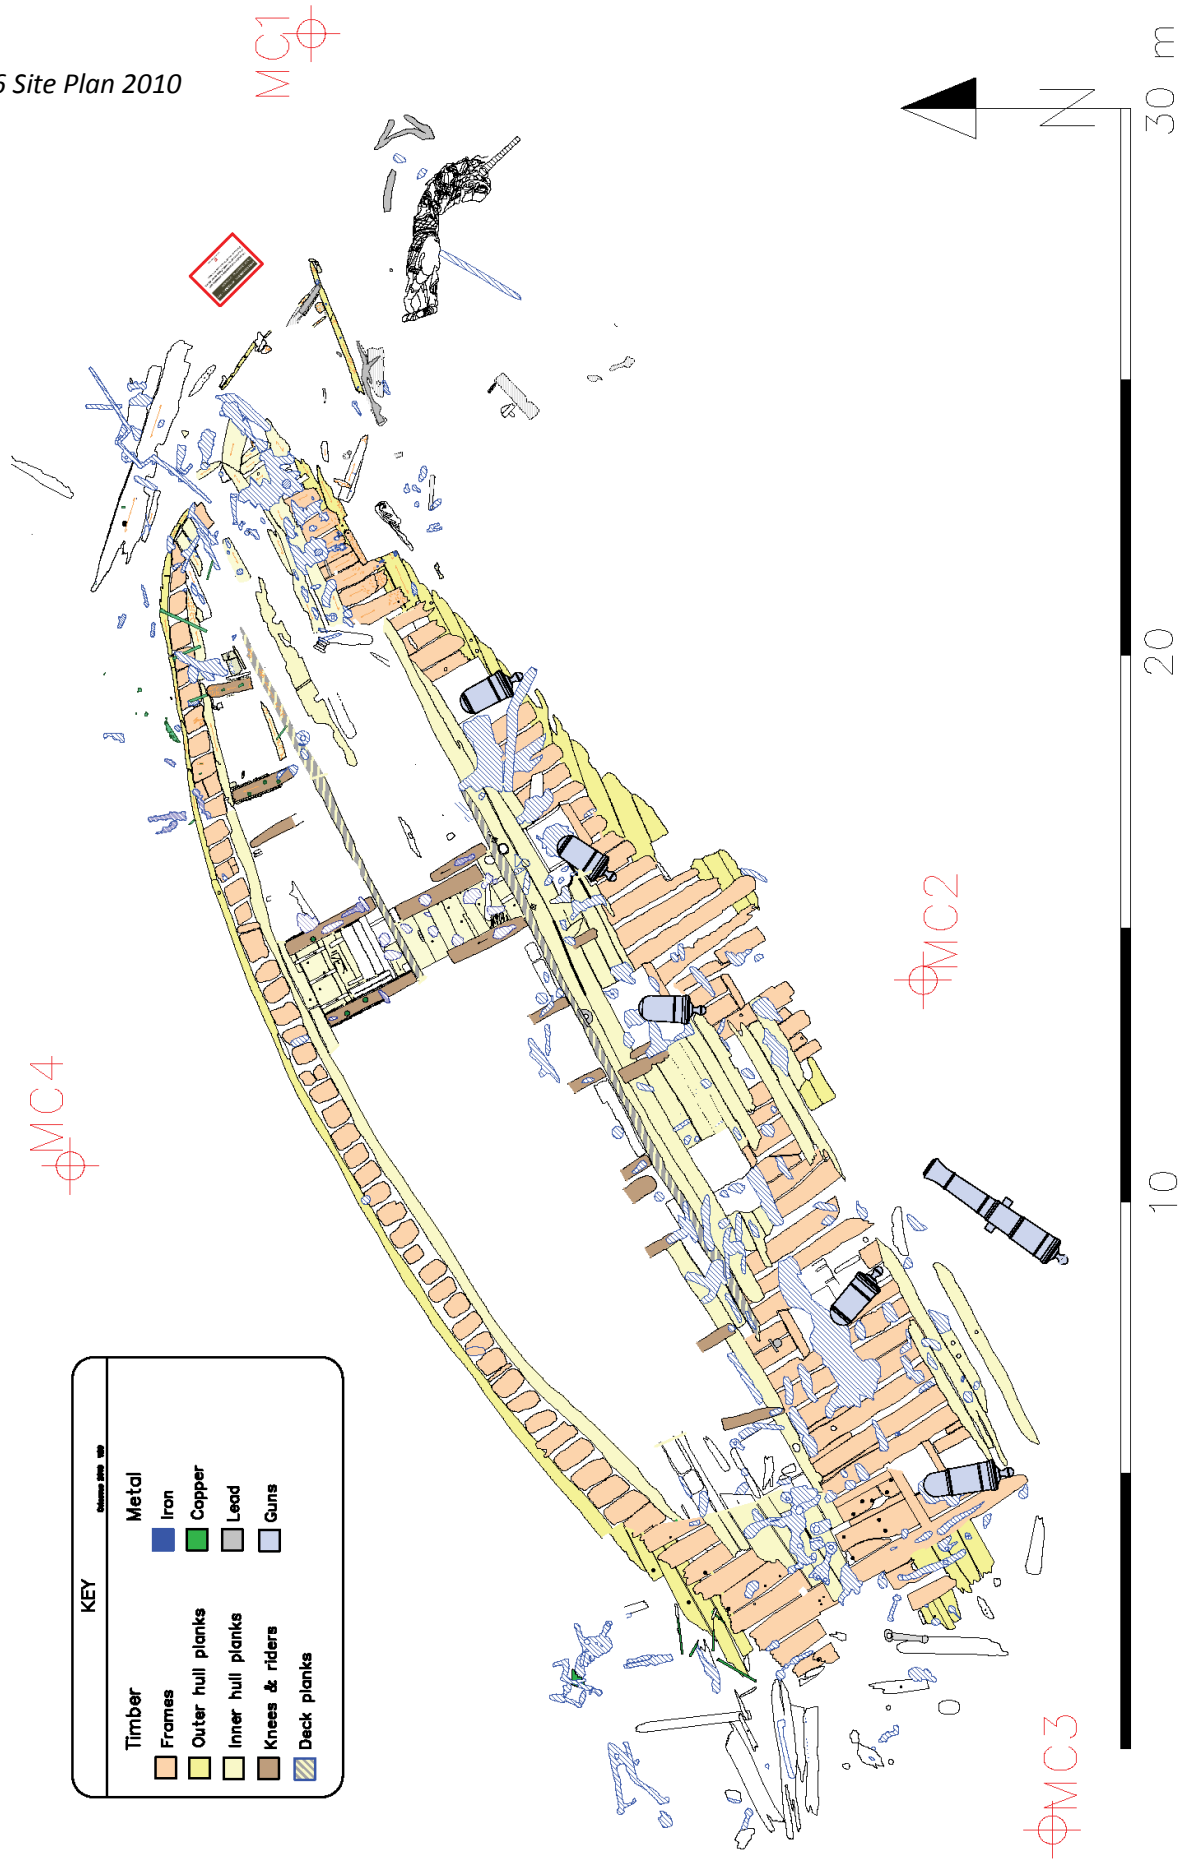
Fig 6 Site Plan 2010

The recording of the newly-exposed timbers has demonstrated that previously buried timbers are now exposed on the seabed. This is due to the documented diminution of the sediment levels around the wreck (see below). As well as the newly exposed timbers, previously exposed timber has now decayed and areas previously recorded are now missing. Previously buried iron structures were also recorded, notably part of the main mast shroud chains. The extent of these changes can best be judged by comparing fig 5 – the plan existing in 2009 – with the site plan after the newly-exposed timber was recorded this year – fig 6 below.

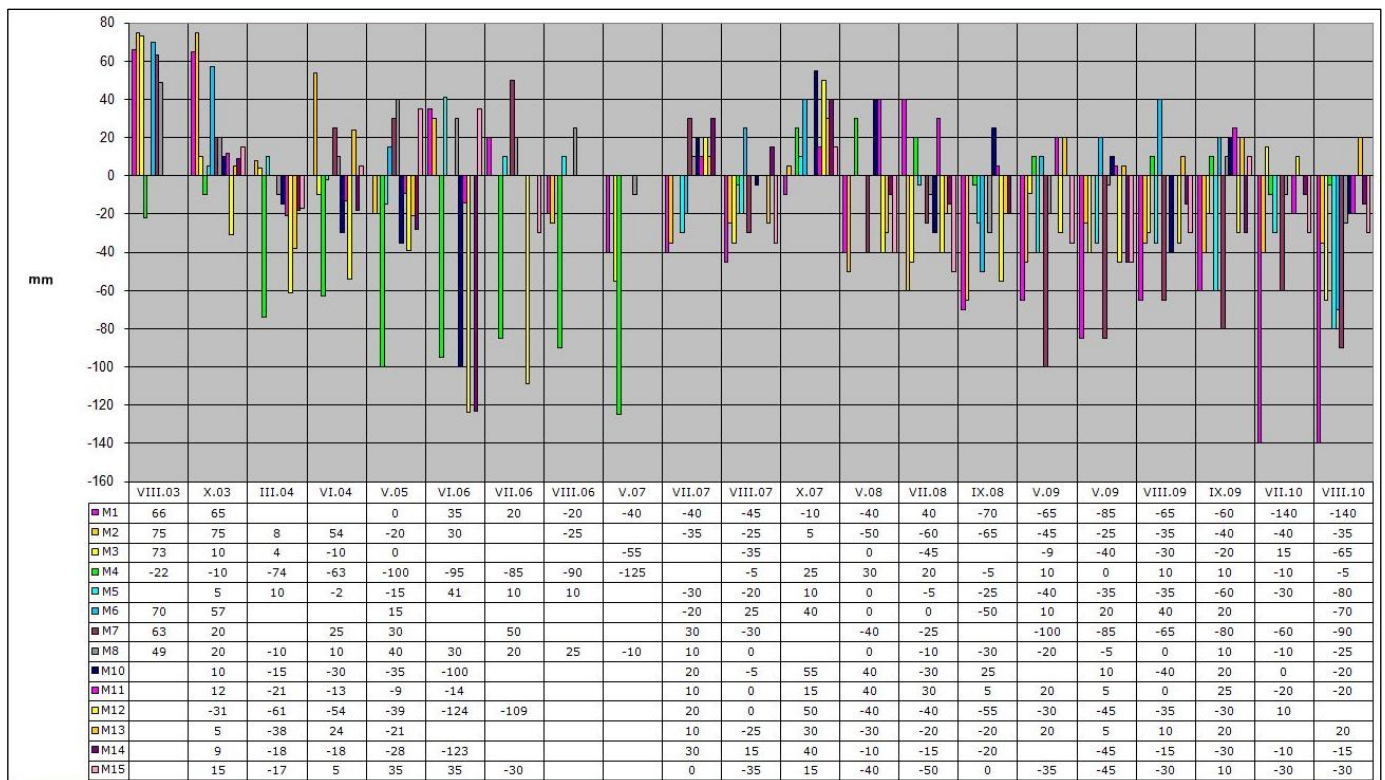
Routine monitoring of the sediment levels around the wreck was undertaken on two separate occasions this year – on 24th July and 31st August. These results are shown along with previous readings in the form of bar charts - figs 7 and 8 below. These charts confirm the impression gained by regular divers on the site that the sediment levels have fallen considerably over the last 12 months. The recorded fall in levels since September 2009 is one of the most marked recorded to date.

One of the most noticeable exposures noticed this year was in the central part of the site. Previously the timber in this area was almost entirely buried; new timber is now exposed over much of this area. Consideration should be given to the recording of this timber before it suffers decay – previous work (Camidge, 2005a) has shown that this newly exposed timber will be severely damaged and eroded within 18 months of exposure by wood boring organisms.

Fig 7 Bar chart of sediment level changes relative to May 2003 for M1 to M8; August 2003 for M10 to M15. Values shown are in millimetres; positive values denote a rise in seabed level (relative to 2003) while negative values denote a fall in seabed levels (relative to 2003).

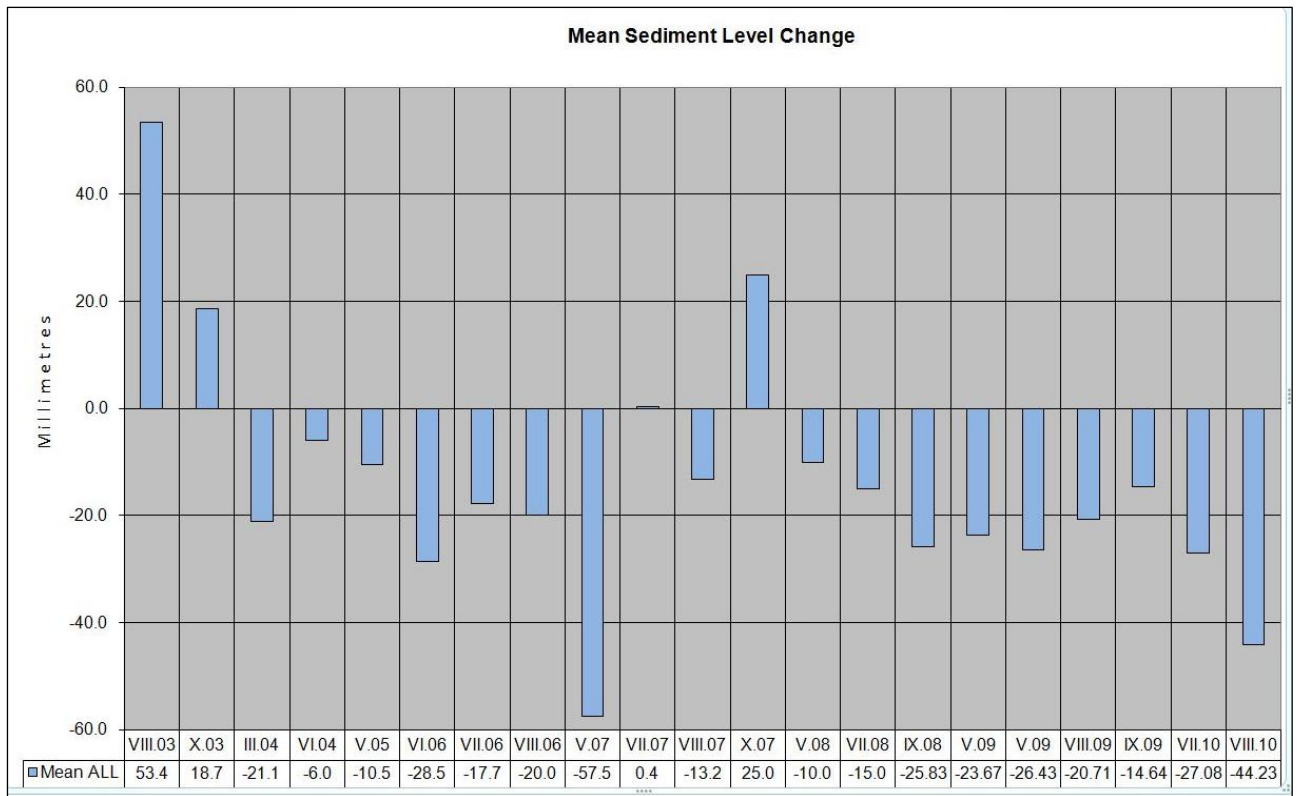
Fig 8 Bar chart showing the mean overall change in seabed sediment level (relative to the level in 2003) for all monitor points. All values are in millimetres. Zero represents the seabed level in 2003; negative values denote a mean fall in sediment levels, positive values a mean rise in sediment levels
