# HMS COLOSSUS

## SURVEY REPORT 2006

KEVIN CAMIDGE

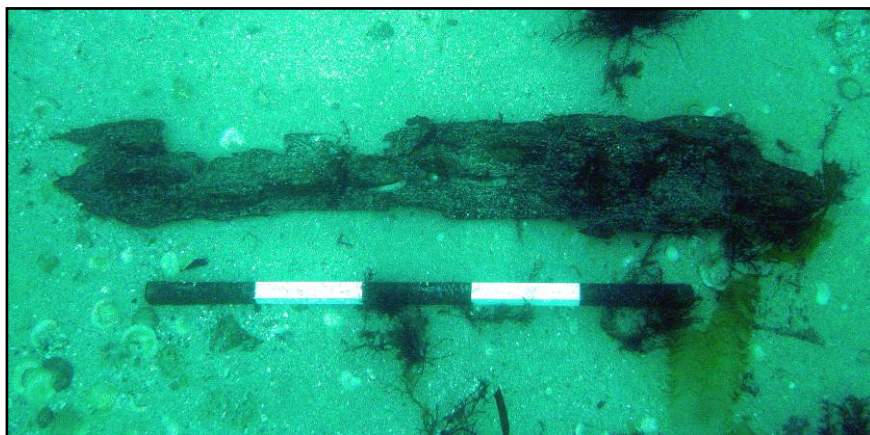
The exposed timbers on the stern site continue to deteriorate. The most obvious evidence of deterioration is due to the action of wood boring organisms *torpedo* and *limnoria*<sup>1</sup>. The exposed timber now exhibits clear signs of gribble tunnels and in the most severe cases parts of the timber have become detached and have been dispersed by the tidal flow over the site.

*Detached timber, found on the seabed 3m to the north of control point C. (260149.5E, 5535593N) Scale 0.5m*

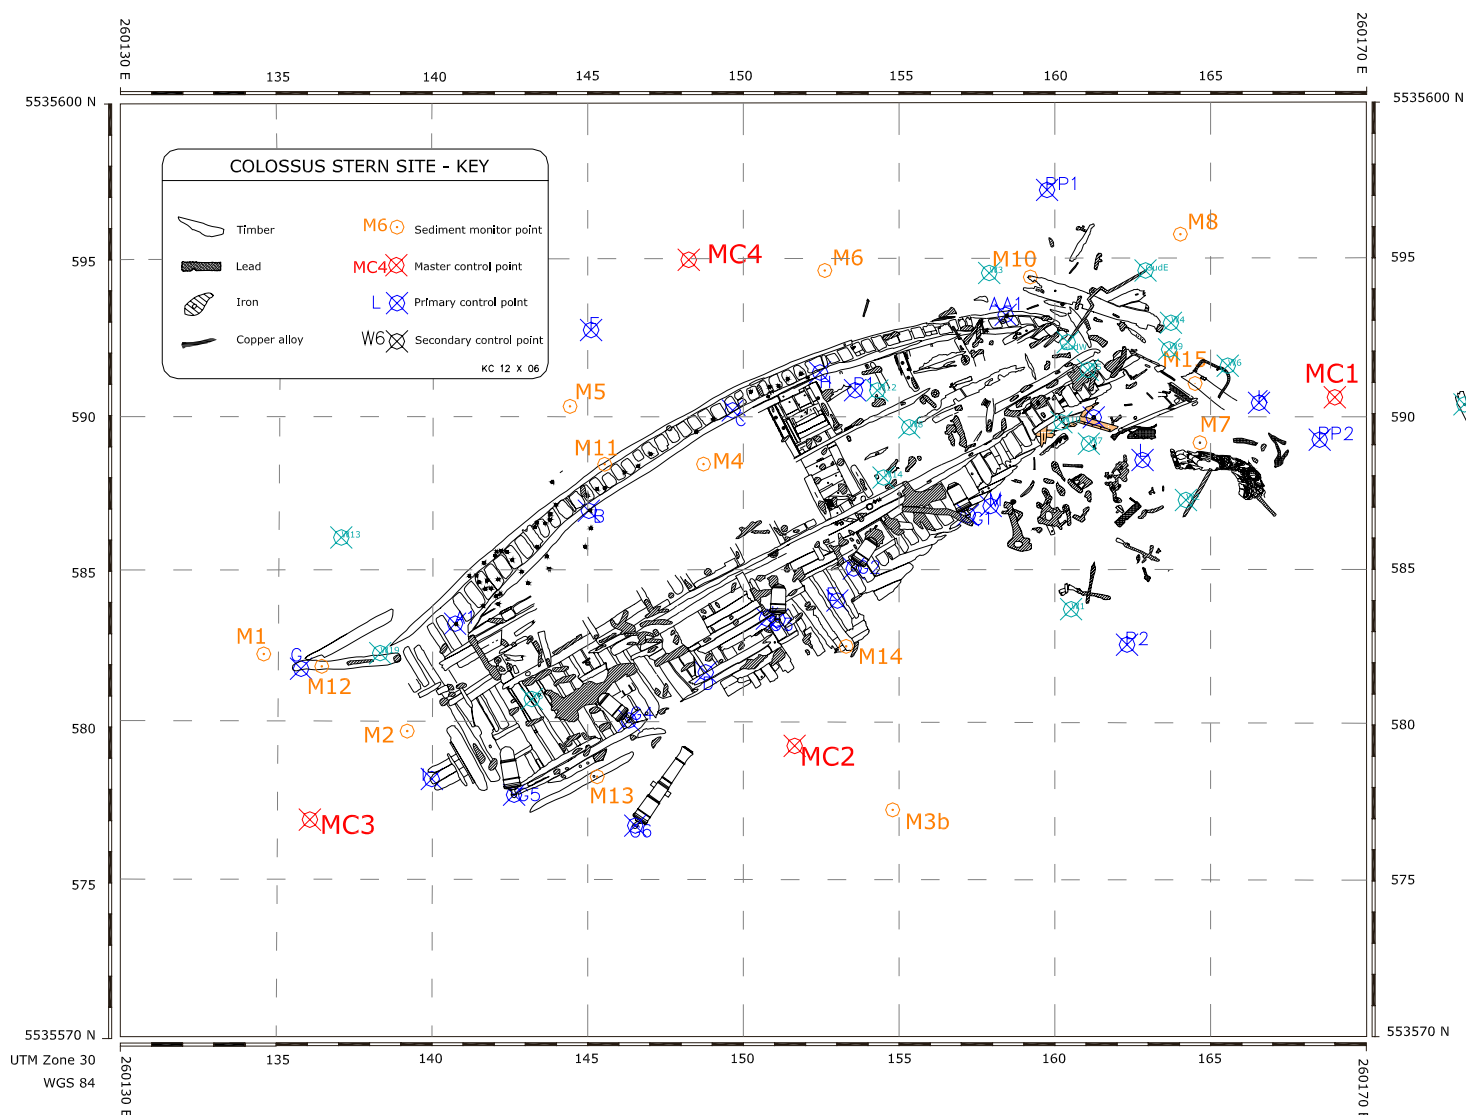
This decay is evidenced by the loss of four of the six sediment level monitoring points (M10, M11, M13 & M14) by July of this year. These were attached to sound exposed timbers of the wreck, which have now decayed so badly that the monitoring points themselves are no longer extant. The monitor points consisted of 100mm galvanised nails driven into sound timber in August 2003 – a clear indication of the ongoing deterioration of the exposed structure of the ship.

The sediment monitor pins M1 to M8 are 600mm long x 12mm diameter stainless reinforcing bars. These were fixed into the seabed around the outside of the wreck so that exactly 100mm of the bar was exposed above the seabed when they were installed in May 2003. In August 2003 six additional monitoring points M10 to M15 were installed on the timber of the wreck itself. These consisted of 100mm galvanised nails driven into the timber. Measurements from these points were taken by placing a spirit level on the top of the nail and measuring the height above the adjacent seabed. The location of all the sediment monitoring points can be seen on the plan below.

The labels on all of the control points and sediment monitoring points need to be replaced as the existing ones are now either missing or difficult to read.

New sediment monitoring points need to be installed next year to replace those which have now disappeared due to the loss of the timber to which they were attached. It is proposed that new points are installed as close as possible to the original positions (M10 to M15) so that measurements will be comparable to those taken from 2003 to 2006. Measurements of seabed sediment levels need to be continued. In particular, it would be very useful if some measurements could be made during the winter months to test the theory that sediment levels tend to fall over the winter months.

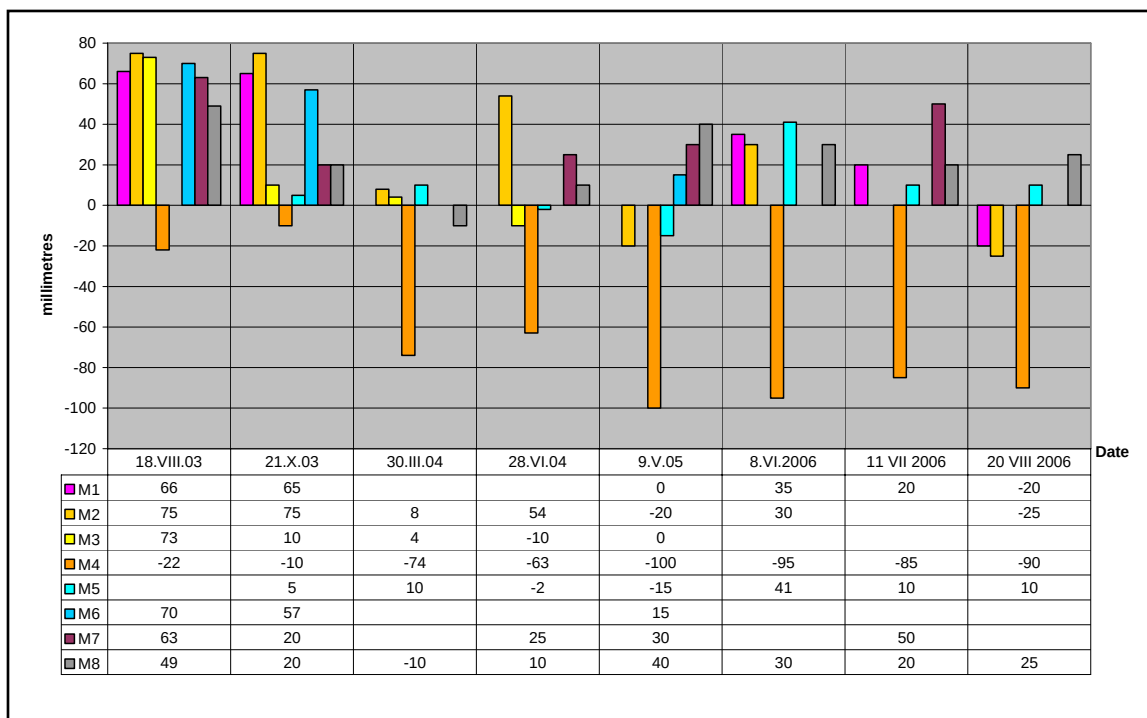
Fig 2 Chart showing the change in seabed sediment level (relative to the level in 2003) for monitor points M1 to M8. These points are located around the outside of the exposed timber – see location plan above

As can be seen from figures 1-5 above, seabed sediment levels on the site have continued to fluctuate. The overall trend, however, is for sediment levels to be lower than they were when measurements began in 2003 – see particularly fig 5. The theory proposed in the Colossus Stabilisation Trial report that the sediment levels fall during the winter months and slowly rise in the summer months needs to be tested by continuing to monitor the sediment levels on the site.

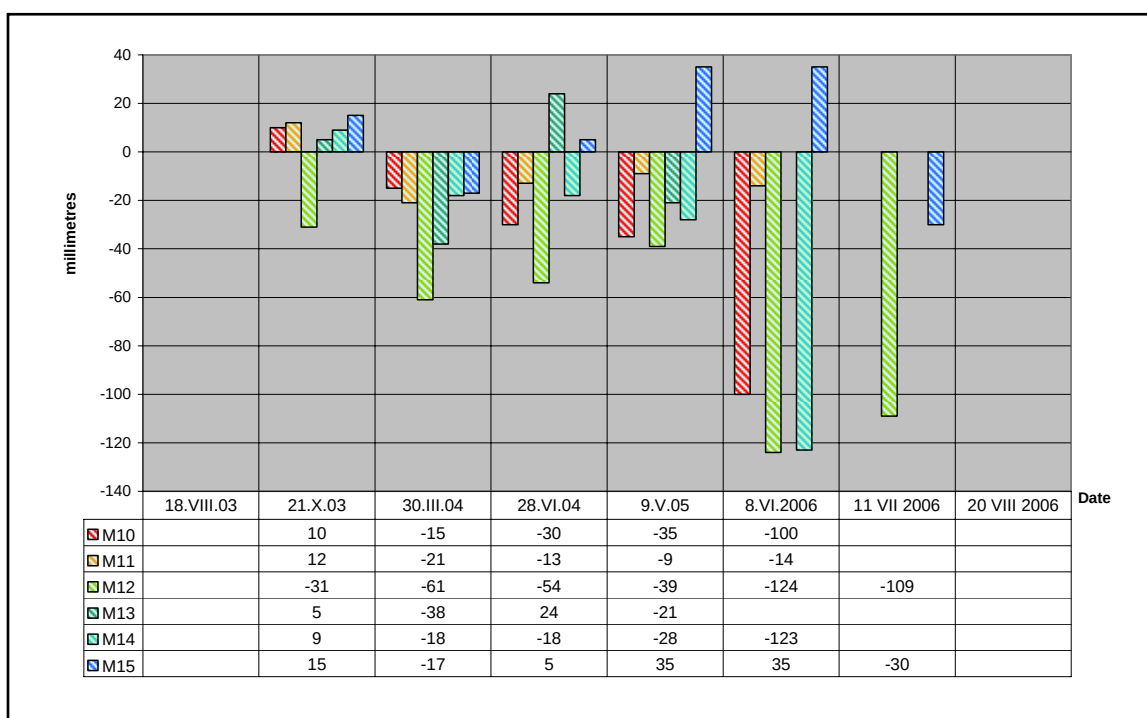
Fig 3 Chart showing the change in seabed sediment level (relative to the level in 2003) for monitor points M10 to M15. These points are located adjacent to the exposed timber – see location plan above

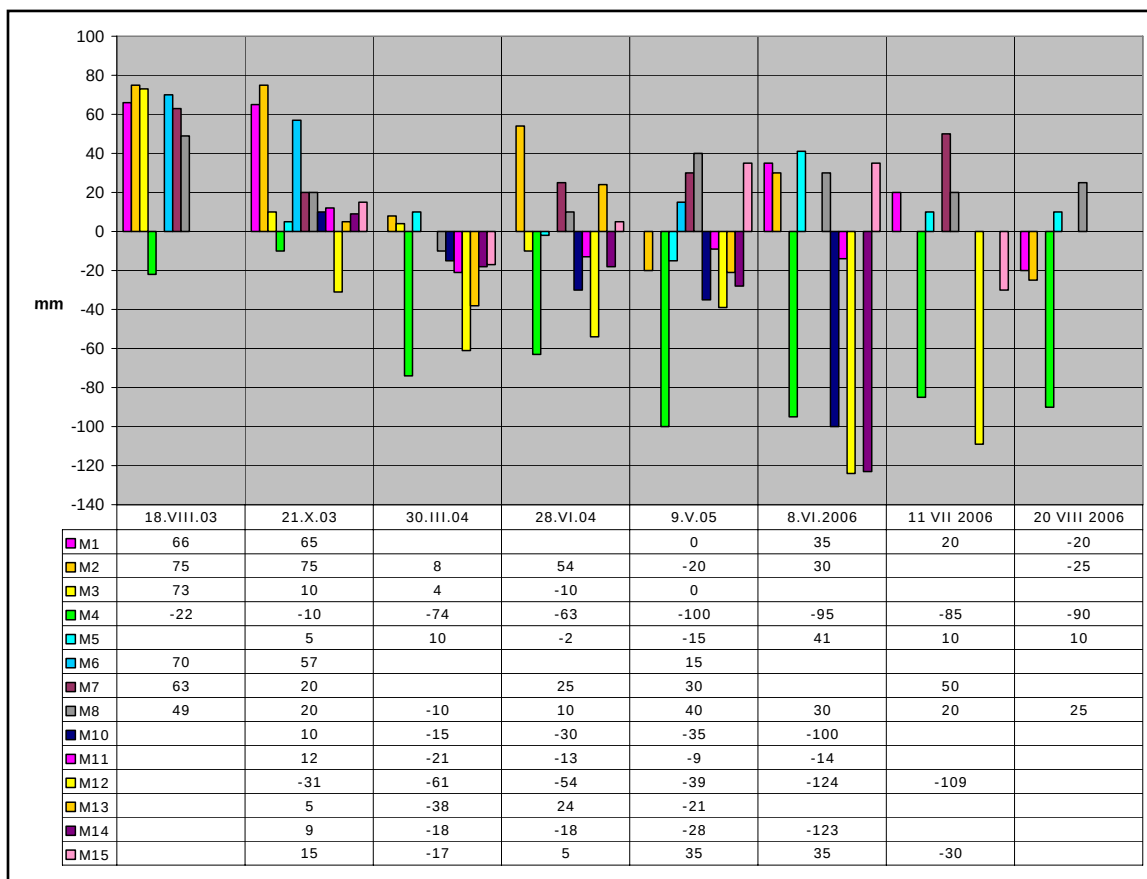
Fig 4 Chart showing the change in seabed sediment level (relative to the level in 2003) for all monitor points. Zero represents the seabed level in 2003, negative values denote a fall in sediment levels, positive values a rise in sediment levels

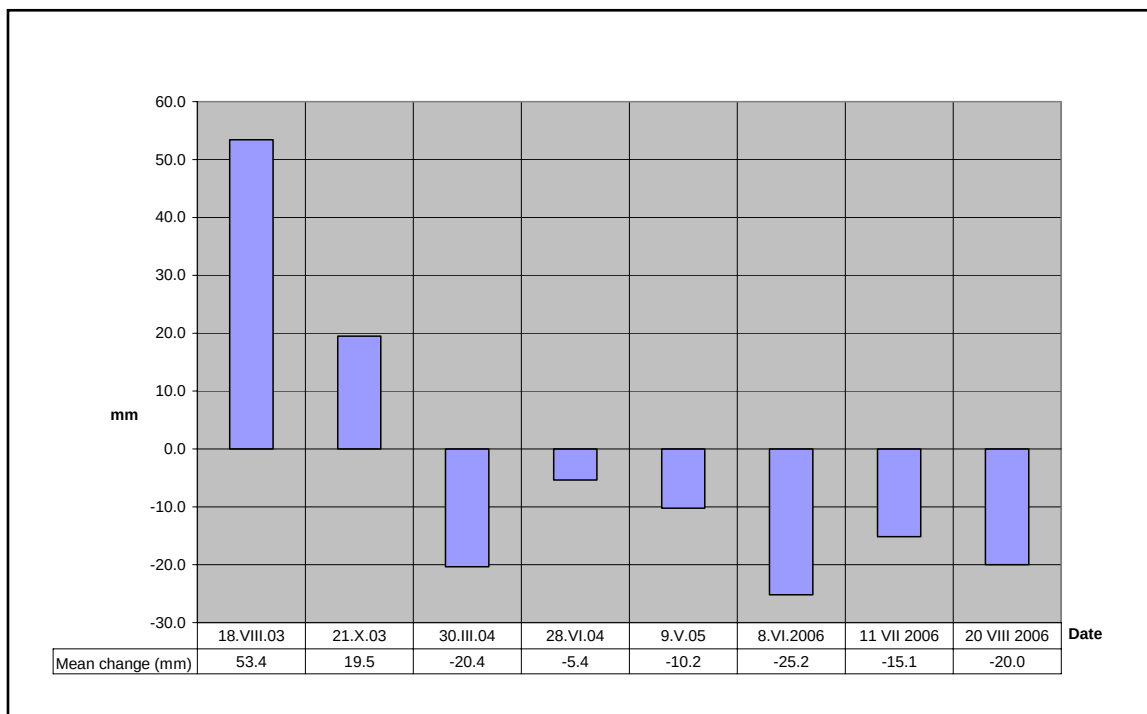
Fig 5 Chart showing the mean overall change in seabed sediment level (relative to the level in 2003) for all monitor points. Zero represents the seabed level in 2003, negative values denote a mean fall in sediment levels, positive values a mean rise in sediment levels

Continued monitoring of the exposed timber is essential, particularly as it is clear from the sediment monitoring that the seabed sediment levels are continuing to fluctuate, but are consistently lower than they were in 2003 when the sediment monitoring was started. In particular the elements exposed and subsequently reburied at the stern of the vessel by the ADU in 2001, which were of outstanding quality and preservation, need to be watched in case they become exposed and thus subject to rapid deterioration. As it is inevitable given the current seabed level trends that this stern area will eventually become exposed, this area should be considered for stabilisation - as proposed in the Colossus Stabilisation Trial report in 2005. Failing this, then the small area at the stern should be excavated and properly recorded before it is too late. Careful consideration of the resources required for such an undertaking would need to be made.

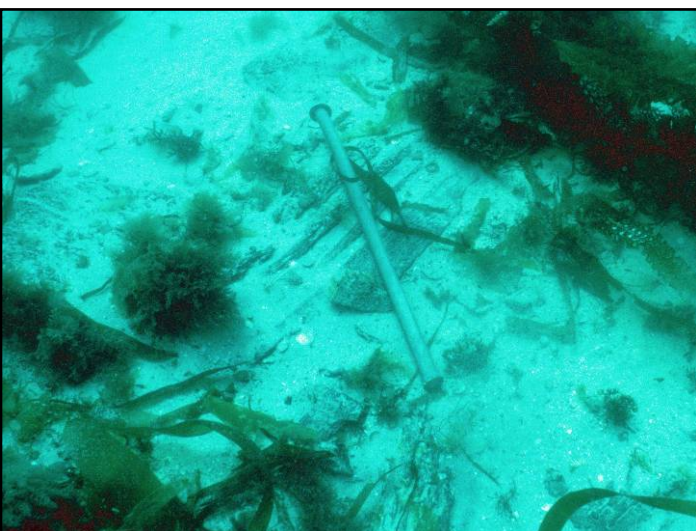
*Below left: Copper fastening bolt with rove attached. Western end of the exposed timber, close to control point A1. This was not visible when the site plan was made (2001 to 2003) and has almost certainly been moved.*

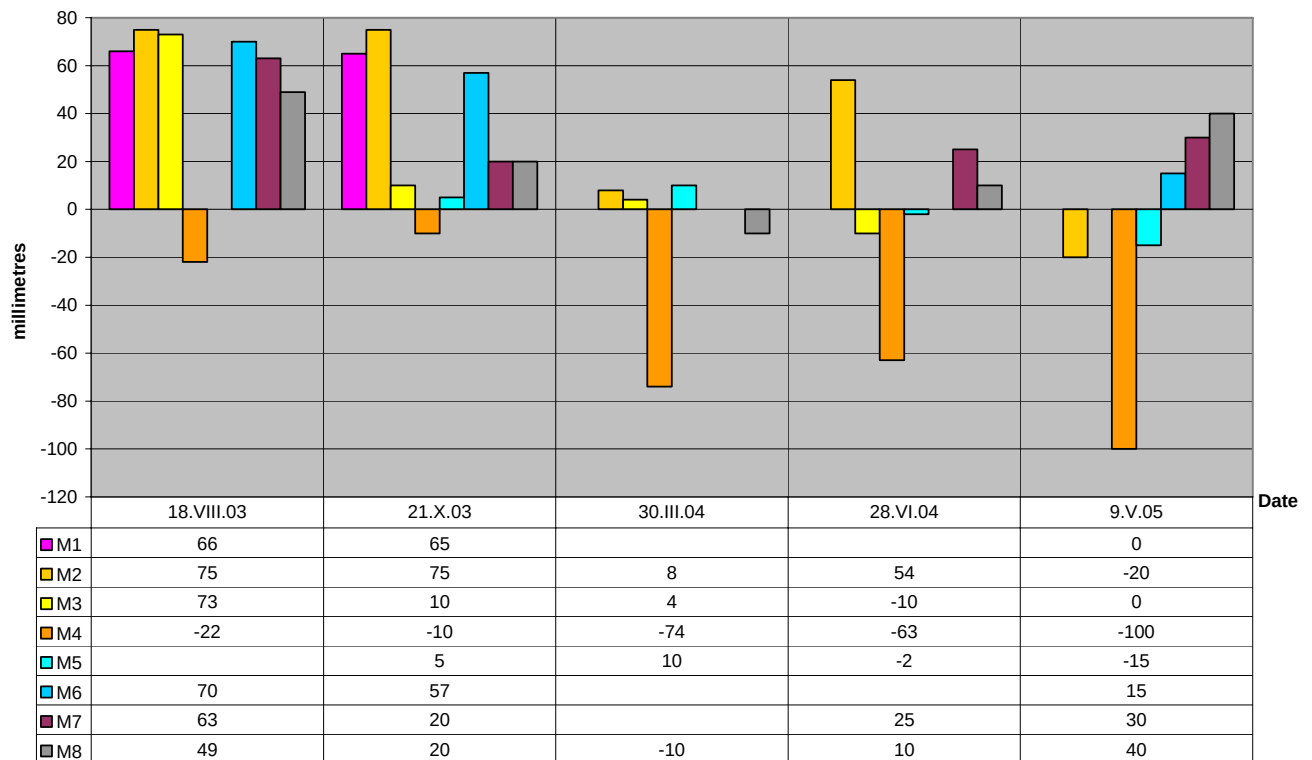
Fig 10 Seabed levels relative to those in May 2003 at monitor points M1 – M8

All except one of these monitoring points were situated around the outside of the exposed timber of the wreck. The exception was M4 which was placed in the centre of the wreckage (see sediment monitor location plan fig 3). The seabed level at M4 fell fairly consistently throughout the period of the trial.

The other seven points (M1-M3 and M5-M8) all recorded rises in sediment over the first three months of the trial of 49 – 75mm. This accumulation of sediment largely disappeared over the winter (between October 2003 and March 2003); at the March 2004 inspection the levels were roughly comparable with those at installation. The June 2004 inspection revealed a more mixed picture with three of the points (M3, M4 and M5) showing a fall in levels while the other three points (M2, M7 and M8) showed a rise in seabed levels. At the final inspection in May 2005 two points (M1 and M3) were the same level as in May 2003. Three points (M2, M4 and M5) showed decreased seabed levels and three points (M6, M7 and M8) showed a rise in sediment levels. Interestingly, all three of the locations showing a rise in level at this final inspection are all on the eastern side of the wreck. The evidence is not conclusive but it would seem that there is a tendency for sediment to accumulate throughout the summer months and to fall during the winter months. If this is a genuine and ongoing trend then its cause may well be the higher energy conditions generated by winter storms.

After the two years of the trial the mean of the seabed level measurements taken at these eight points (M1- M8) was -6.25mm. This is a relatively small change but can have a major impact on exposing timber which is only just below the surface of the seabed. So although the levels vary, currently the overall trend is one of sediment loss at these original monitor points.

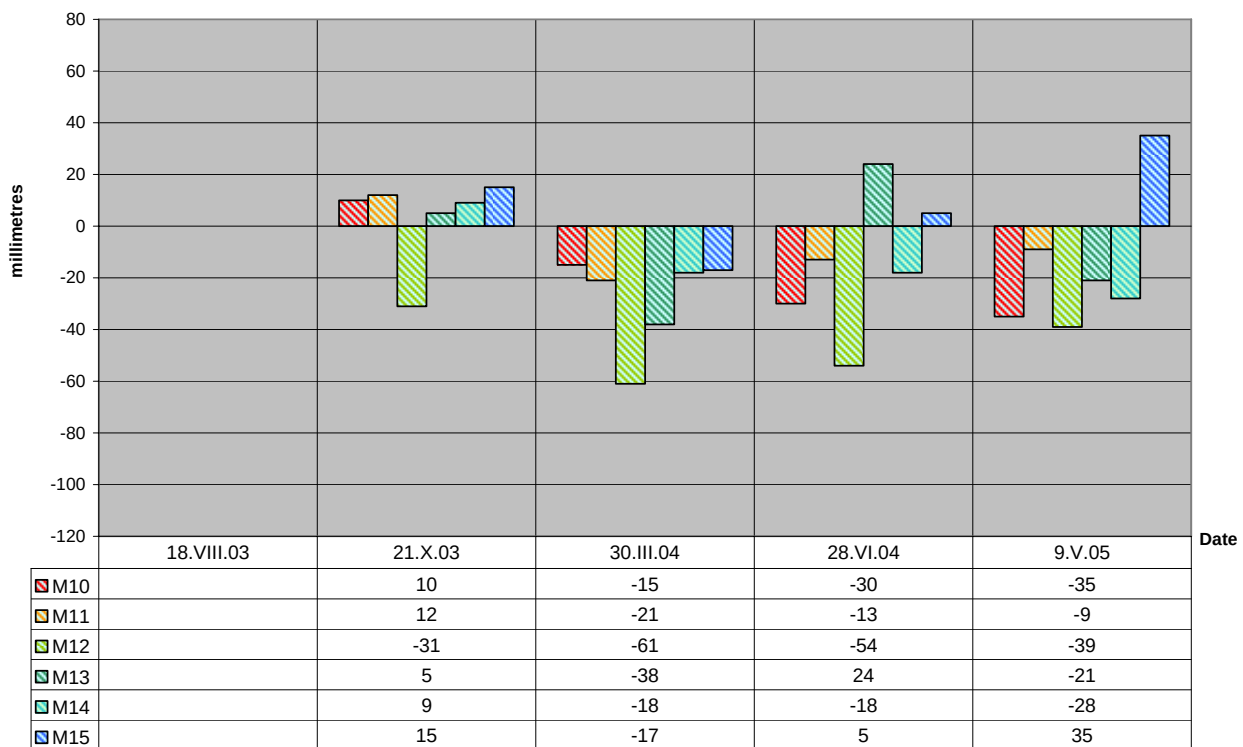
Fig 11 Seabed levels relative to those in August 2003 at monitor points M10 –M15

In August 2003 six extra sand monitoring points (M10 – M15) were installed. These were all placed adjacent to the exposed timber on the seabed in an effort to monitor the conditions immediately adjacent to the timber, where continuing seabed level decline had been observed.

After three months (October 2003) all except one of these points showed a small rise in sediment level. The exception, M12, showed a fall of 31mm. At the next inspection in March 2004, sediment levels at all six points had fallen (relative to the levels at installation in August 2003). For the remainder of the trial, the majority of these points showed a fall in the sediment levels since August 2003. This trend is visually more convincing on the sediment level charts (fig 11) for this set of points when compared to those for the original points M1 – M8. After the two years of the trial the mean of the seabed level measurements taken at these six points (M10 - M15) was -16.2mm. So although there is some variation in levels there is a strong overall trend of sediment loss at these six monitor points.

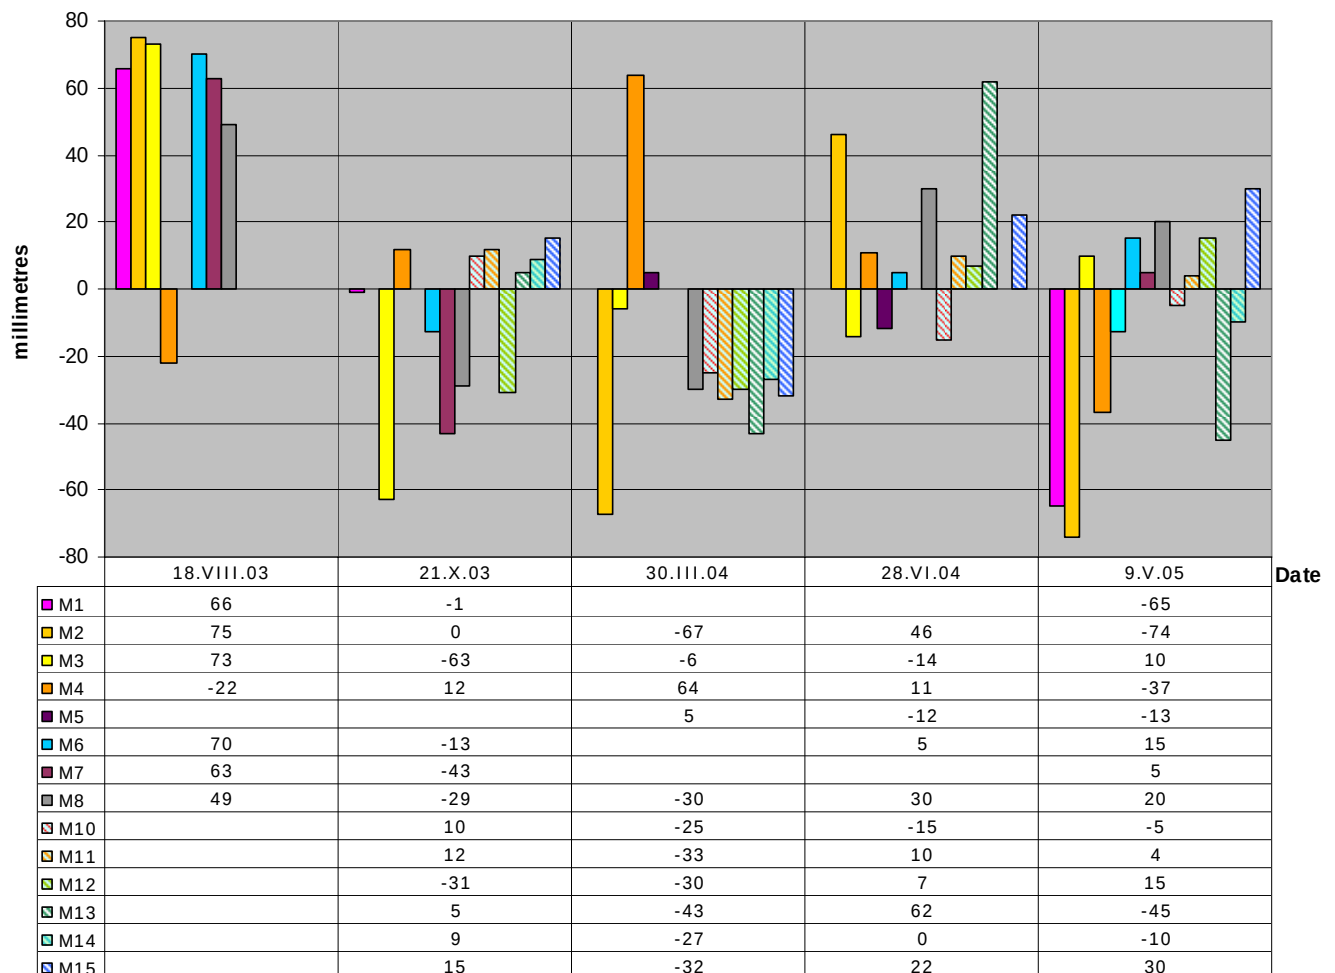
Fig 12 Seabed level changes between inspections recorded at monitor points M1 –M15

From the chart above it is apparent that there is no overall clear cut rise and fall of the seabed levels over the whole site. Considering all fourteen monitor points together, there was not any inspection where all the observations were sediment rises or falls – but always a mixture of the two. What this does illustrate is that there is measurable sediment mobility over the site. The tendency to sediment level falls at the edges of the exposed timber (monitor points M10 – M15) perhaps demonstrates scouring at the edges of the exposed timber.

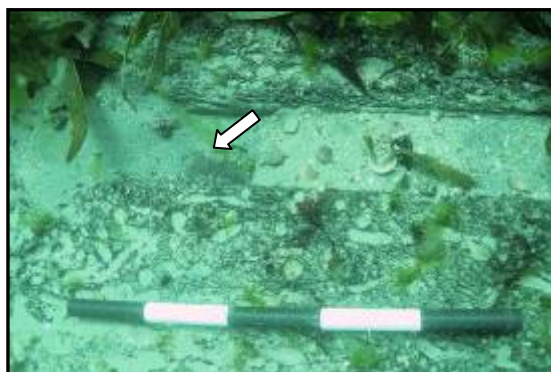
From observations of the exposed timbers of Colossus it is also apparent that crabs are digging holes around the timbers and are probably contributing to local scouring around them. This phenomenon has been observed on a number of occasions during the stabilisation trials. Some of the observed holes dug by crabs are of an impressive size.

*Edible crab digging a hole between frame timbers east of Gun 1.*

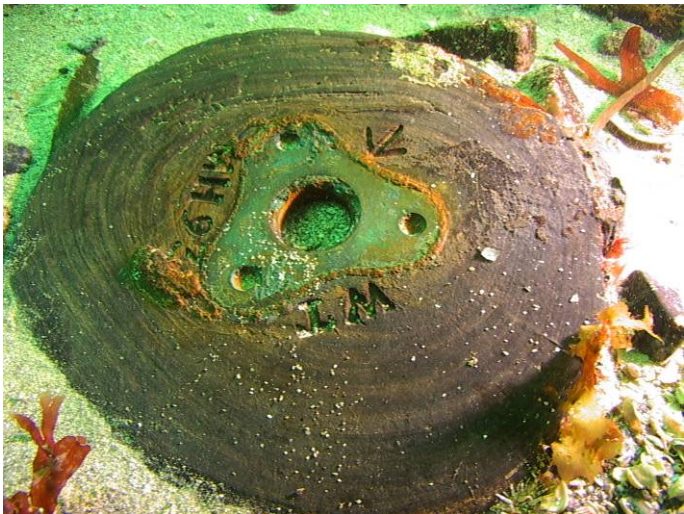
Sheave photograph

The only other thing of note to report that was performed while under your survey licence, was the placing of a sandbag over an artefact on the stern section of the wreck. The artefact, a lignum vitea sheave, was totally uncovered and in danger of being lost over the winter. After consultation with EH the task was performed just prior to a force eleven gale which could have resulted in the artefact being further dislodged or even lost. We photographed the sheave before placing the sand bag. (see photograph supplied)
