# ***Royal Anne Galley*** **Marine Environmental Assessment** **The Lizard, Cornwall**

## **Phase 4: Inspection and Monitoring**

| <b>Report Number</b> | <b>2014R052</b> |
| <b>Date</b> | <b>17 September 2014</b> |

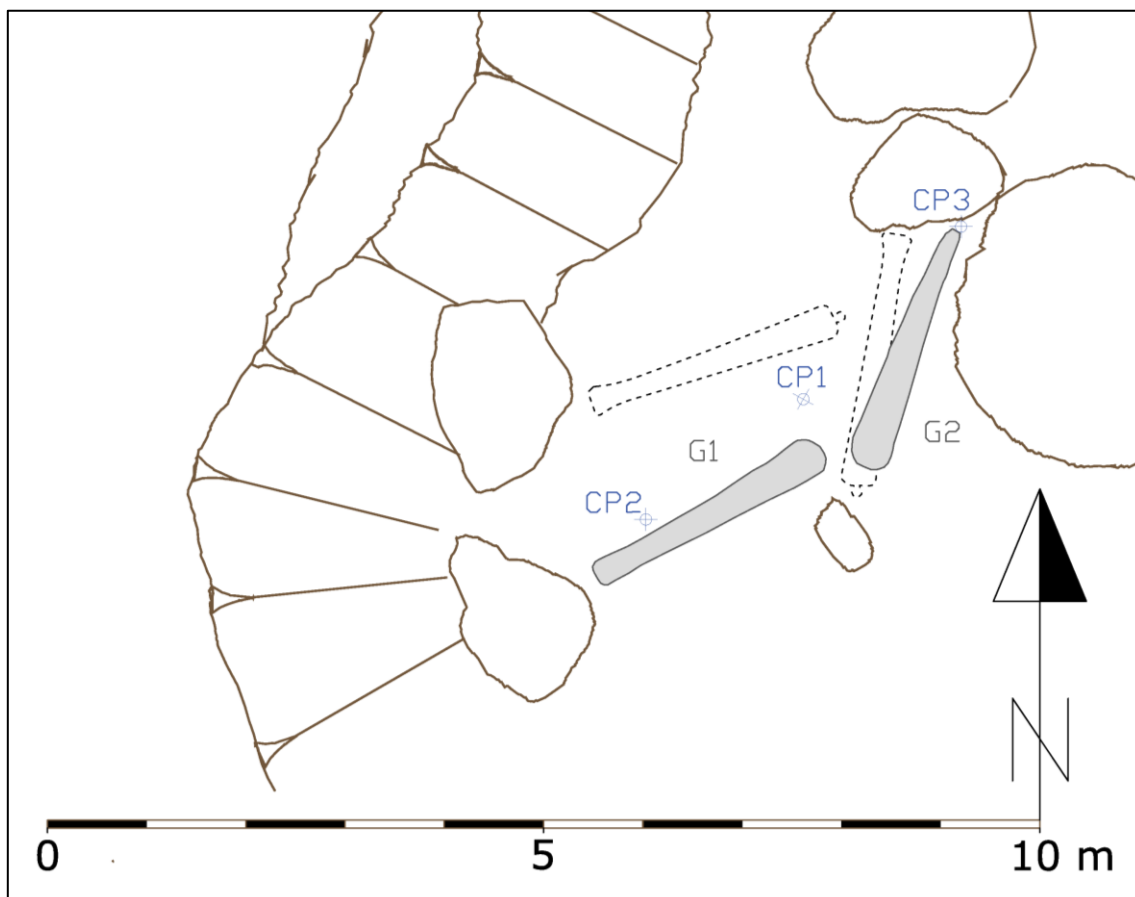
As soon as the two iron guns (G1 and G2) were relocated in June this year it was apparent that their relative positions had changed since October 2010 (Fig 3). Further investigation showed that the muzzle of Gun 2 had moved about 0.55m to the west — the gun had been rotated about its breach. The other gun (G1) had moved 1.6m to the south and had been rotated by about 10°. The surface of this gun is also now free from concretion, showing an area of exposed and actively corroding iron on its surface. This is probably where the gun was previously concreted to the seabed, this part now being uppermost, the gun having been rotated by about 180° about its long axis.

*Fig 3 Plan showing the relative positions of Guns 1 and 2. The dashed outlines show the guns as they were in 2010; the solid outlines shaded in grey show the guns as they were surveyed in June 2014. The new control points installed in 2014 are shown in blue (CP1, CP2 and CP3)*

Both guns are in poor condition, and are missing their buttons and trunnions. The lack of trunnions in particular suggests that these guns have been subject to movement and erosion since their deposition in 1721. When surveyed in June 2014, Gun 1 showed several areas of active corrosion where concretion had been removed from the surface of the gun, possibly during the winter storms of early 2014. Recording of the guns began by filling in the CISMAS underwater gun recording form, although unfortunately due to the poor state of these guns only a few of the usual measurements were possible (see Table 2 below).

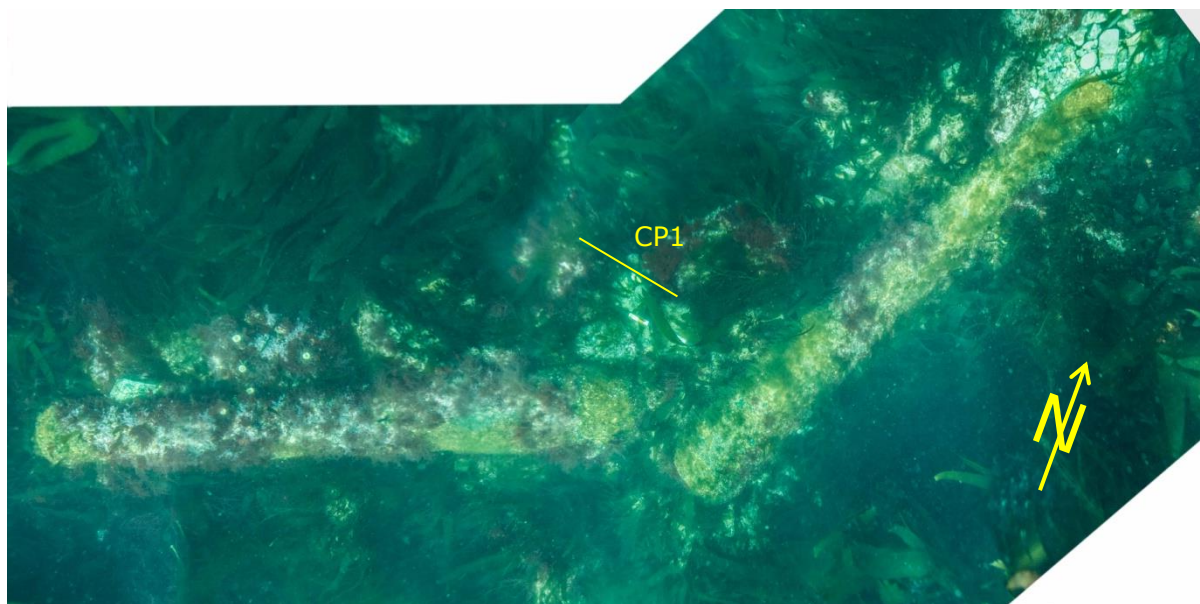
Fig 4 2D photomosaic of Guns 1 and 2. Survey control point 1 is visible near the centre of the picture. The scale (between the two guns, partly obscured by weed, next to the yellow line) is 0.5m long

The next stage in the recording was the production of a 2D photomosaic of the guns produced from a number of overhead underwater photographs (Fig 4). This was necessary as the underwater visibility was not great enough to allow both guns to be captured in a single photograph – even with a wide-angle lens. The photomosaic was then scaled and used to produce the new outline plan of the two guns.

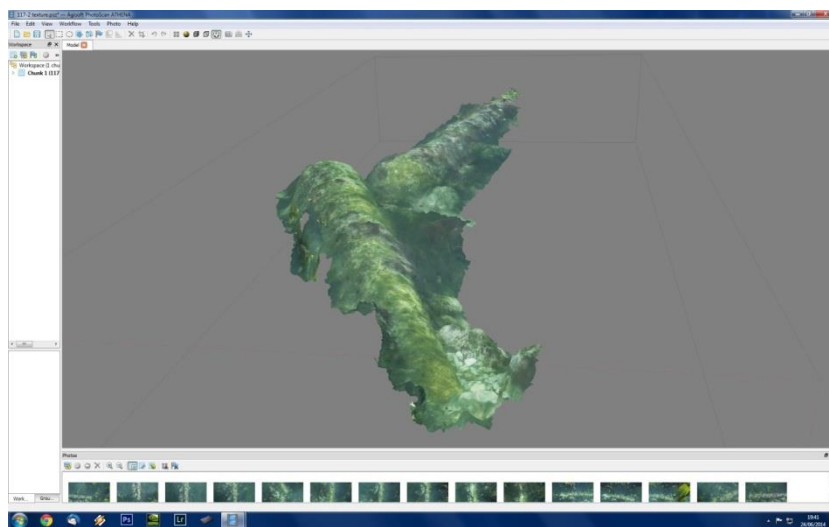
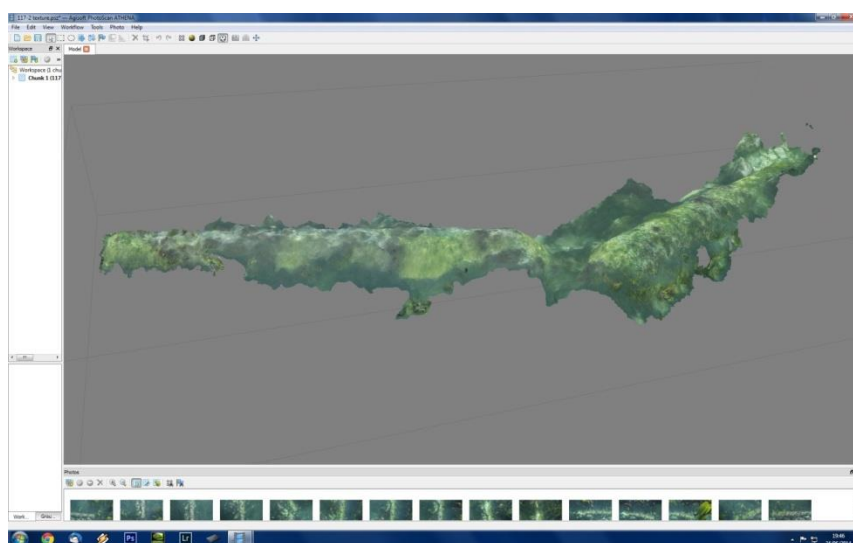
Finally, by way of an experiment, an attempt was made to produce a 3D model of the guns (Fig 5). The conditions were far from perfect, with a profusion of weed and kelp moving in the water making a series of aligned photographs very difficult; the weed moves between camera positions and confuses the alignment software. Normally all weed is removed before attempting 3D photo modelling (McCarthy and Benjamin 2014) but this was impractical in the time available. An alignment was attempted using over 100 underwater photographs processed using Agisoft Photoscan software. The results were never going to be good as the viewpoints were limited by the upstanding weed growth around the guns and by adjacent large rocks. The resulting 3D model has a number of visible lacunae (caused by weed) but it exhibits reasonable dimensional accuracy. CISMAS intends to experiment further with this technique underwater (we have had very good results producing accurate 3D models of cannon and anchors on land).

*Fig 5 Screen shots of the 3D model of the two guns. Each shot shows a different viewpoint of the model*

The two iron guns on the site were surveyed (to establish their new position) and drawn by means of a 2D photo-mosaic. A 3D photo model of the guns was also made; this proved to be reasonably accurate but the resulting image was unsatisfactory due to lacunae caused by the abundant weed growth around the guns.

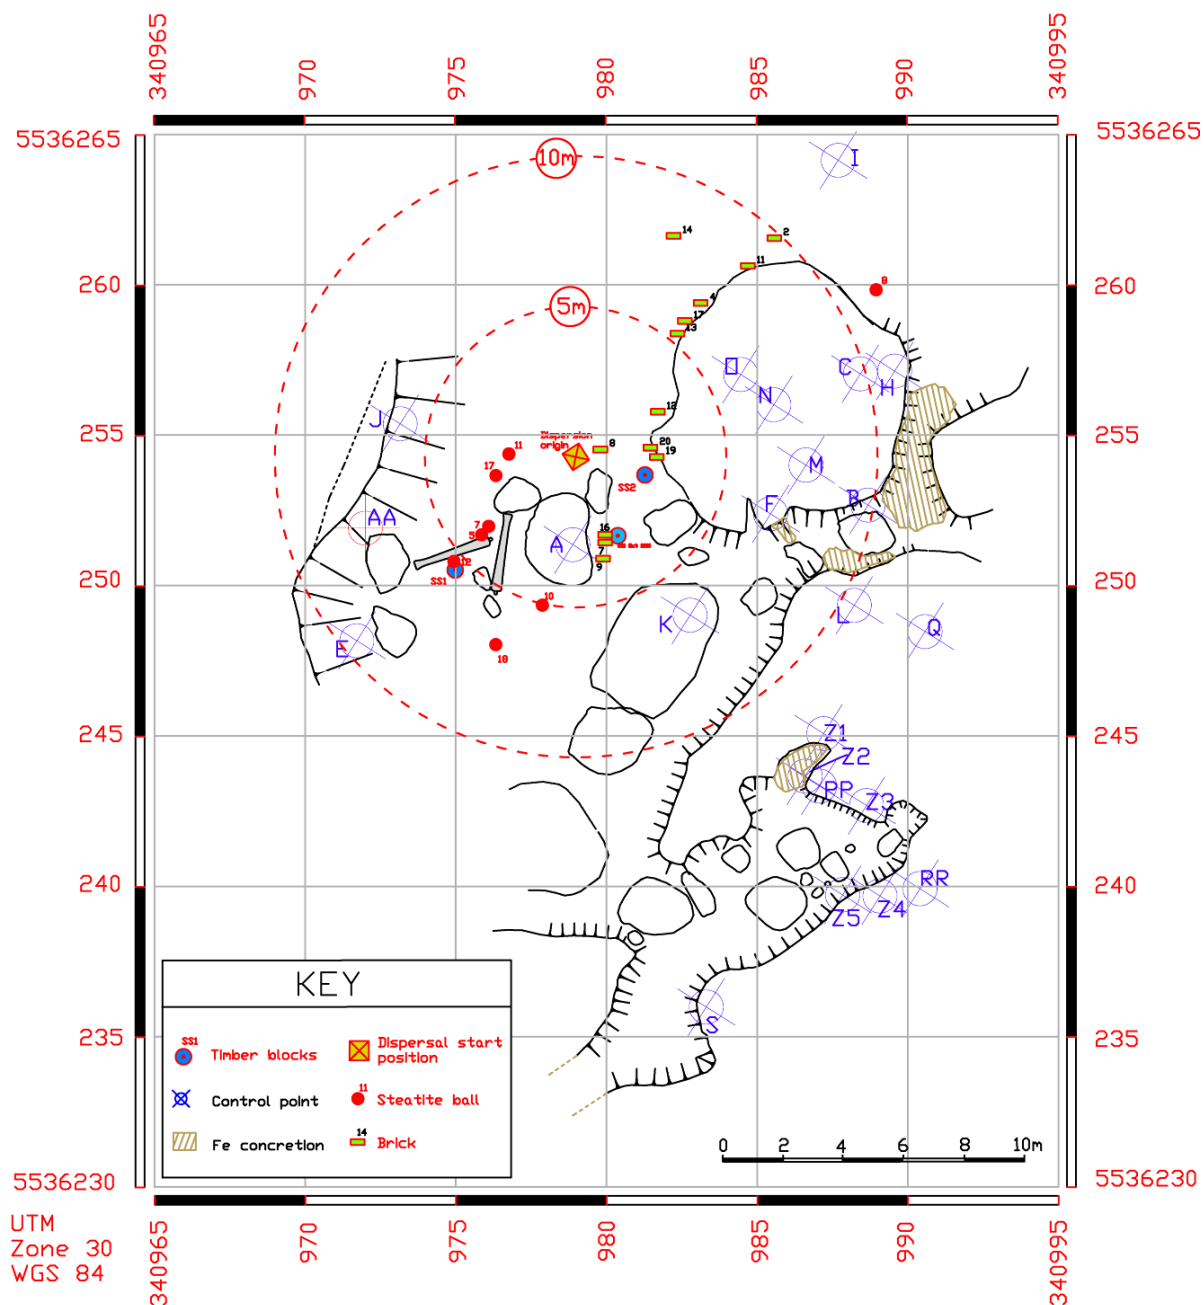
What is remarkable for such a high-energy site is the high percentage of the dispersal objects relocated within 10m of their starting position (Fig 7). Those who know this site all predicted that most—if not all—of the dispersal objects would be lost. What is even more surprising is the distribution of the dispersal objects as recorded in October 2010 (Figs 9 and 10 below). With the single exception of sphere 8, the objects had been sorted into two distinct areas; the bricks had all been moved to the east while the spheres have all been moved to the west of their original positions (Fig 12). This 'sorting' of the dispersal objects was a most unexpected result. As the two types of object have similar densities (2408kg/m<sup>3</sup> and 2735kg/ m<sup>3</sup>) the differentiation was likely to be due to their different size and shape. This theory was bolstered by the fact that the granite block SS1 measuring 0.2mx0.35mx0.25m and weighing 30kg was moved by 5m to the east between deployment and recovery—thus behaving in the same way as the bricks. Why the smaller spheres had been moved in a different direction is not clear. The following comments were received from Jon Rees, principal oceanographer at Cefas:

Fig 9 Site plan showing the positions of the dispersal objects (deployed 16 April 2009 and their positions 18 months later, on 16 October 2010)

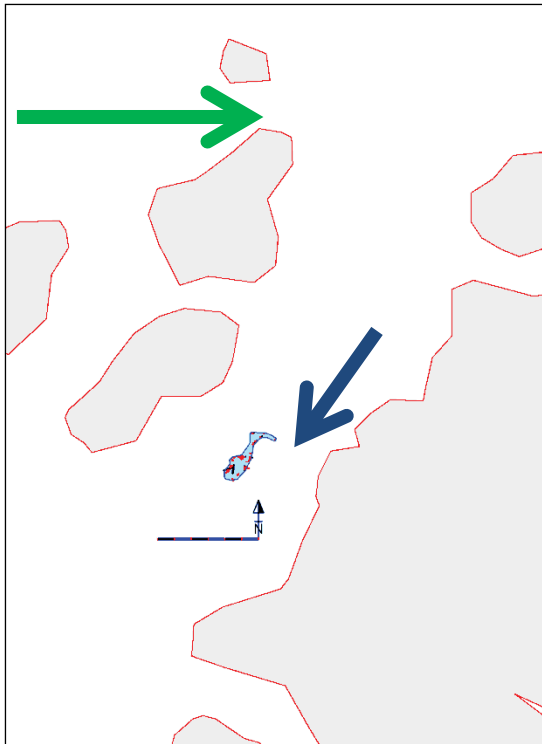
**Fig 11**

The dispersal objects now all occupied a narrow corridor aligned north-east/south-west (see Fig 10). This perhaps suggests that the main forces acting on these objects are aligned in a similar direction. This is also surprising as the main observable force acting on the site is the prevailing swell which invariably sweeps the site from west to east, which is different from the observed movement of the dispersal objects. The key to understanding this may lie in the sub-surface terrain of the area around the site. Plotting the rocks which break water at spring lows shows that the site lies in a long north east — south west gully, which may well channel the swell and current along this alignment (Fig 11). Without proper measurements of water movements over the site, it is not possible to be certain; but the position of the dispersal objects in 2010 would seem to indicate this.

The outline of the dispersal corridor is shown (blue arrow) relative to the rocks which dry at low water. This demonstrates how the dispersal objects form a pattern which aligns with the deeper water running north-east / south west through the site. The scale bar is 30m long with 5m divisions. The green arrow indicates the direction of travel of the prevailing swell

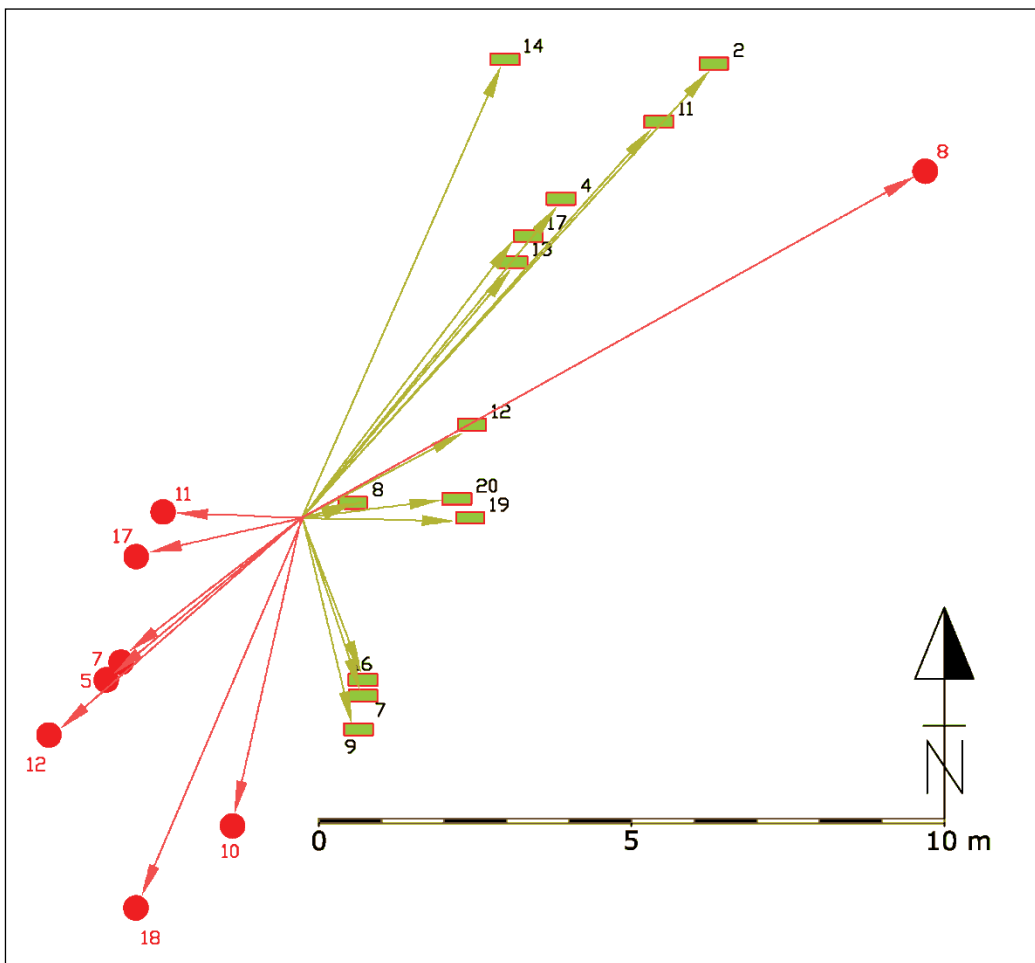
It has been suggested (EH comments on first draft report) that the differential movement of the two types of object (bricks and spheres) may have been caused by the spheres rolling downhill, while the bricks have reacted to water movements. This is an interesting idea. The impression given to the diver of the seabed in the area of the dispersal trial is that of a flat bottomed gulley. However, reference to the contour plot of the area (Fig 8) shows that the area where the majority of the spheres were observed in 2010 is in fact a shallow depression, while the majority of the bricks have 'travelled' uphill. This may account for the differentiation seen in 2010. By 2014 the spheres had all left the shallow depression and were all found (albeit only three of them) on higher parts of the seabed. We should perhaps be careful not to speculate too much on matters which are clearly the province of an oceanographer. It may be worth undertaking a small study of the data in collaboration with someone with expertise in the area of seabed sediment transport.

**Fig 12** Dispersal objects: movement, clearly showing how the bricks and spheres have been differentially moved. Bricks are shown in yellow and spheres in red

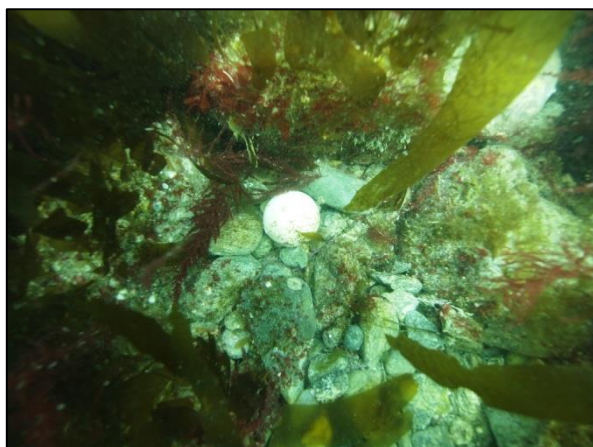
Of the 40 dispersal objects originally placed in 2009 only three were located in 2014 (Fig 14). Interestingly, all three of the objects located were steatite balls (Fig 13). None of the bricks were found at all, despite the bricks being by far the larger of the two object types deployed. All four divers were involved in searching for the objects, and in total six man-hours were spent searching. In the final stages of the search the search area was extended out to a radius of 15m from the starting position (as deposited in 2009) (Table 5). There are a number of possible explanations for the paucity of dispersal objects located in 2014. The objects may have been dispersed beyond the area searched; they may have been buried and are no longer visible on the seabed or a combination of both of these factors. What is also of note is that two of the three balls located this year were not found in October 2010 – these were either buried or outside the 10m radius searched in 2010.

*Fig 13 One of the dispersal objects (steatite ball 3) as found on the seabed in June 2014.*

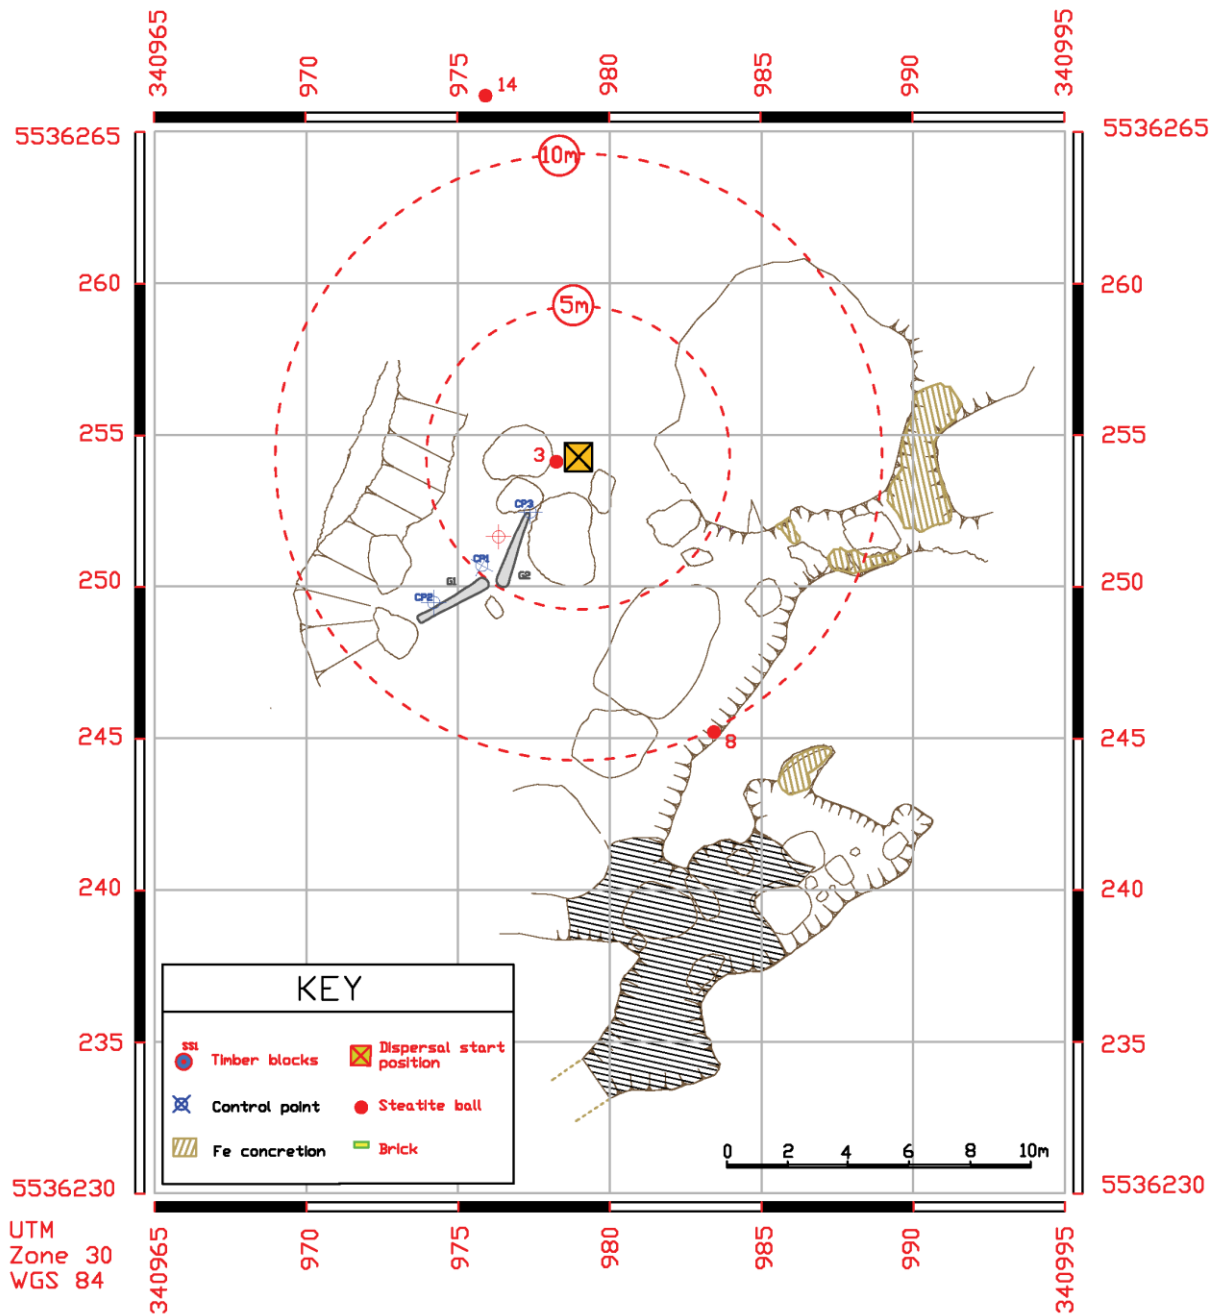
The only dispersal object located in 2010 and in 2014 was the steatite ball number 8. It may not be coincidental that this ball was the single exception to the southerly grouping of balls noted in 2010 (see Figs 9 and 10). Ball 8 has moved 15.63m in a south south west direction between 2010 and 2014. Because of the small number of objects located, it is difficult to draw any conclusions about the distribution of the dispersal objects in 2014 – except to note that the three balls located all lie roughly within the same 'corridor' as seen in the 2010 distribution (see Fig 10). Although it is perhaps not surprising that the majority of the dispersal objects have lived up to their name (i.e. had been dispersed) it is hard to account for the fact that no bricks at all were located in 2014. No evidence of bricks being colonised by kelp as holdfasts has been observed on any occasion – so this cannot be advanced as a likely cause of the absence of any of the 20 bricks from the search area in 2014.

Fig 14 Site plan showing the positions of the three dispersal objects located in 2014, steatite balls 3, 8 and 14. Note also the new positions of the iron guns G1 and G2

Despite extensive searching, only three of the 40 dispersal objects placed in 2009 were relocated in June 2014. All three of those located were steatite balls. None of the 20 bricks were found despite an extra search in all the locations where the bricks had been found in October 2010. It is hard to draw conclusions as so few of the dispersal objects were relocated. However, given that the 2010 inspection revealed that the bricks and balls had been differentially moved (see Figs 8 and 9) it is tempting to conclude that a different fate has befallen the bricks, which may account for their absence from the 15m radius searched around their original location.

Given the paucity of dispersal objects found this year it is probably not worth specific searches for them. However, if searches are made for exposed artefacts (as suggested above) then any dispersal objects located during the process should be plotted on the site plan. Study of dispersal data by oceanographer/expert in seabed sediment transport might be considered.

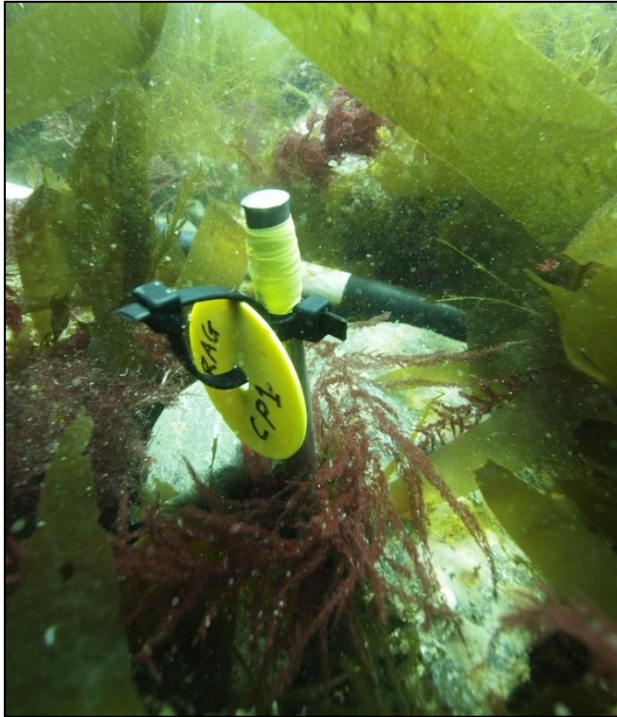
None of the existing survey control points were found intact during the 2014 survey. This is not really surprising; during the excavation of the site the control points required regular replacement. Most winters saw the loss of many of the points. It was, however, possible to see where control point A (to the west of gun 2) had been, due to iron staining of the rock it had been driven into. Three new control points consisting of 12mm diameter stainless steel rods 0.4m long were driven into the seabed in the area around the iron guns (see Fig 15). The position of each of the control points is given in the Table 6 below.

*Fig 15 Survey control point CP1 in position on the seabed*

The majority of the existing survey control points on the site had disappeared, due mainly to the action of mobile rocks rolling over the site. The previous positions of two of these existing points were found and used to position three new control points on the site – CP1, CP2 and CP3. These have been placed in the gully containing the iron guns
