# HMS COLOSSUS

## PROGRESS REPORT 2003

KEVIN CAMIDGE

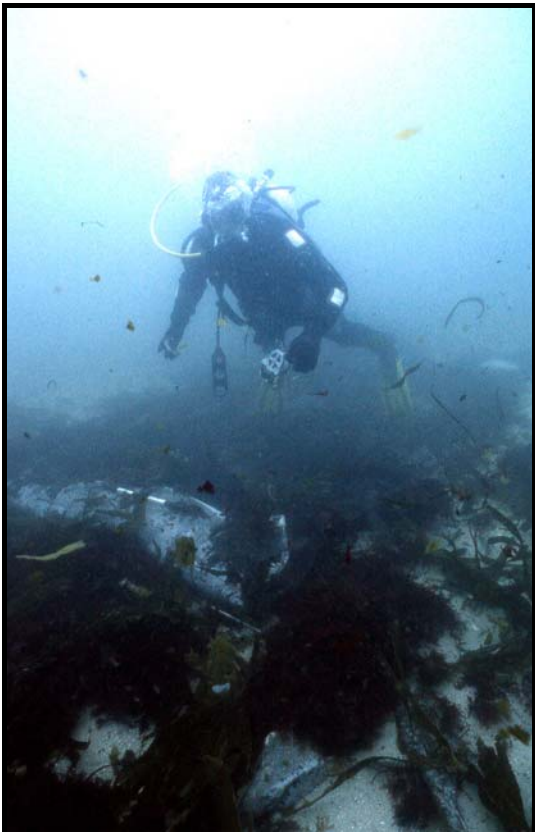
Left : The debris netting deployed in V2. The mesh is the darker area behind the row of sandbags. Scale = 0.5m

Although this mat was still in position it was no longer floating freely in the centre. The mat had been anchored to the seabed by a coating of rust coloured weed similar to that encountered on the Terram mat V1. In accordance with the instructions given to me by Martijn Manders (page 13 of the Project Design) another layer of mesh was installed over the top of the existing mesh. The ends were fastened to the sandbags and the middle allowed to float freely c.0.50m above the seabed. There was no measurable change in the level of sediment in the area of this mat.

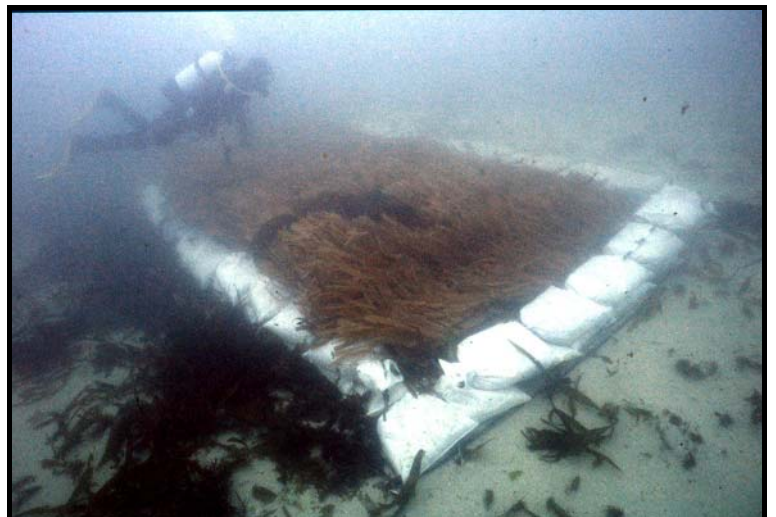
Below : The floating frond mat from Seabed Scour Systems in area V3. Note the double layer of sandbags used to hold the mat in

This mat was also still in position. Interestingly, the floating fronds had become a preferred habitat for numerous small fish and shrimps. Some weed was also growing on the fronds. There was once again no measurable accumulation of sediment around the area of this mat.

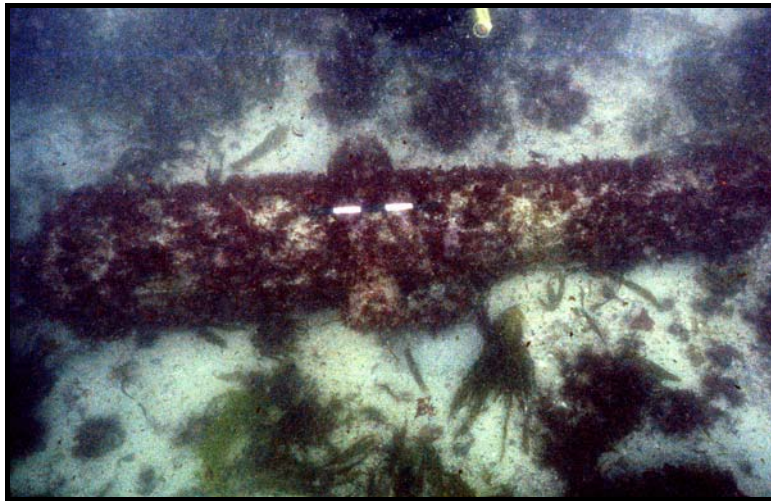
Left : From above, in very poor visibility. Note that the gun is upside down.  
Scale = 0.5m

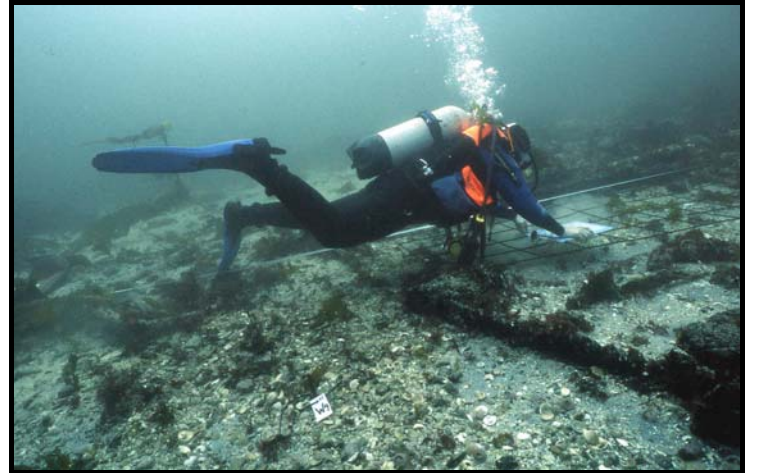
Left : Exposed timber, looking from gunport 0 towards gun 1.

The timber exposed at the stern of the wreck, particularly on the south side, is now standing some 0.25m above the seabed. This timber was all resurveyed in August this year (see Survey August 2003). This timber is very vulnerable to any storm surge on site this winter so it was consolidated by placing a row of sandbags against the southern exposed edge (see photo).

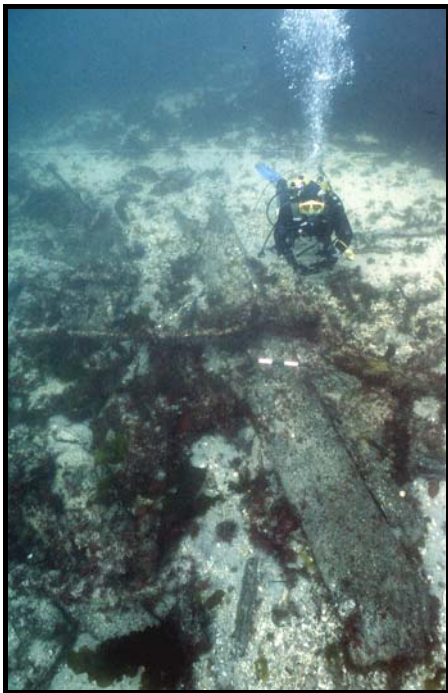
Left : Gudgeon strap and inner stern post (?)

The substantial piece of timber lying under the gudgeon strap is probably the remains of part of the stern post. It is 4.5m long, 0.59m wide and about 0.25m deep. At its southern end this timber has the remains of two other timbers joined to it at an angle – these are probably parts of the deadwood. There are two iron fastenings still attached to this timber, an iron staple [*Fe staple*]<sup>3</sup> and an iron bolt. This timber should probably be the other way up (the adjoining timbers would have originally faced west) – it possibly turned when it became detached and fell to the sea bed. [*Inner Stern Post*]

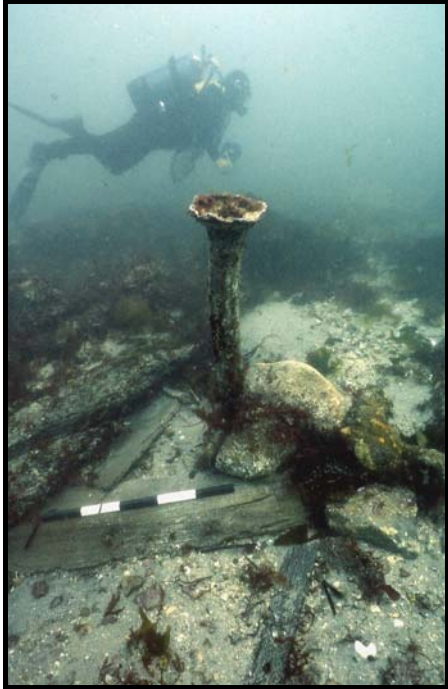
Left : Lining timbers of the port side quarter gallery (immediately in front of the Lead pipe TD1)

In the vicinity of the rearmost upper gun deck port a number of thin softwood planks (c. 0.01m thick) have been exposed on the seabed [*Quarter galley lining boards*]. These are lying partly under (outboard of) the outer hull planking. As this is very close to the area where the quarter gallery would have been attached to the hull, this timber was probably originally part of the lining (internal decoration?) of the port side quarter gallery. This timber is very fragile and has already started to break up. It may be worth considering taking a small sample of this timber before it is dispersed.<sup>4</sup>

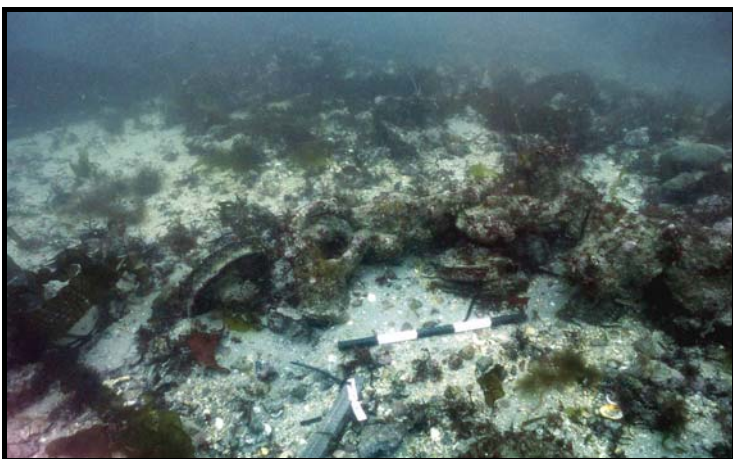
Below : Fe concretion – remains of chain plates.

A number of iron concretions to the south of the surviving timber at the stern are probably the remains of the port side mizzen chain plates. The chain plates were iron straps which attached the lower deadeyes of the shrouds to the outside of the ship's hull. These shrouds were substantial, and were likely to be rope of about 6" circumference<sup>5</sup>. Six iron concretions are visible on the plan [*Mizzen chains*]; two of them clearly show the holes where the deadeyes would have been. These are both about 0.26m in diameter (just over ten inches) – the Bellona deadeyes were apparently 9¾ inches in diameter. The mizzen chain plates are shown on one of the existing building plans for Colossus – the surviving iron concretions are in exactly the place shown for them on the building plan<sup>6</sup>.

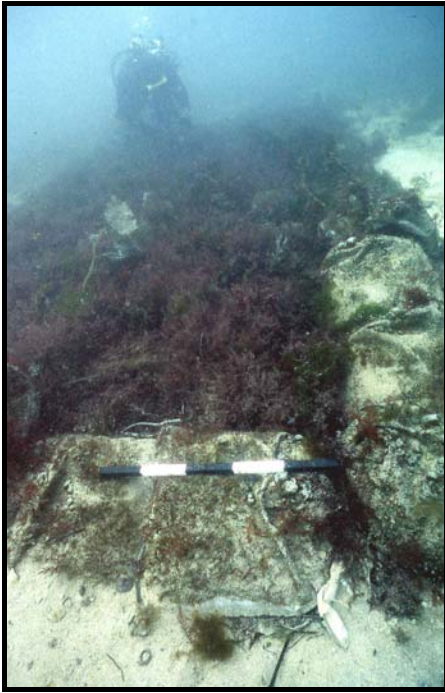
This mat was still in place. The sandbags holding the mat in place were exhibiting moderate weed growth. The mat itself was thickly covered with a fine rust coloured seaweed; this was 0.10 to 0.15m in height. Samples were taken of this weed and I hope to have an identification made (any suggestions?). A very thin coating (1-2mm) of sand was evident over the surface of this mat.

Left : Terram 4000 mat (V1) showing the weed growth on the mat

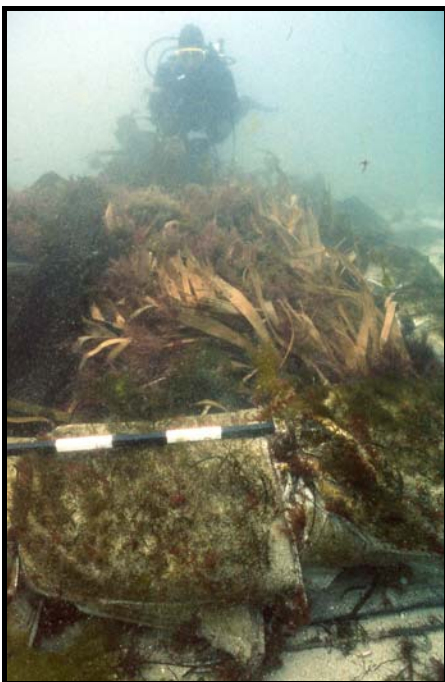
Left : Frond mat (V3)

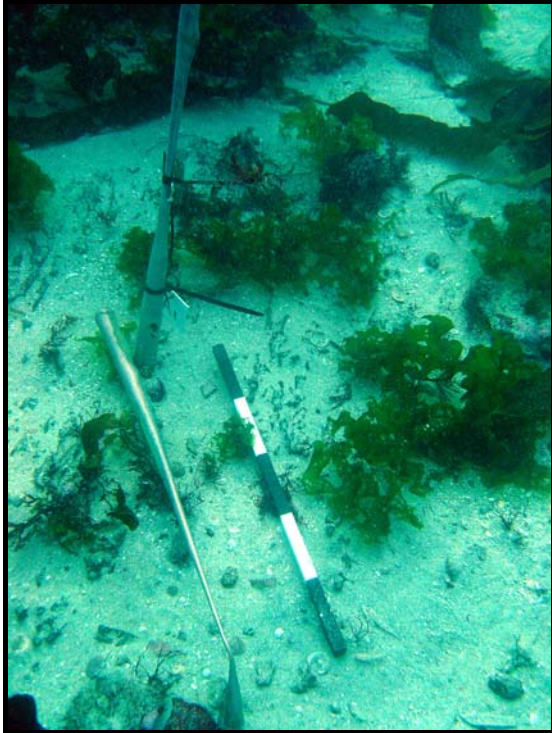
The area of the wreck was covered with a thick layer of kelp, much of it attached to small boulders and lumps of iron concretion. Interestingly the copper alloy pins around the wreck had been highly polished (see photograph). This phenomena has not been observed before on the site since survey began in summer 2001. It is difficult to see what has caused this abrasion – possibly sand particles suspended in the water?

Left : Copper fastening pins by control point A1 – showing the polishing of the copper

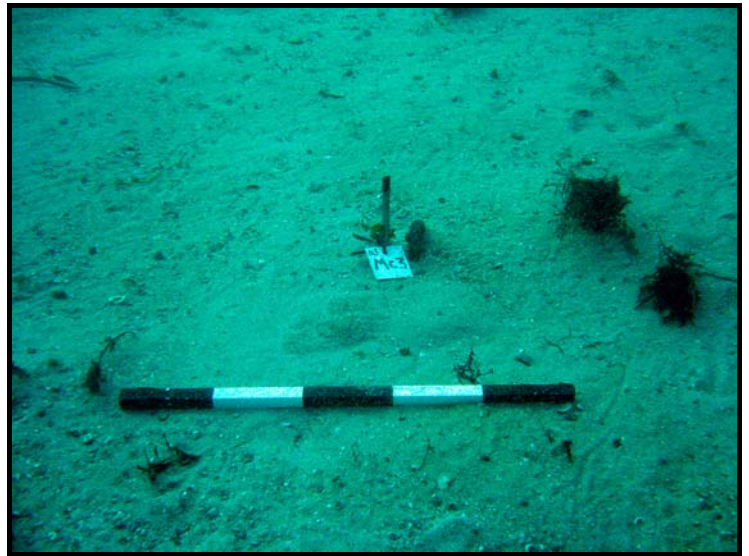
Above : Master control block MC3, deployed in August 2003. By October the granite block had been covered with sand.

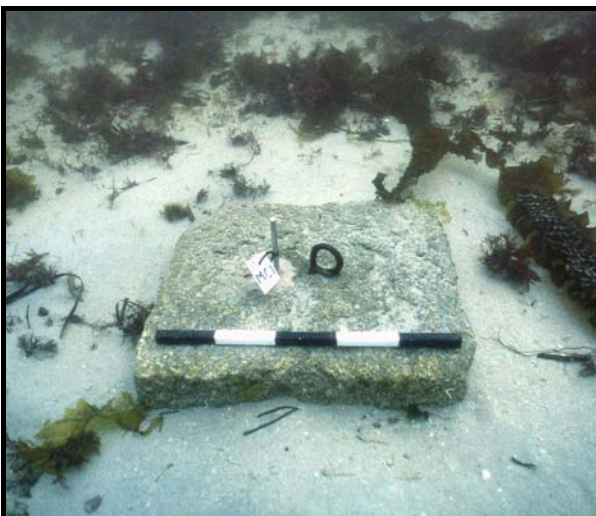
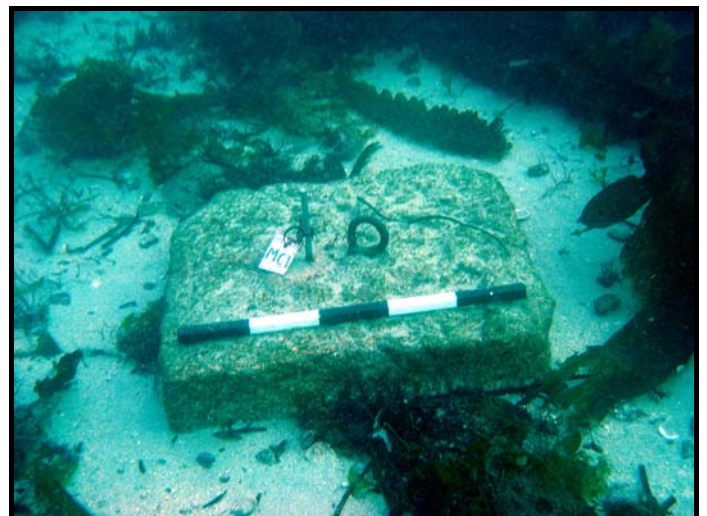
Below : Master control block MC1, after installation in August 2003 (below left) and in October 2003 (below right). Notice how the sand level has dropped slightly since August.

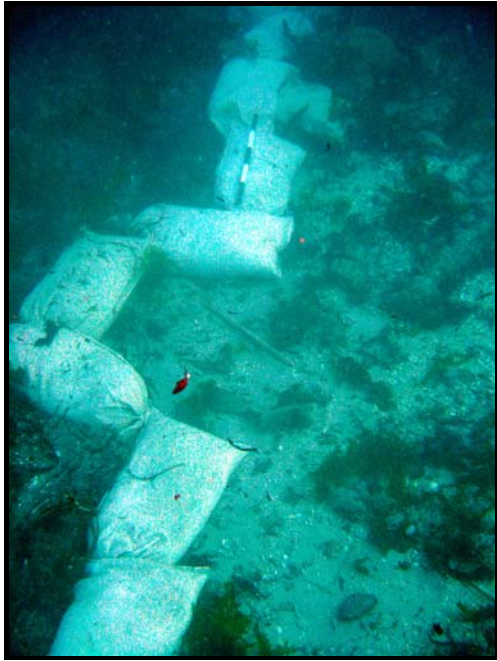
Above: Sandbags placed along the southern edge of the timber at the stern.

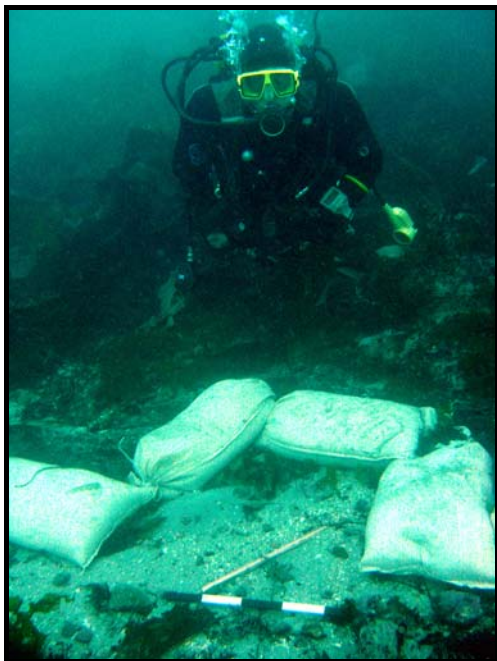
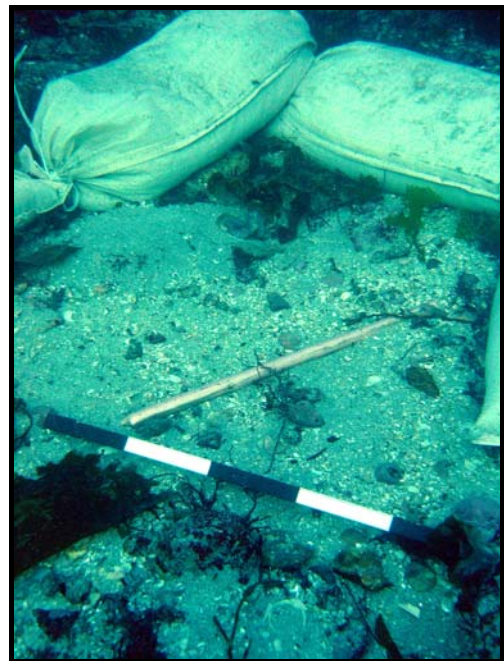
Below: Copper alloy fastening bolt by gun port zero showing the polishing of the copper.
