HMS COLOSSUS

HMS Colossus Stabilisation Trial Progress Report 2004

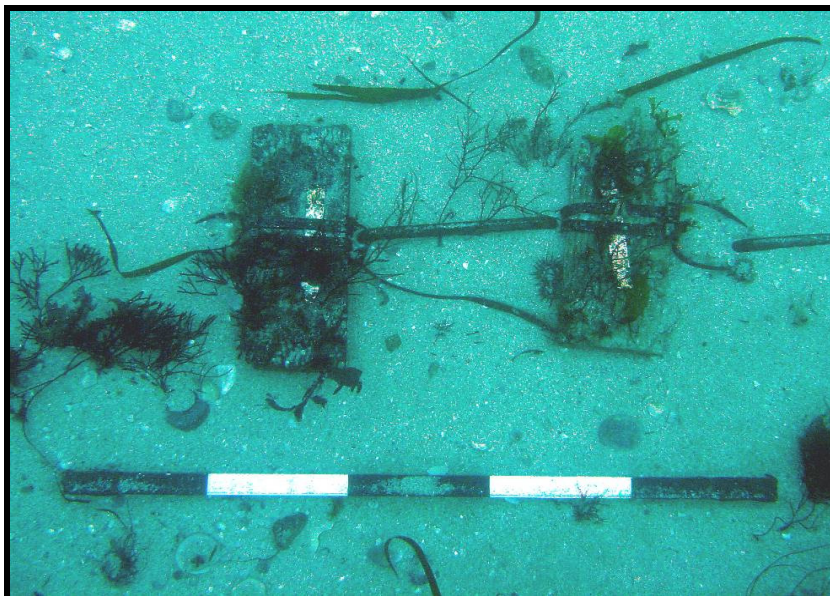
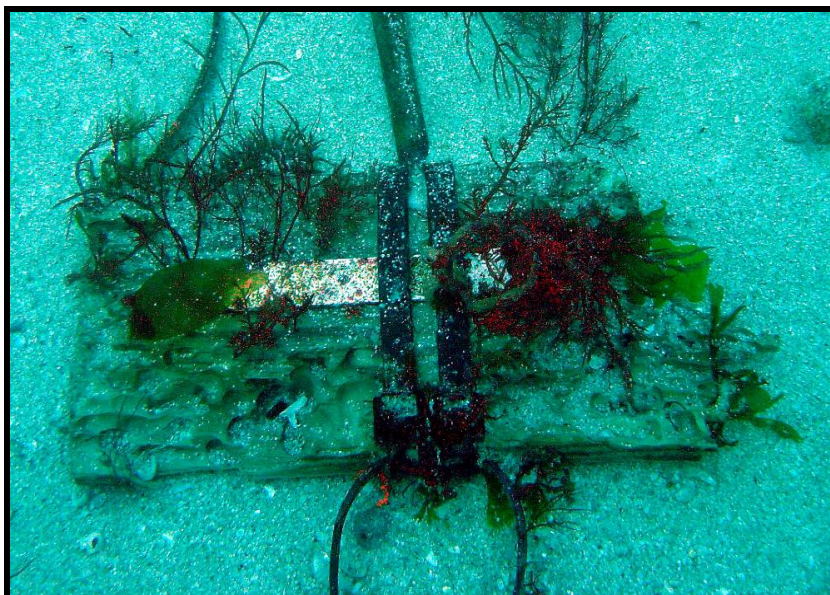
All control blocks were still in place. Weed growth is evident on the blocks in this area. All of the blocks in the control area are now showing clear signs of attack by wood borers (see photograph). The seabed level around the control area appears to have decreased by some 3 to 5 mm (measured from the top of the stainless hoops used to secure the sample blocks to the seabed).

The oak and pine sample blocks were retrieved from each of the test areas. These were then labelled, packed into a cool box with ice packs and dispatched to Mark Jones at MRAS by 24-hour courier. The blocks from the seabed (control V0) clearly show attack by wood borers – see photograph below. Preliminary results (communicated verbally by Mark Jones) from the X-rays of these blocks indicate that there is heavy attack in the control (V0) samples, no attack in those from the Terram (V1) mat, and slight attack from the mesh (V2) and frond (V3) mats. These blocks had been in place for just under 12 months.

The same blocks almost
12 months later
29.III.2004. Note the
weed growth and the
teredo attack.

Closer view of the pine
block after nearly 12
months on the seabed.

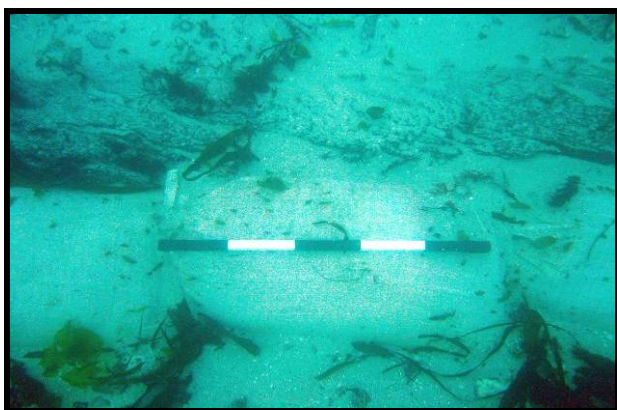
The row of sandbags emplaced against the south-eastern edge of the timber (October 2003) is still in place. The gaps between the sand bags and the timber have filled in with sand (see photograph below). The sand bags have not caused the exposed timber to rebury – so it continues to be attacked by gribble – but

they have probably prevented the timber from breaking up along the vulnerable south-eastern edge.

Sandbags deployed October 2003 – note how sand has filled in the space between the timber and the bags.

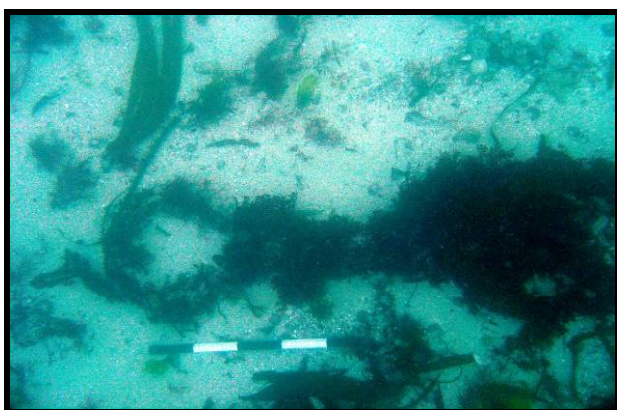
New material continues to be exposed around the wreck, particularly on the west side where remains of the port side main chains are now visible as well as new timbers (see photograph).

Material exposed on the west side of the wreck – here is part of the main chains

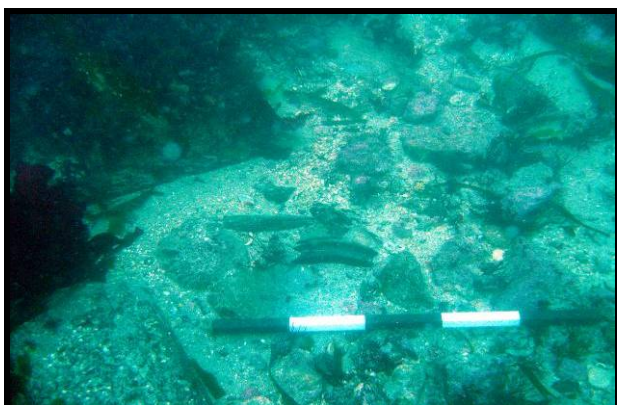
Newly exposed timber and a rigging block sheave.

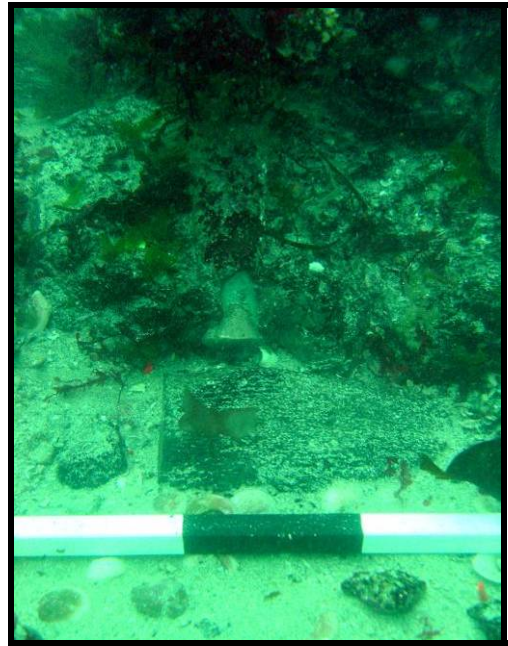
The kelp growth was slightly less than when I last saw the wreck in October of last year. The copper alloy fastening bolts along the north side of the wreck are in several instances showing newly exposed sections at their base where timber has recently broken away. This is shown in the photographs below and seems to amount to about 50mm thickness of timber loss. This gives an indication of the possible process of timber erosion on the wreck; first exposure, then attack by gribble which weakens the timber until it breaks off and is carried away by the tide.

Copper alloy bolt – base exposed by timber decay

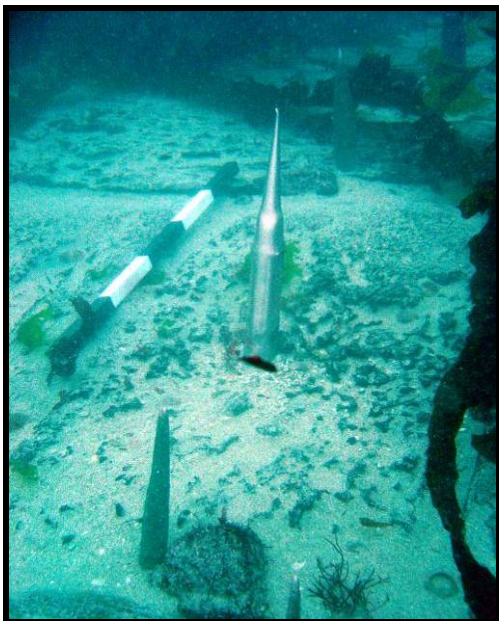
Copper alloy bolt – polished, probably by sand abrasion

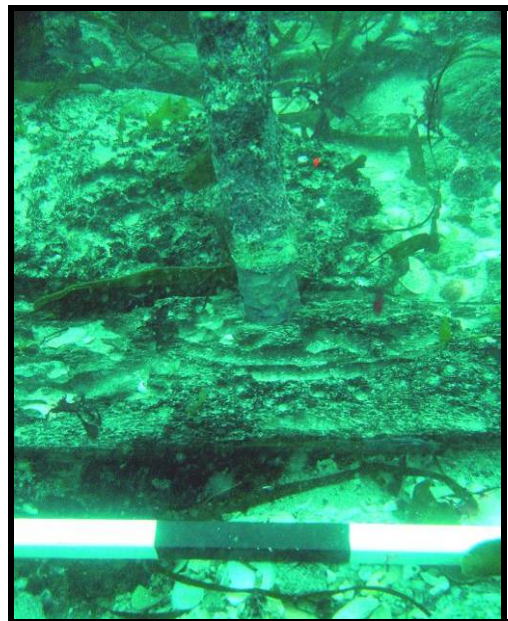
Copper alloy bolt – base exposed by timber decay

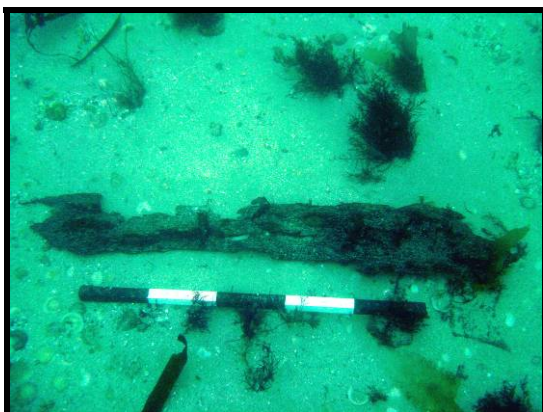
During the work on site a small piece of badly eroded carved timber was observed on the northern edge of the wreck. It measured approximately 0.75 x 0.15 x 0.03m, had the remains of carving on one side and was planed flat on the other. There were the remains of what appeared to be a number of copper fastenings evident on the smooth side of the board. This timber was mobile, and when first seen was travelling slowly along the seabed. It was photographed and placed beneath the line of 'anti erosion' sandbags at position 260158.8E 5535588.2N (UTM zone 30) to prevent its loss.

Carved side of the timber

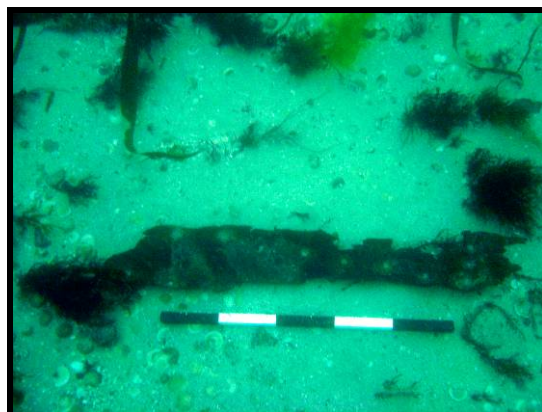
Flat side of the timber with copper fastenings visible

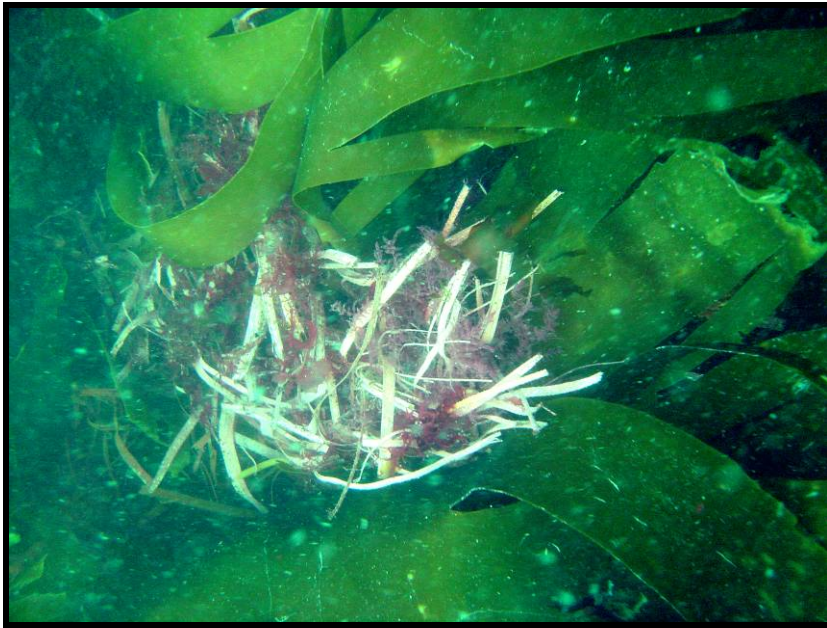
This mat was also still in position. The artificial fronds continue to attract natural weed growth. In places, particularly at the eastern end, the artificial fronds are becoming tangled (see photograph). The depth of sand was measured in three places: V3-A (55mm), V3-B (0mm) and V3-D (85mm). The eastern end of the mat now has no sediment accumulation at all – this has possibly shifted to the western end of the mat – which may account for the slightly raised level at V3-D.

Floating frond mat V3
showing tangling of the
fronds

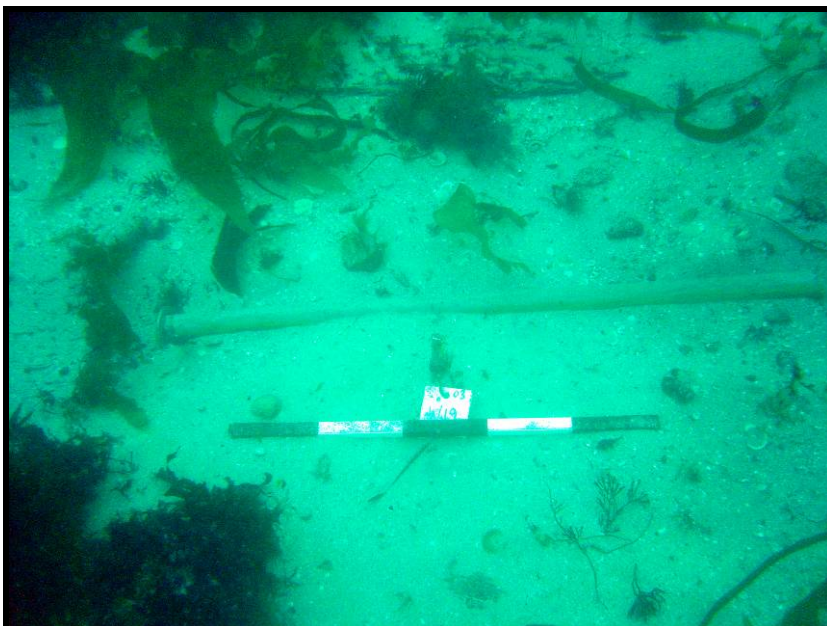
The weed cover over the wreck has increased since March of this year. Several of the copper alloy fastening bolts which were upright in March of this year are now lying flat on the seabed. The exposed timber of the wreck continues to deteriorate. The newly exposed timber at the NW end of the wreck, noticed in March 2004, has been recorded by Wessex Archaeology during their visit to the site – hopefully this data will be made available so that it can be added to the overall site plan.

A copper alloy fastening
bolt [420] – now lying
flat on the seabed.
Temporary control point
W19 is just above the
scale
