HMS COLOSSUS

SURVEY REPORT 2002

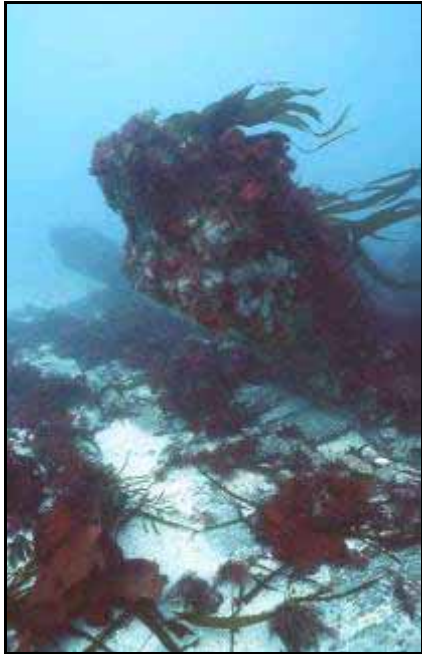
S1 Gun 4 and gun 5 – looking west.

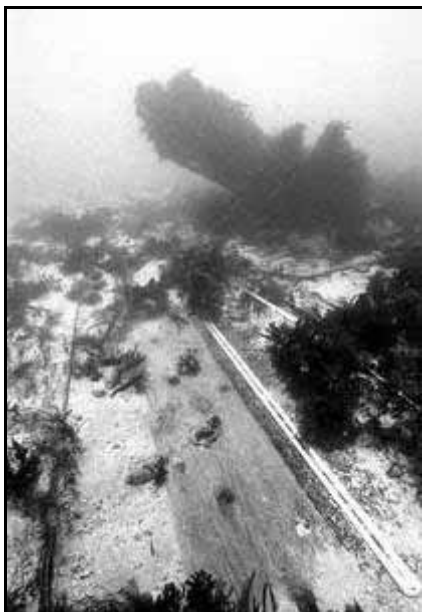
S3 Inner planking and frames – gun 5 in the background – looking west.

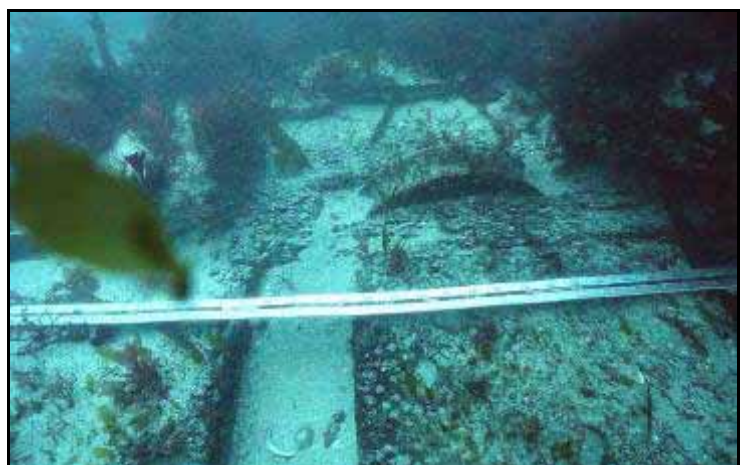
S5 Sheave (pulley wheel) incorporated into the hull to the west of gun 2.

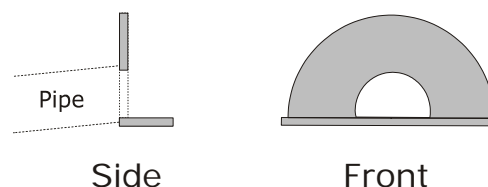
Three lead scupper pipes were observed, all situated just above the deck surface on the upper gun deck (see plan for locations). Two of these are partially eroded, but the centre pipe clearly shows the arrangement of the flange on the inner end of the pipe – see sketch opposite. These flanges must have been

Sketch of the lead scupper pipe flange found on the upper gun deck.

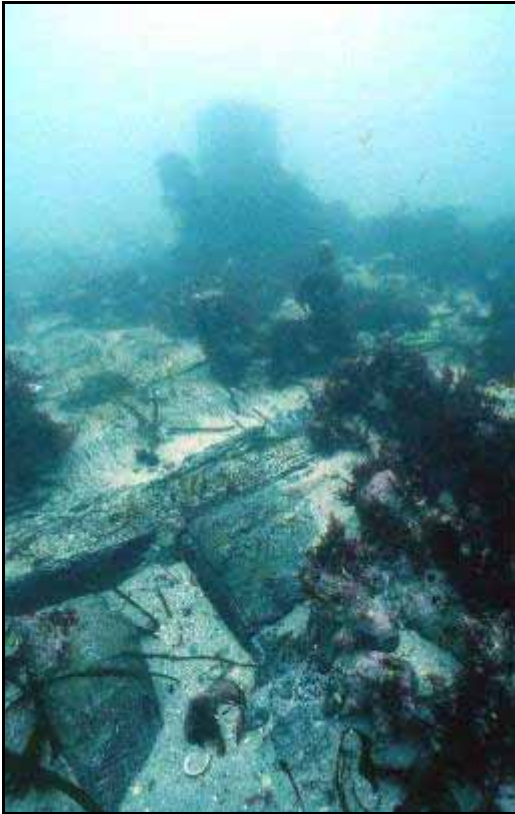
S6 (above) Lower deck gun port showing a fragment of wood inscribed 'PB' (arrowed)

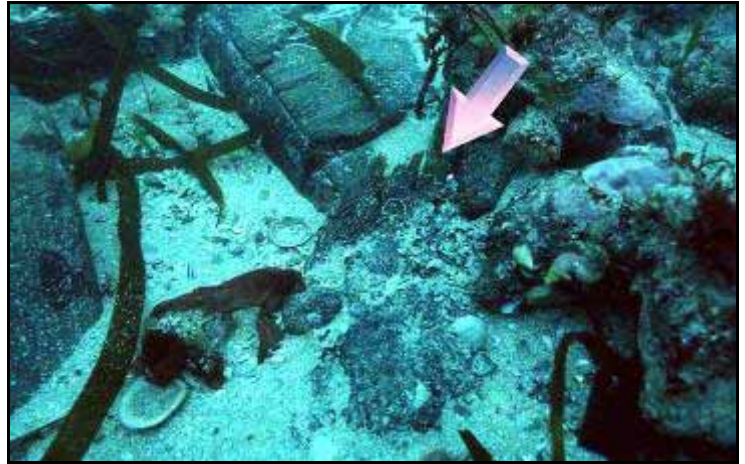
S7 (left) Main gun deck port. Note moulding to the edge of the port. Upper gun deck cannon 5 in the background.

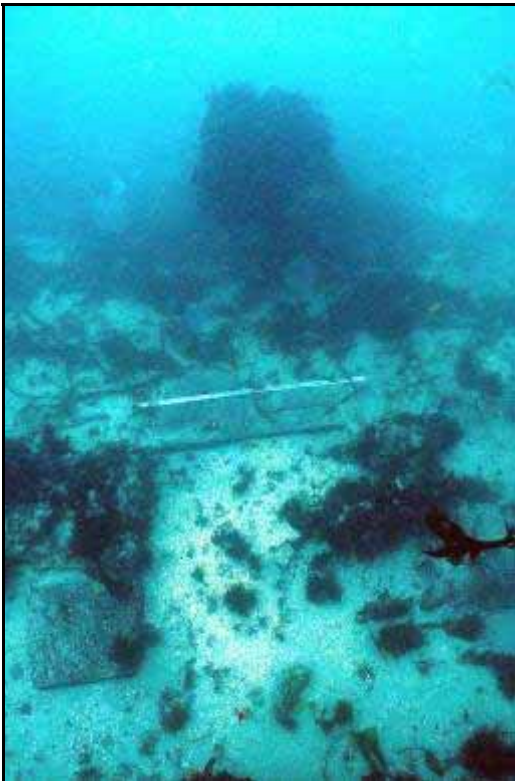
S8 (left) Quarter deck gun port – gun 3 in the background – looking north.

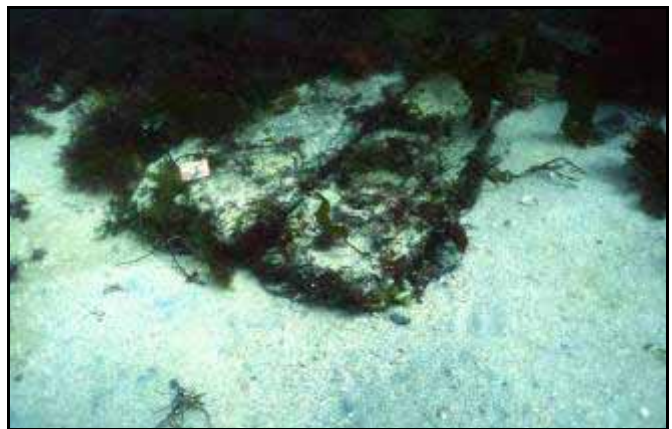
S9 (below) Scouring around the timbers of the wreck – by control point I (centre left), looking north-east.

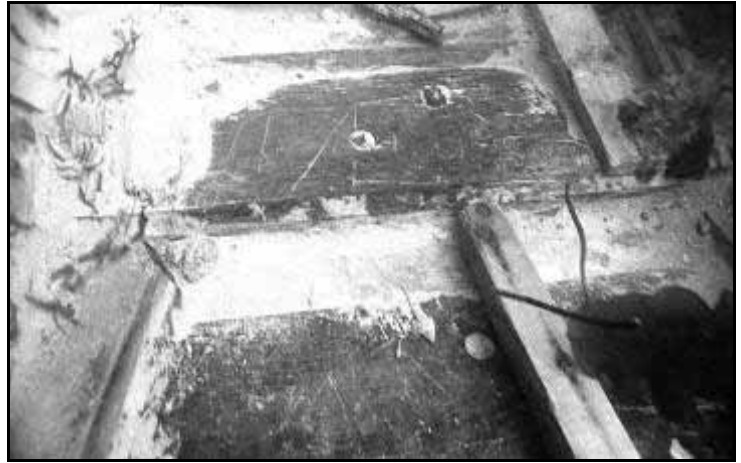
E2 Orlop deck, tree nails and a crude incised sketch on the inner planking of the hull – originally hidden behind the lap-board lining.

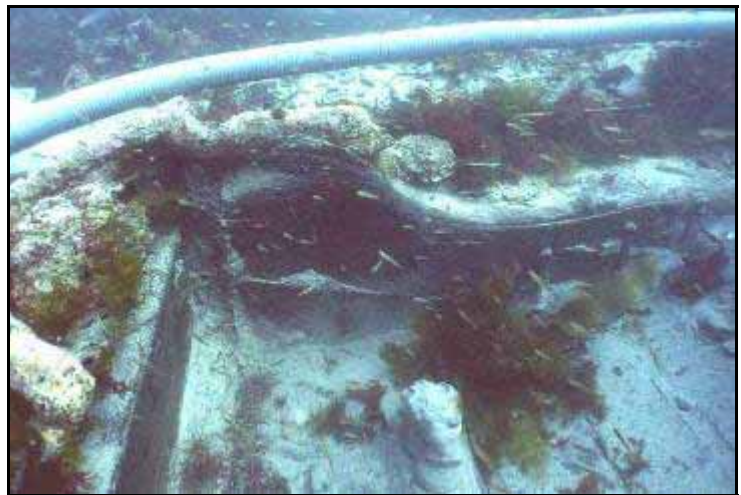
E4 Exploratory trench – main gun deck planking (left) and knee (background). Note the moulding on the corner of the knee.

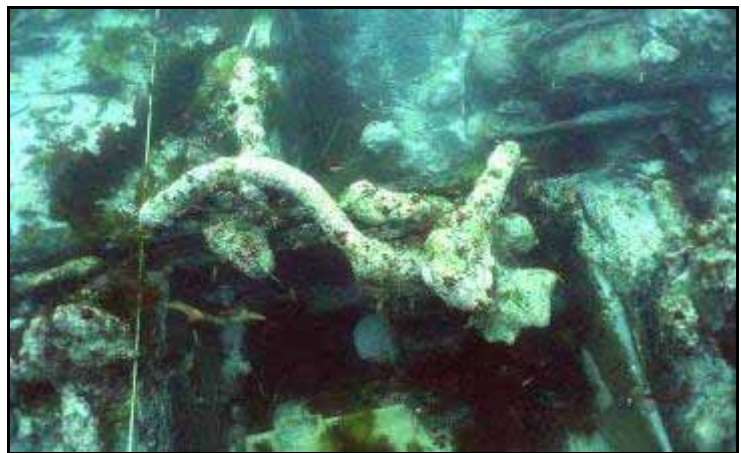
E5 Detail of the ironwork over the main gun deck planking.

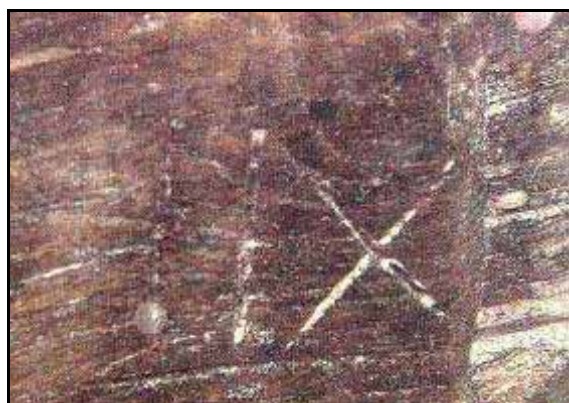
E8 Detail of the eastern knee on the orlop deck, showing possible builders' mark 'IIX'. Photograph by Robin Witheridge.

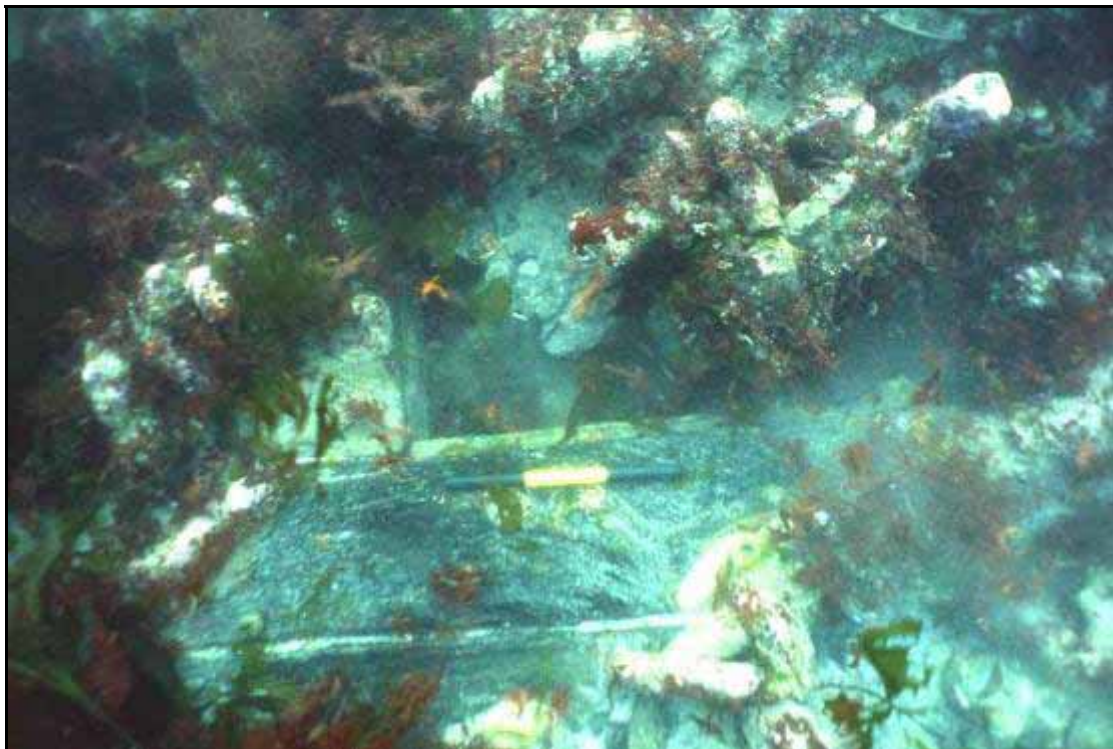
E10 Gun port 2. Note the moulding applied to the inside of the port. Scale 0.30m
