COLOSSUS 2024

PROJECT REPORT

CISMAS

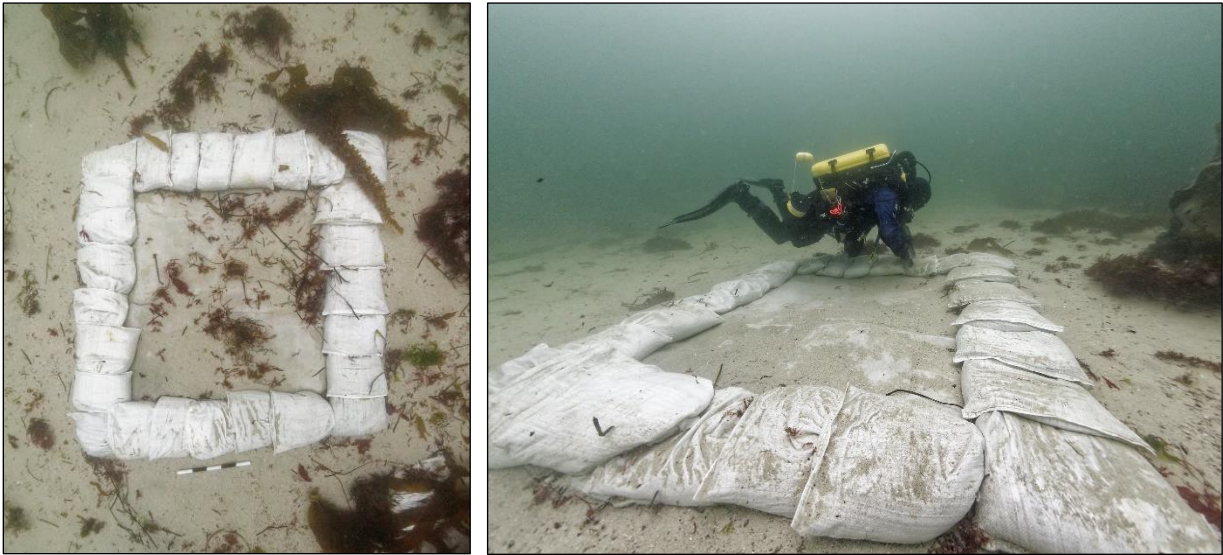
Fig 11
The Terram covering over the 25-year repository shortly after installation in September 2024. The Terram is 2 metres square (scale = 0.5m)

The first task CISMAS undertook in 2024 was to place a two-metre square of geotextile (Terram 4000) over the 25-year repository to protect it from falling sediment levels. The Terram was held in place by sandbags, placed in a continuous line around the edges of the Terram.¹⁰ This method has been used elsewhere on the site and has proved very effective at protecting elements of the wreck from falling sediment levels. Previously, the Terram and sandbags have been quickly colonised by seaweed and a layer of sand quickly accumulates over the geotextile.

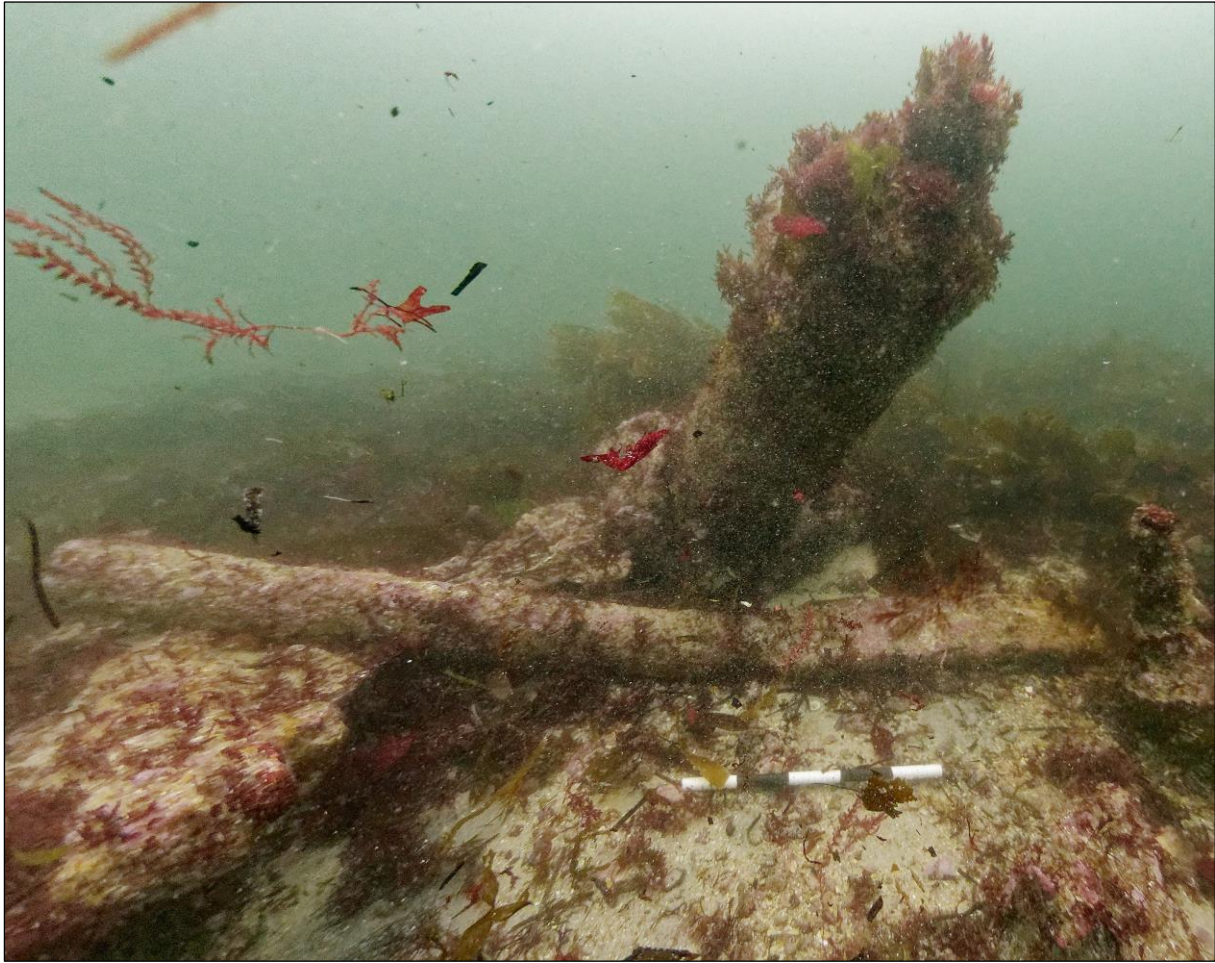
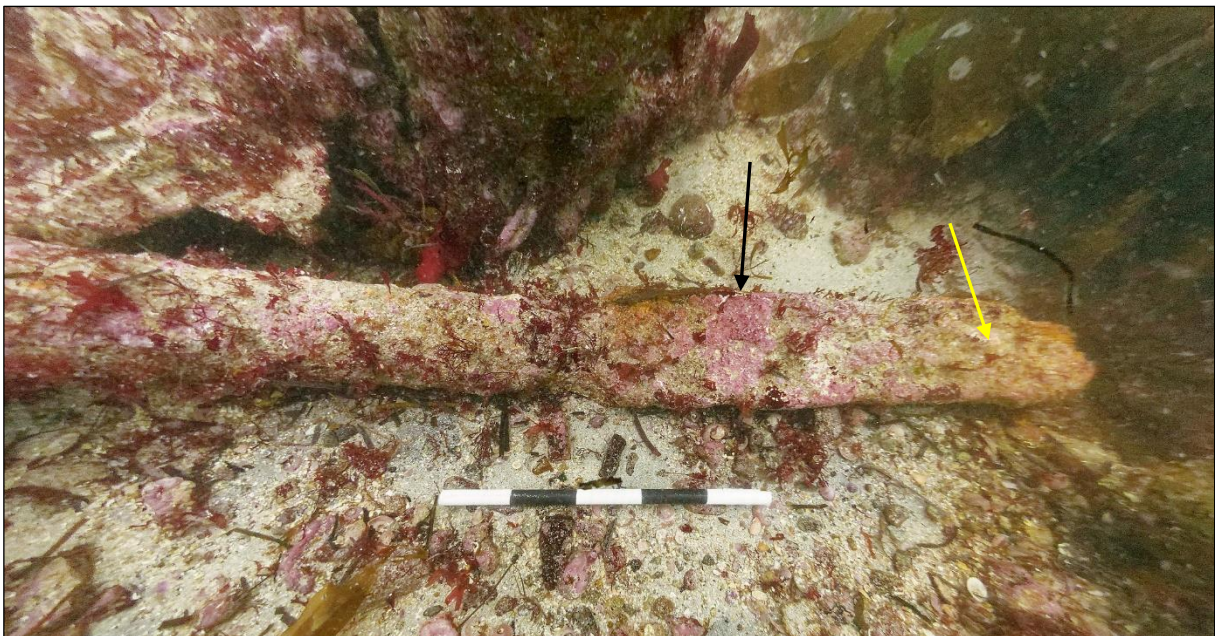
Fig 14

The iron consists of a bar 2.35 metres long, square sectioned at its southern end (0.17 x 0.17m) and roughly circular in section for the rest of the bar (0.14m \varnothing average). It is slightly bent and appears to be twisted as well. This is a substantial piece of iron and considerable force would have been needed to bend it. We initially speculated that the anchor had become fast on the seabed and the shank was bent and broken when attempting recovery of the anchor.

The iron anchor shank found adjacent to Gun 1 after removal of marine growth. The position of the anchor ring hole can just be made out in the lower photograph - where it shows as a slight indentation in the iron concretion, indicated by the yellow arrow. The black arrow indicates a different textured area on the 'square' which may be where the nut was originally attached (the nut located the stock on the square). Scale = 0.5m

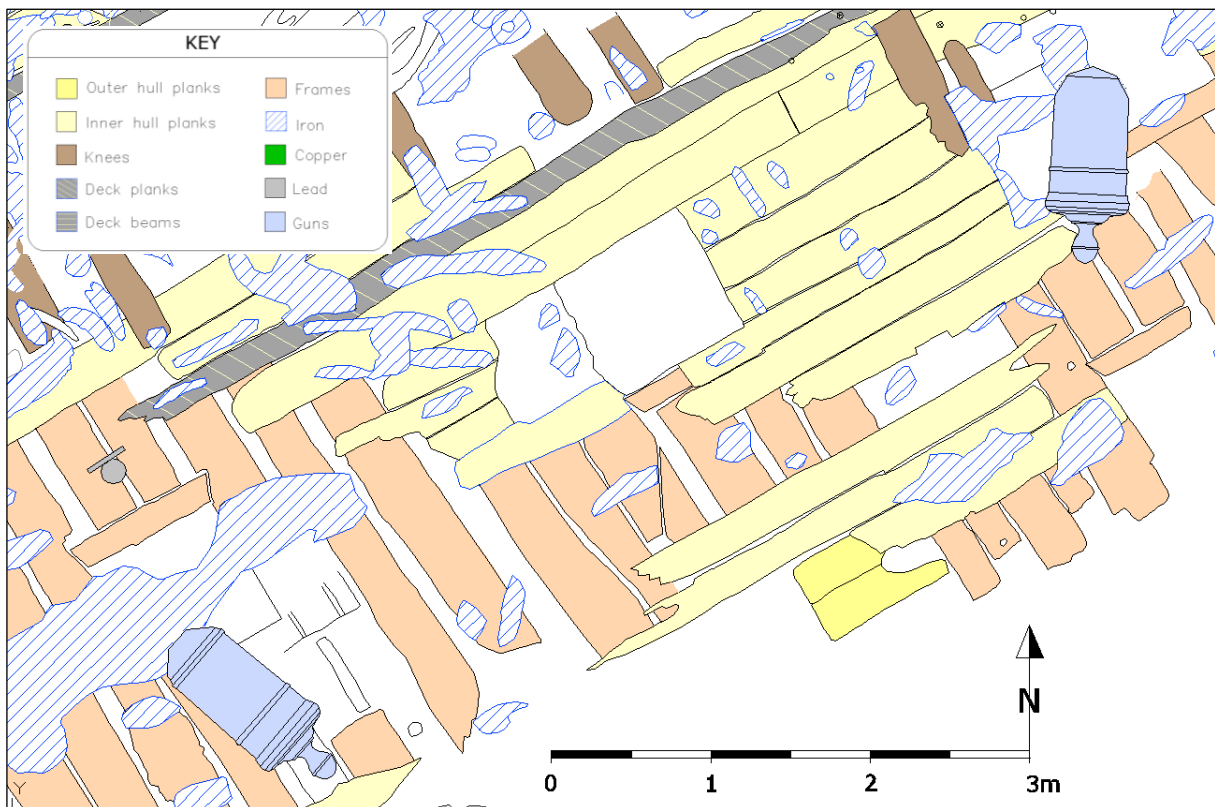
Fig 17

Detail from the *Colossus* site plan showing the empty gunport (centre). The blank space to the left of the gun port is where the timber was covered by sediment in 2001/2

Referring to figs 17, 18 and 20 it is clear that a great deal of timber shown on the 2001 plan no longer exists. Much of the inner hull planking has now gone - exposing the gun port lintel, sill beams and many more of the hull frame timbers. The inner hull planking was constructed of substantial strakes of around 12 inches wide by 3 inches thick, which were in near-perfect condition when first seen in 2001. It has only taken a little over twenty years for these to largely disappear from around the gunport. Similarly, the deck planking of the upper gun deck shown in fig 17 is, sadly, no longer with us.

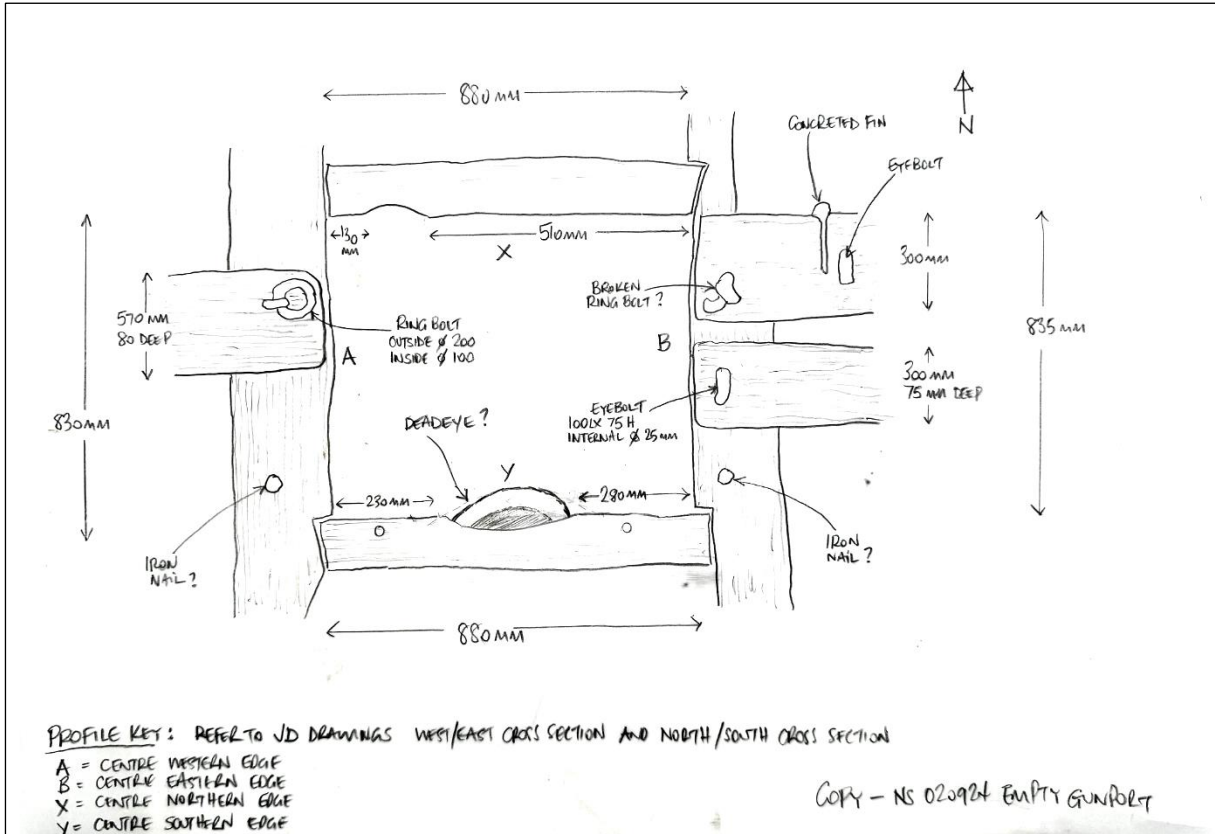
Fig 18

Sketch plan of the empty upper-deck gunport made in September 2024 – drawn by Nick Sodergren.

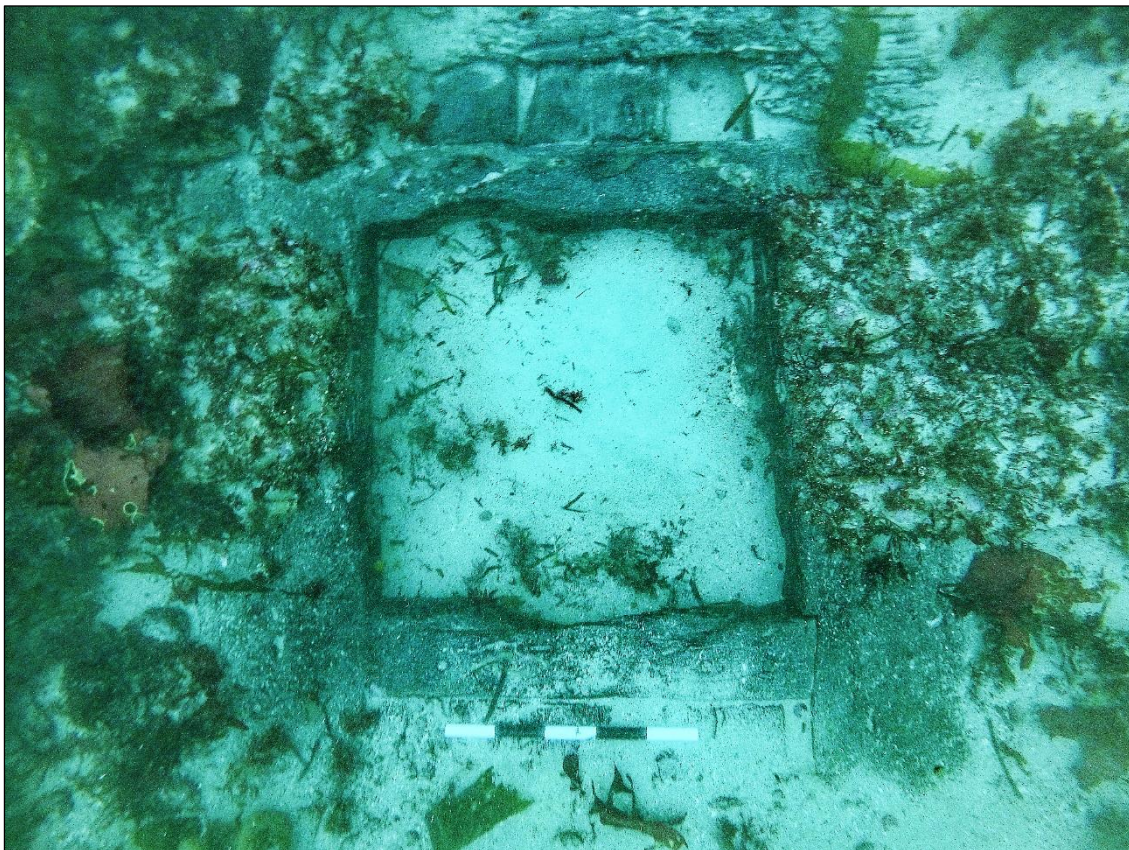
Fig 20

It is now also possible to see damage to the gun-port lintel (the timber along the south side of the port), in the form of a missing central curved section. This was probably caused by the upper part of the gun muzzle striking the lintel on recoil (which could be particularly violent when the gun was hot). To reduce this type of damage, naval guns have flared muzzles while garrison guns often have a ring at the muzzle. There is a similar piece missing from one end of the gun port sill.¹⁵

The gunport, partially de-weeded in September 2024. It is clear how decayed the remaining inner hull planking is now (not long for this world), and the frame timbers are showing evidence of gribble and teredo attack. This is a good underwater photograph – but note how much more information is contained on the drawings above (figs 17 and 18); the ideal situation is to have both. North is up and the scale = 0.5m long

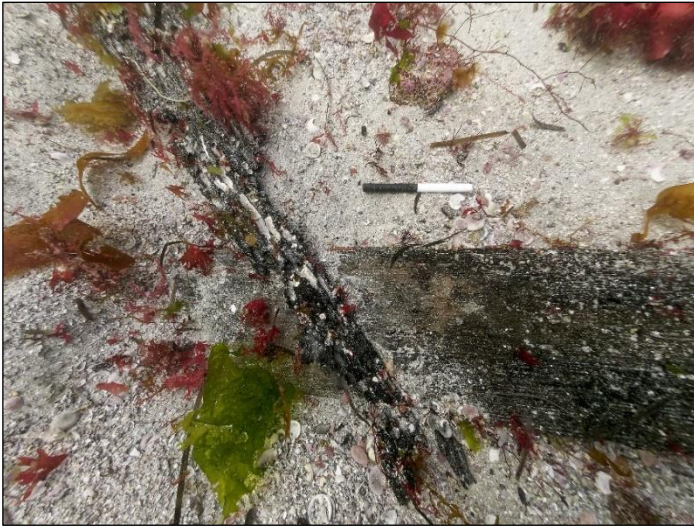
Fig 27
Plank 1 and timber
Scale = 0.2m

Not far from these there was a piece of planking (2.85 x 0.20 x 0.075m) which showed signs of attack by wood boring organisms. This lay over another piece of timber, thicker than the planking so possibly structural (frame or deck beam timber 1.10 x 0.25 x 0.11m). Close to this was a second section of planking (2.30 x 0.20m), and finally, a substantial iron bolt (1.60 x 0.08Ø m). Only a very small area was searched and it seemed that everywhere we looked there was wreckage. This area should be recorded properly and its true extent determined. As all the timber observed was showing evidence of attack by wood boring organisms, this needs to happen fairly soon.

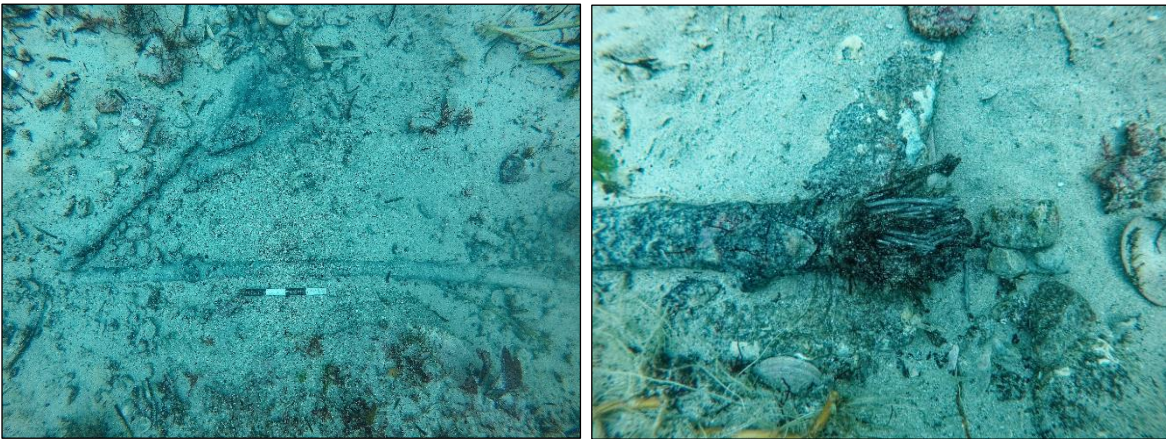
Fig 37

One of the reasons for selecting this target was the magnitude of the magnetic anomaly, but sadly in this case it was probably caused by a disused, broken, steel armoured electricity cable partly buried on the seabed (fig 37). Several fragments of 19-20th century pottery were also seen (normal for this area as it has long been used as an anchorage).

Left: the broken armoured cable found partially buried on the seabed. Right: detail of the end of the cable

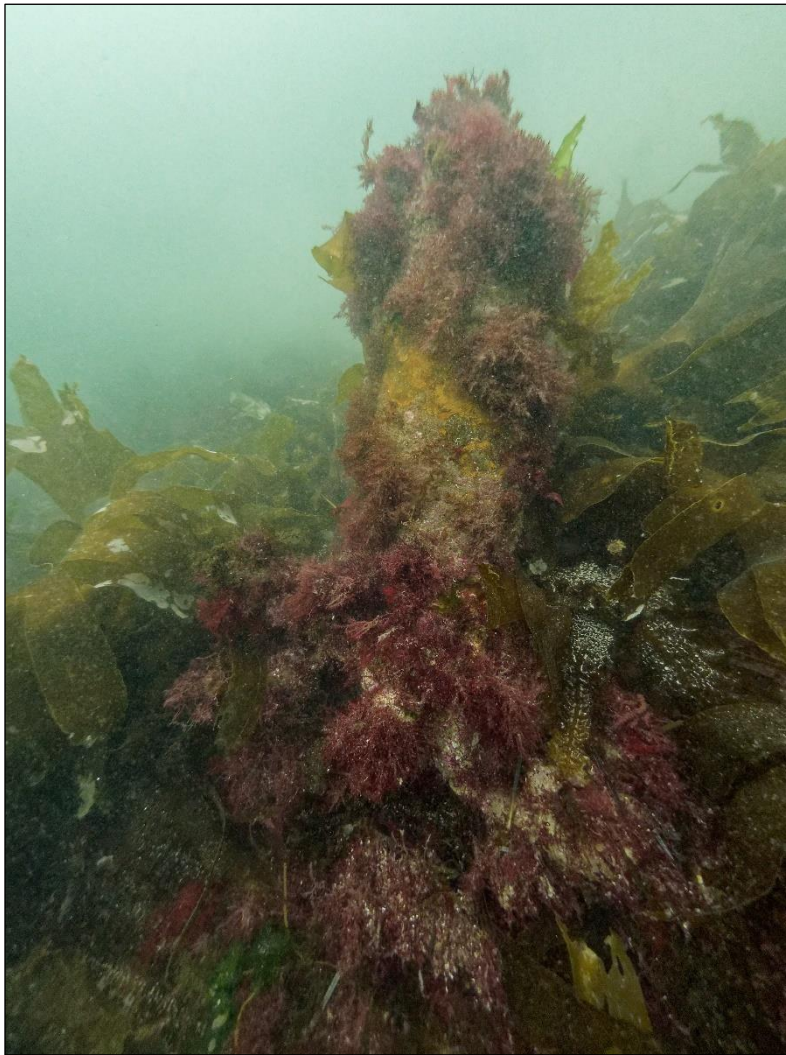
Fig 42

One of the row of upper gun-deck 18-pound guns as they were in September 2024

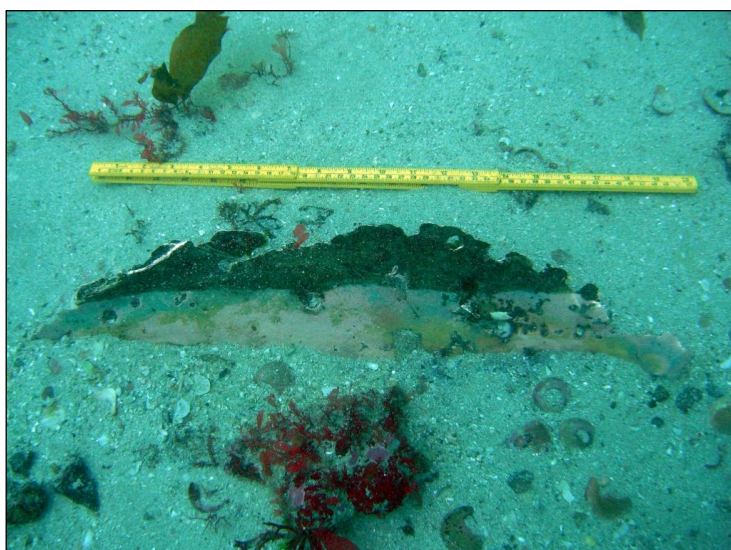
Fig 47

An example of upstanding objects demonstrating a fall in seabed sediment levels - a piece of copper sheathing on the wreck clearly showing where the copper has been newly exposed by the falling sediment levels

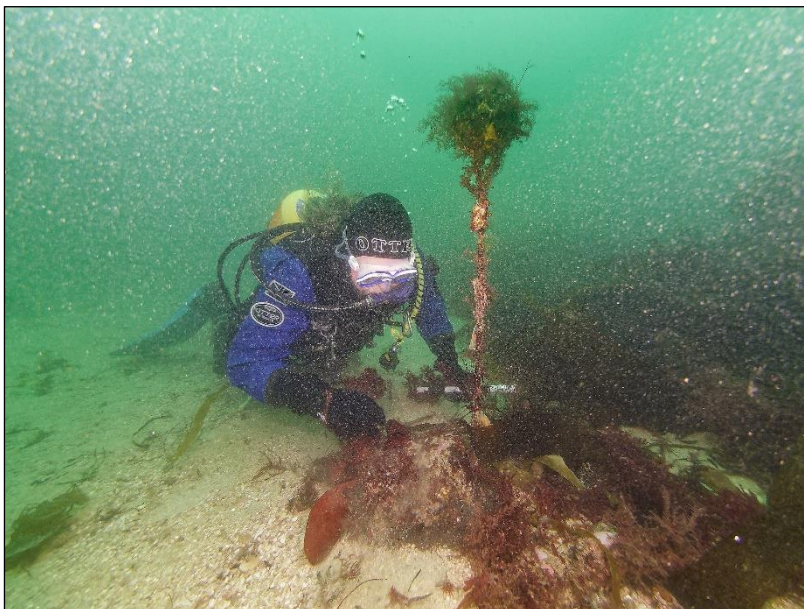
Fig 54

One of the problems besetting physical dive trails is maintenance. Marine growth builds up on the station markers, making the numbers impossible to read. Many different solutions have been tried, including commercial and homemade anti-foul paints, embossed number tags and stamped metal disks. On this site, all were defeated by the luxuriant growths of 'sea weed' over anything we put onto the seabed.

One of the station markers in 2024

A solution to this problem would be to mark the stations using a system which would work even when covered in marine growth. One possibility is outlined in fig 56 below. New underwater guide slates would need to be made to correspond with the new station markers.
