HMS *Colossus*

Reburial Trial – First Retrieval

Interim Project Report

CISMAS

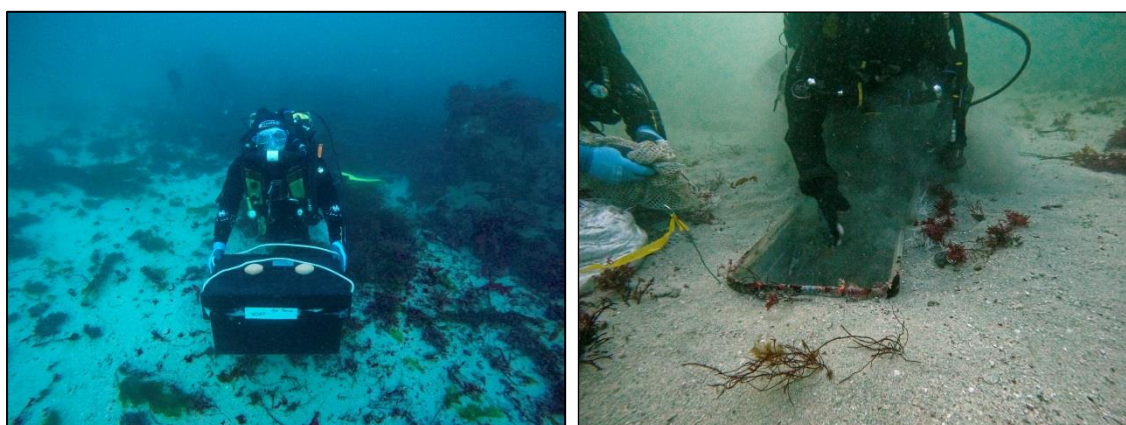
Fig 8

The 10-year recovery crate (A) was located and the remains of the sand bags over the top were removed. The sediment was then excavated by hand until the first objects were encountered at depth of about 20cm below the top of the crate. Objects were then transferred into a lidded plastic crate, one at a time until the repository crate was completely empty. This was undertaken by a team of three divers. One diver excavated the sediment over and within the crate, the second diver placed recovered objects into the recovery crate (fig 8) and the third diver photographed the whole process. The excavation of the sediment was entirely by hand to avoid any damage to the buried objects. The sealed recovery crate containing the objects was then transferred to the support vessel by two divers.

Left: the crate used to transfer the objects to the surface. Right: the partially excavated 10-year finds repository.

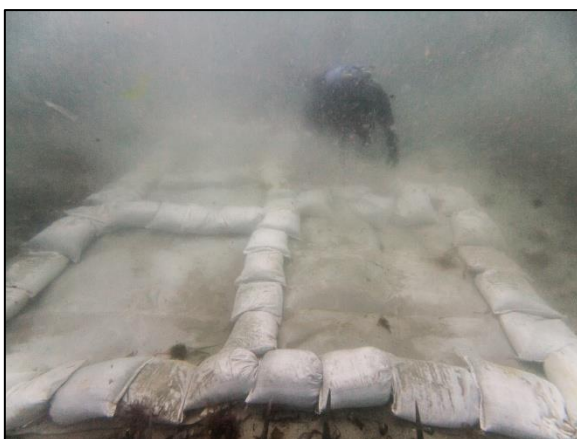
Fig 10 - Terram and sandbags one day after installation over the site of the small excavation in June 2012

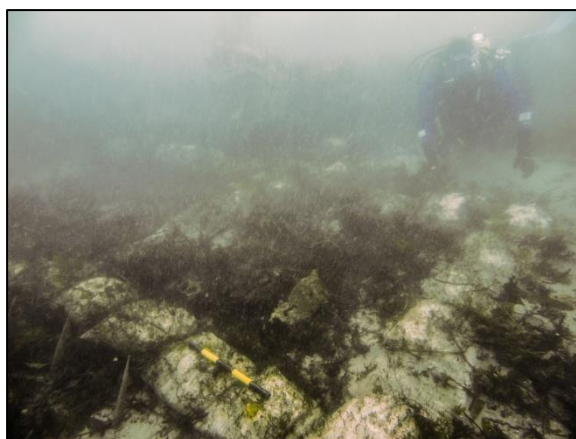
Fig 11 - The same Terram and sandbags three months later.

We have found that Terram sheet held in place with a continuous line of sand bags around the edges is a most effective method of stabilising the seabed on this site. It has also been found effective on the Swash Channel site (personal correspondence with Dave Parham). The Terram and sandbags are quickly populated by sea weeds and grasses. The shallow trough created by the sandbags then fills with sediment. Within 12 months the mat and sandbags are buried with heavily weeded sediment and are very difficult to recognise even when looking for them.

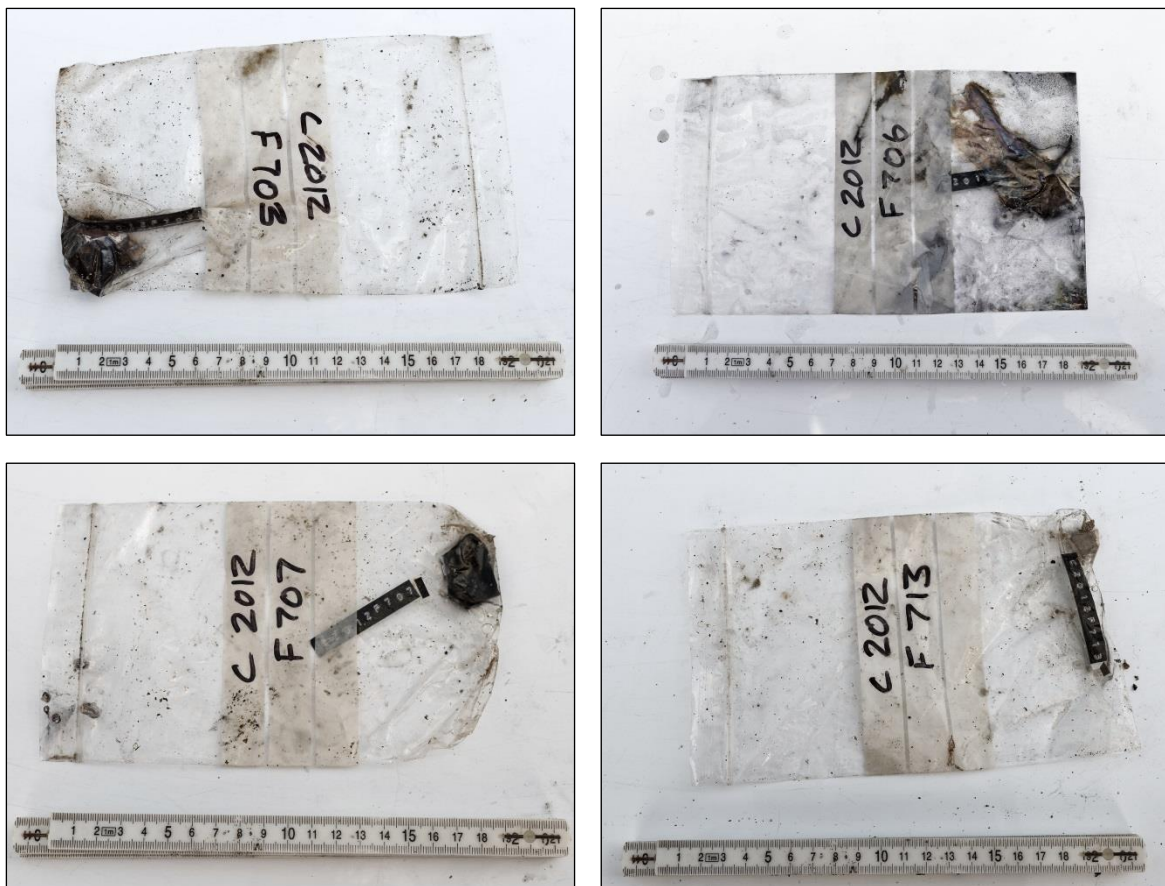
The labelling methods used all performed well and were legible without any signs of deterioration. The marker pen on the polythene bags performed surprisingly well with no deterioration of the bag markings discernible after 10 years of burial. It will be interesting to see how well these markings survive after 25 years of burial. The embossed 'Dymo' plastic labels also all survived without visible signs of deterioration. Below are photographs of the first four bags in the reburial sequence (F703, F706, F707 and F713) – these are representative of all the bag markings.

Fig 12 - Examples of the artefact bags photographed 24 hours after recovery after recovery in 2022

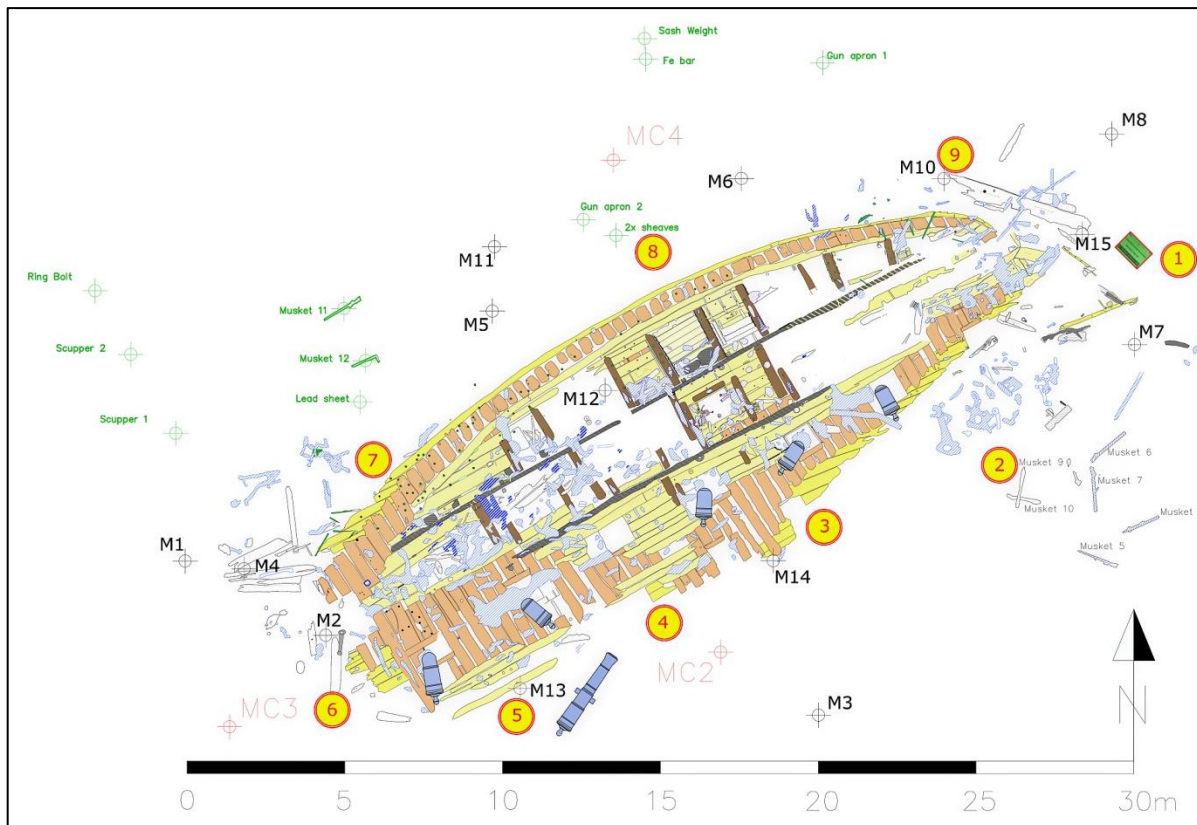
Fig 16

On the last dive of the project an area of new wreck material was discovered to the north of the wreck. This new material had been exposed by falling sediment levels. Given very limited time, the items were photographed and quickly plotted on a measured sketch plan. These items were subsequently surveyed and recorded in September 2023 (Camidge et al., 2023). All the items were left in place on the seabed in 2022.

Sketch showing the new wreck material to the north of the wreck (shown in green). The positioning of these objects is approximate.

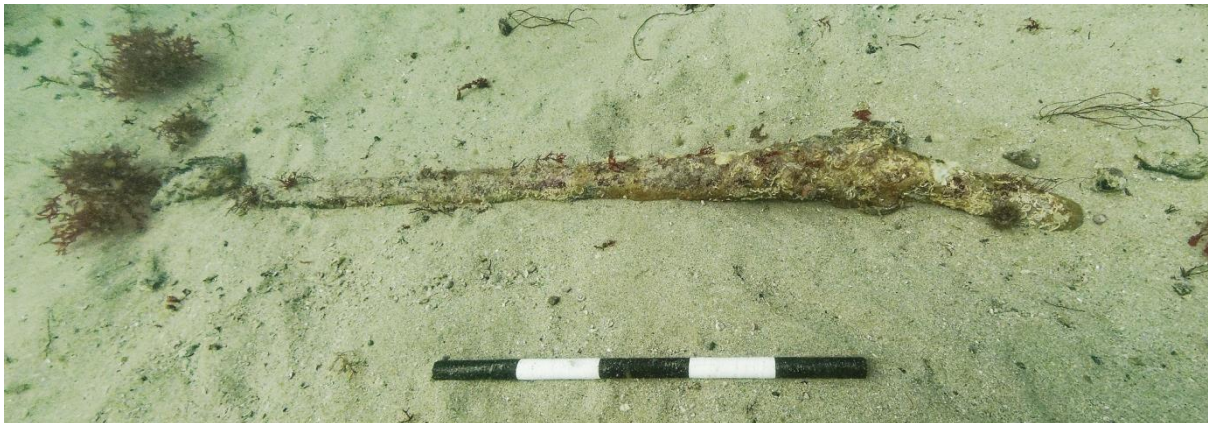
Two new muskets were found (musket 11 & musket 12 on fig 6), lying partly exposed on the seabed some 5m north of the main area of wreckage.

Fig 17 - Musket 11 exposed on the seabed – scale = 0.5m

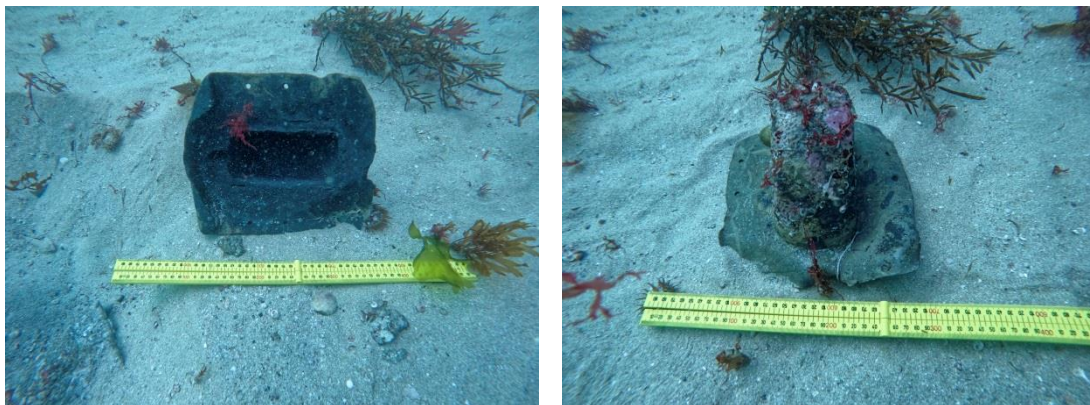
Fig 18

Several lead objects were observed, including a lead gun-apron, and part of another (gun aprons 1 & 2 on fig 16). Gun aprons were covers for the touch hole of cannon, in this case with a shaped pod to accommodate the flintlock firing mechanism. They quite often have the calibre and the number of the gun inscribed into the lead. These objects should be considered for recovery.

Gun apron 1, as found on the right, and turned over on the left. Note the holes to secure the apron to the gun.

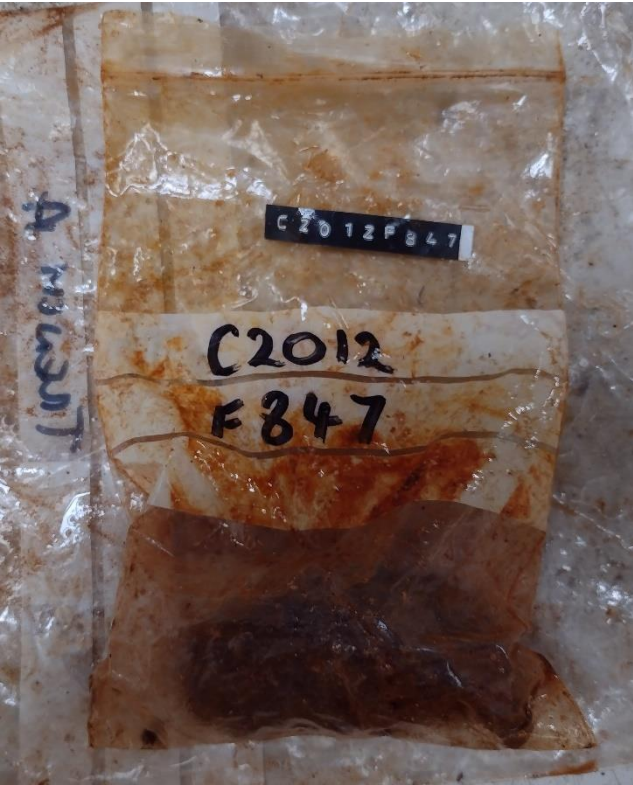
Fig 33: example of iron stained bag containing concretion

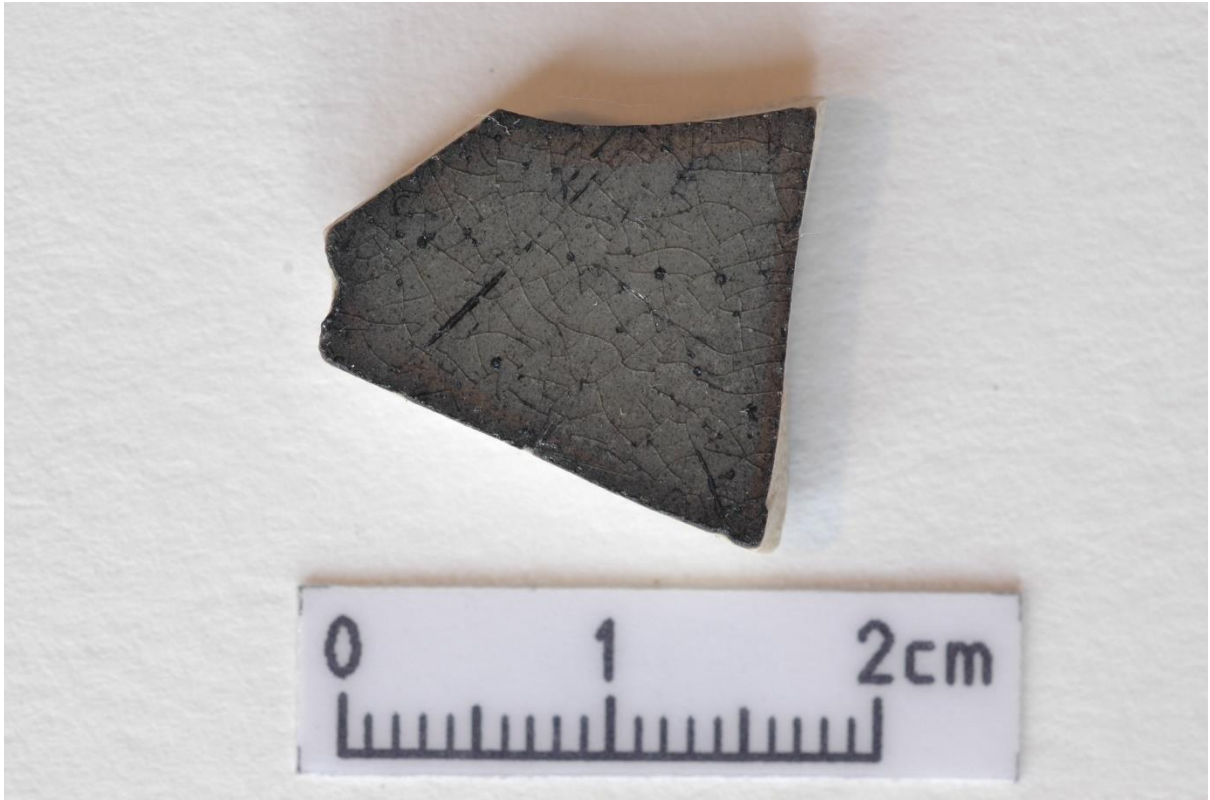
Fig 35: F713 in 2012

Physically, the artefacts have altered little, although all the iron concretions are now more iron-stained than there were ten years ago and one of the ceramic sherds has darkened, whilst another one, F713, has bleached with time (although there is some doubt about whether this is the original item). The copper alloy tacks/nails have changed little in appearance, apart from the strip, F849, where red cuprite (copper oxide) has formed on the surface. This artefact appears to have undergone more mineralisation, based on its X-ray image.

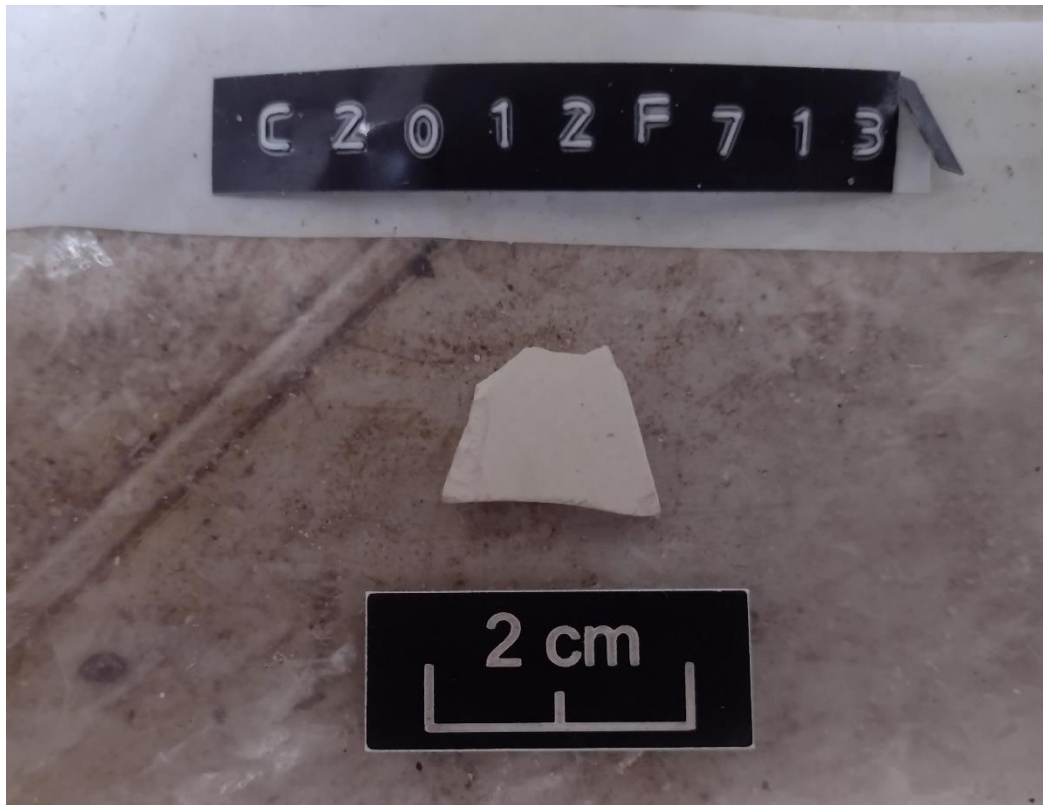
Fig 36: F713 in 2022

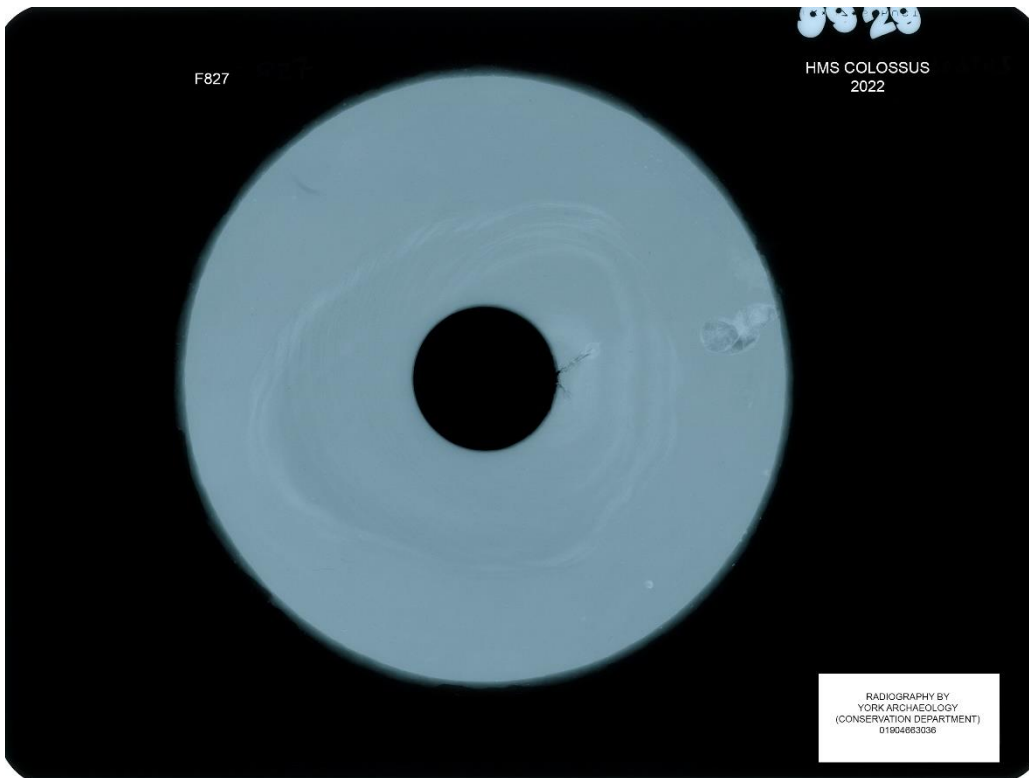
F825	Lignum vitae	0.897	21.3	8069	0	Very hard and dense sheave, slight cracking has developed and slight erosion through use. No evidence for shipworm from X-ray image.	B
F827	Lignum vitae	0.855	25.0	8055	1	Very hard and dense sheave, physical erosion to both faces through use. One crack visible and possible exit holes. X-ray image shows one large calcareous lined tunnel from worm attack.	A

Fig 37: X-ray of F827, 2022, after 10 years in crate A
