HMS Colossus Dive Trail

HMS Colossus was a 74 gun warship built in 1787 at Gravesend and wrecked in 1798. These 74 gun ships were one of the most successful types of the period. They were about 51m (170 feet) in length and had a crew of over 600. During her relatively short working life (eleven years) *Colossus* saw action at Toulon, Groix, Cape St Vincent and Cadiz. She also took part in the capture of two enemy ships *Le Vanneau* and *Vrai Patriot* in 1793

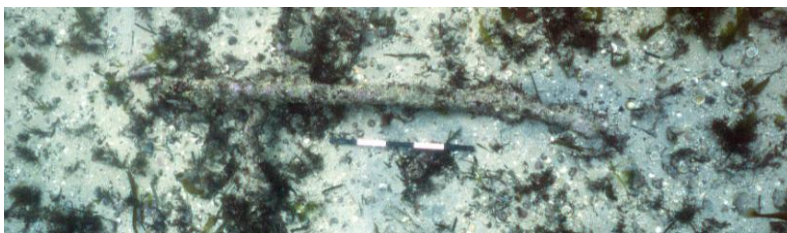
2

Here you can see the remains of several muskets. These were used by the 120 marines on board *Colossus*, as well as by the ordinary seamen. These are sea service muskets, similar to the well known 'Brown Bess' of the British Army, but simpler and slightly shorter than the standard land musket. They were smooth-bore flint-lock weapons and fired a lead ball of 0.75 inch diameter. The accuracy of this type of weapon was low; the effective range would have been well under 100m. The barrel is made from steel, the stock is wood and the trigger guard and butt plate are copper alloy.

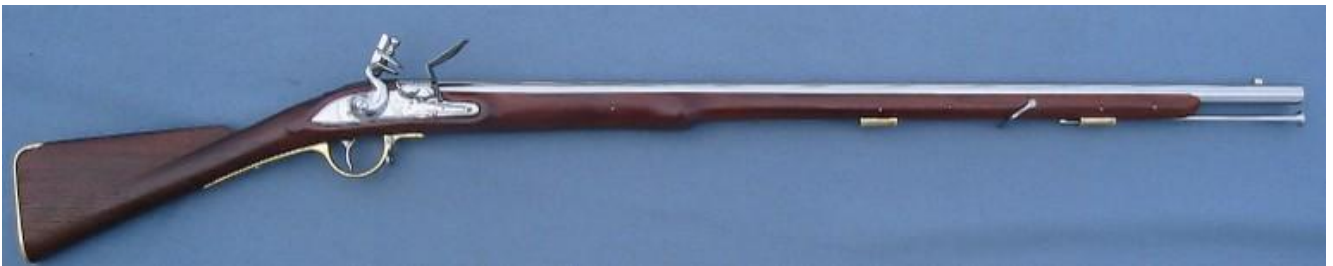
2

This is what the now corroded muskets would have looked like. The musket was fired using black powder (gun powder), which was ignited by sparks generated by a flint striking a steel plate.

To the north of the muskets are a number of large iron objects. These are the remains of the mizzen chains, the iron fastenings which held the shrouds (supporting ropes) from the mizzen mast to the outside of the ship's hull.

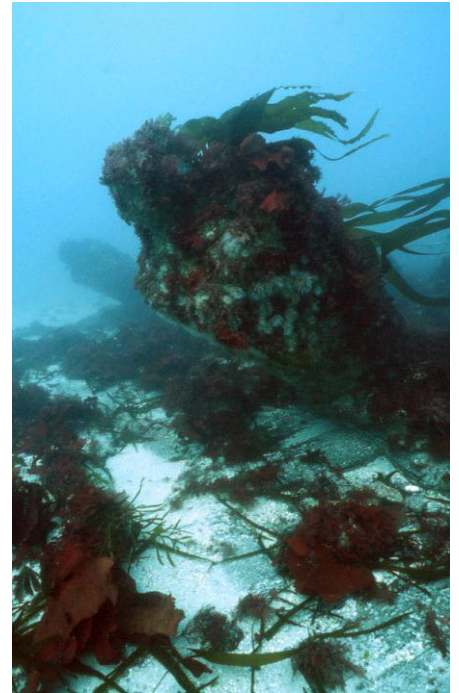
3

Colossus carried 74 guns on three different levels. These were all smooth-bore cast iron guns designed to fire a variety of projectiles (grape, case, bar, chain and round shot). The guns were classified according to the weight of round shot they fired. The lower gun deck had 28 thirty-two pound guns; the upper deck had 28 eighteen-pound guns while the quarterdeck and forecastle held the remaining 18 nine-pound guns. The guns visible on site are eighteen-pound guns of the Armstrong type, while the lower deck guns were the newer Blomefield design.

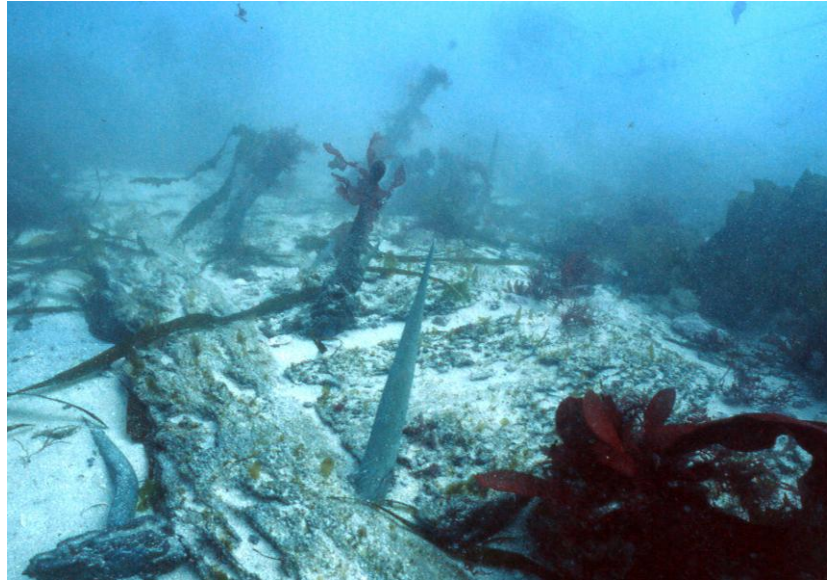
7

The timbers you see here are the partly buried hull timbers. These consist of the inner planking, frames and outer planking. You are at the level of the orlop deck, where cables and sails were stored, below the water line of the vessel.

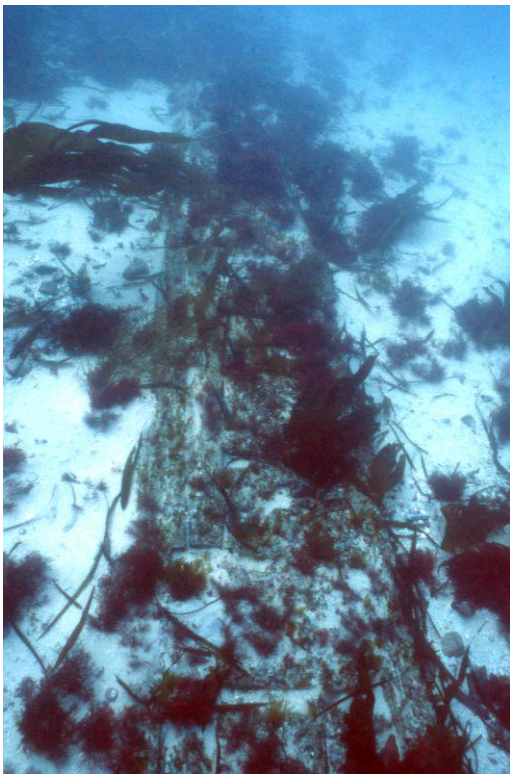
The photograph here shows you roughly what the hull timbers look like at this point (looking east). On the left is the outer hull planking. In the middle, the large square timbers are the frames of the ship. On the right hand side is the inner planking. If you look carefully you should be able to see the joins in the planking. Again you will notice how the timbers are being attacked by wood boring organisms – sometimes called gribble.

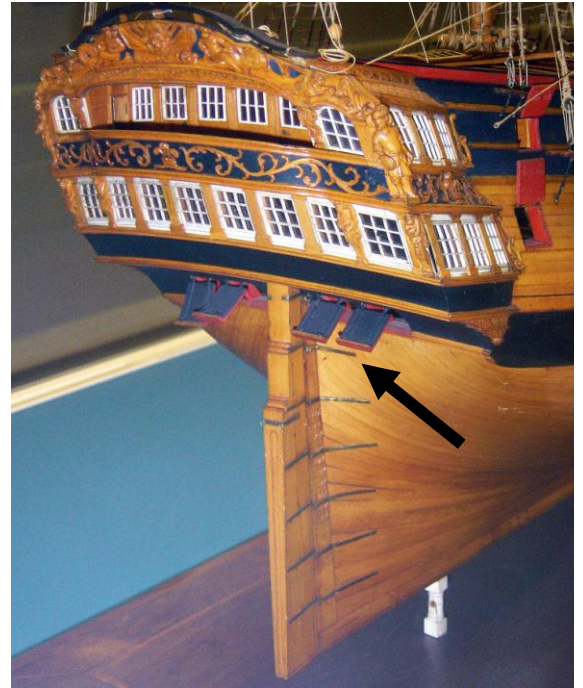
9

This photograph of the stern of a model of a similar ship shows the position of the rudder gudgeon (arrowed).

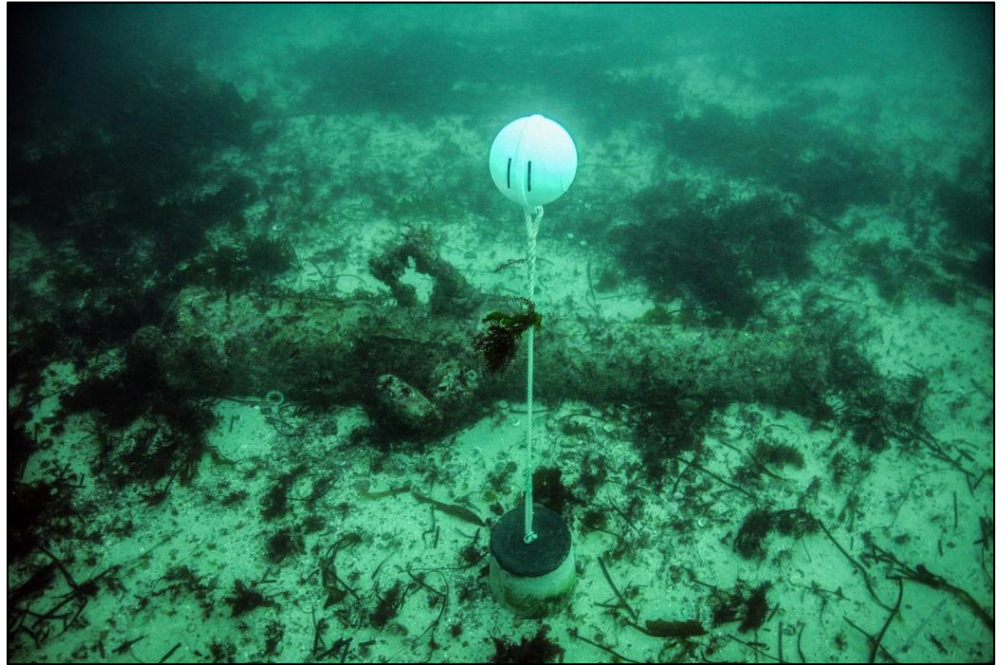
11

At this station you can see one of the Armstrong pattern 9lb guns from *Colossus*. This gun would originally have been on the quarter deck of the ship. Notice that the gun now lies upside down with the iron fastening bolts of the wooden gun carriage still attached to the gun.

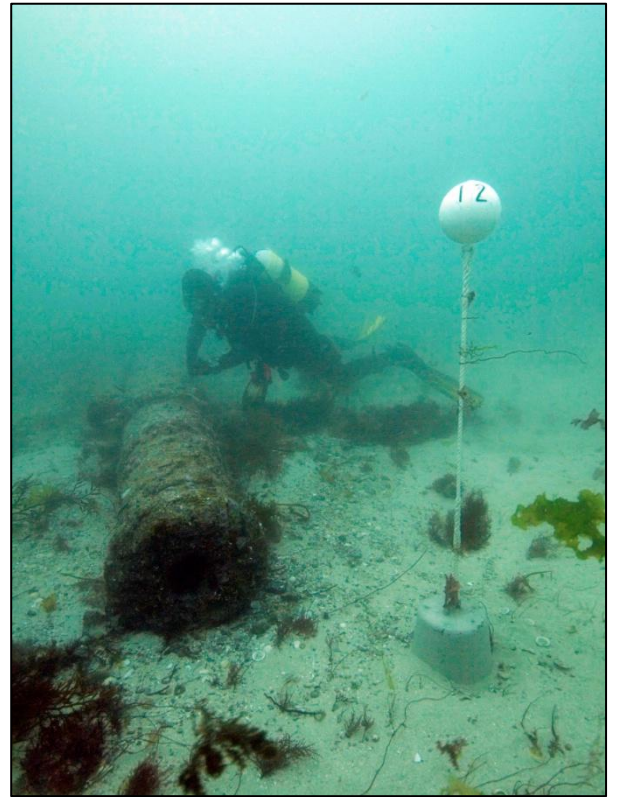
12

At this station you can see one of the Blomefield pattern 32lb guns from *Colossus*. This gun would originally have been on the main gun deck of the ship. Notice that the gun now lies upside down with iron chain wrapped around the barrel of the gun.
