Her Majesty's Fireship

Firebrand

Shipwreck Recording Project

Project Report

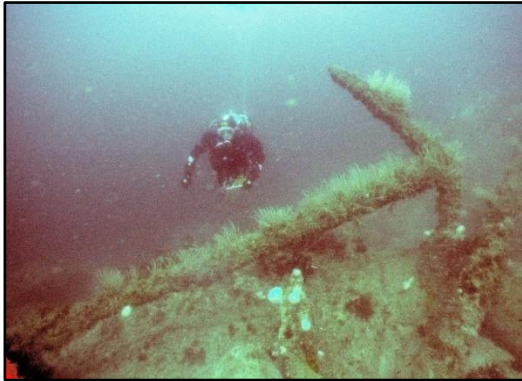
Fig 4
One of the *Firebrand's* four bower anchors – note the missing upper fluke.

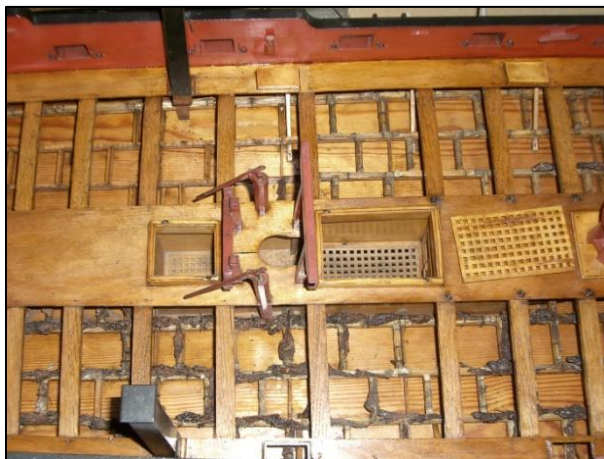
Fig 7
The fire-room viewed from above – note the fire-troughs containing reeds.

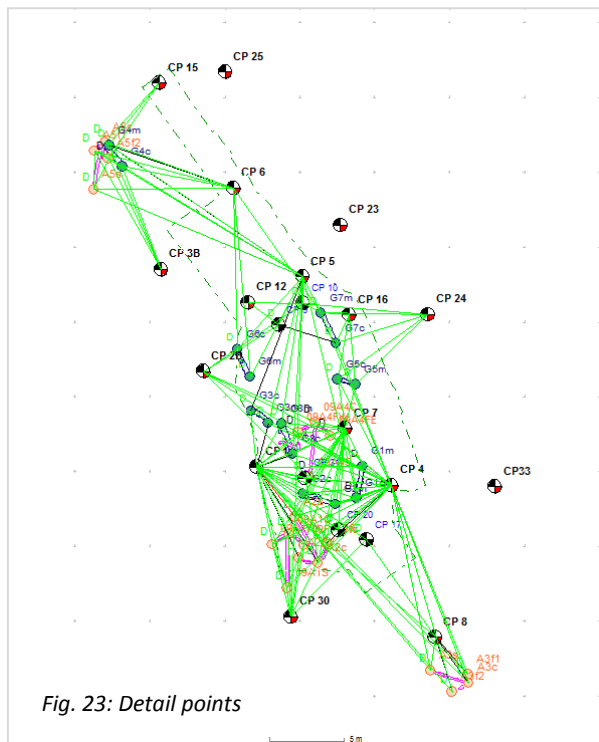
To position each detail point, measurements were made from each detail point to the four primary control points nearest to it. Where not enough primary points were within a close enough distance a measurement was

Fig. 23: Detail points

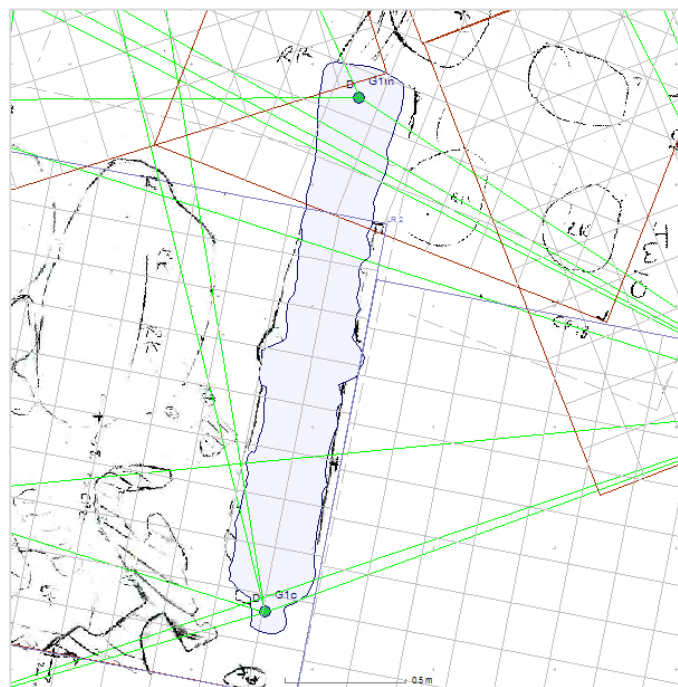
The blue shaded drawing is the estimated position of Gun 1 based on a separate drawing of the gun and the two detail points that position it. Underneath is the scanned planning frame drawing of that same part of

Fig. 24: Gun 1 position comparison

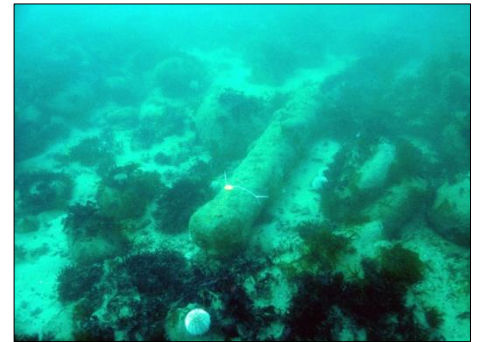
Fig 30 Gun 1

Lying upside-down on the seabed

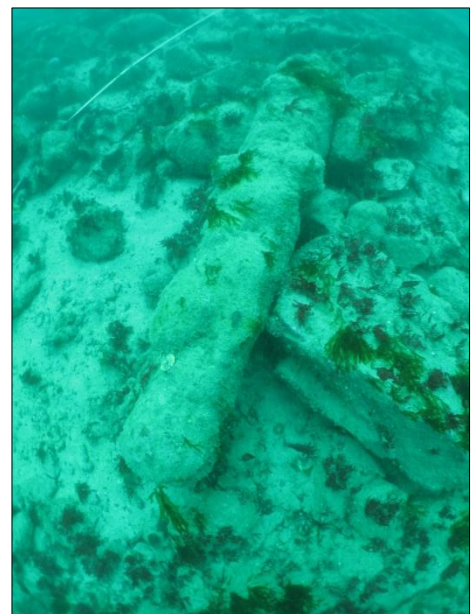
Fig 31 Gun 2

G2			
	Metric	Imperial	Comments
Length (BR to MF)	2.05	6' 8.7 "	
Basing diameter	0.37	1' 2.5"	
BR to trunnion	0.90	2' 11.4"	
Trunnion diameter	0.07	0' 2.7"	Possibly damaged
Bore	-	-

Gun 2, a minion (c. 4lb shot)

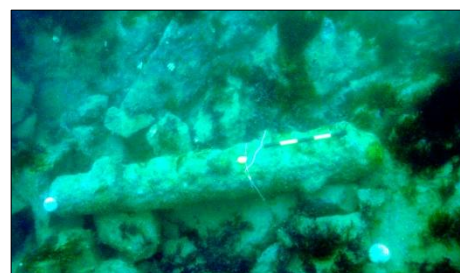
Fig 35 Gun 6

G6			
	Metric	Imperial	Comments
Length (BR to MF)	2.05	6' 8.7 "	
Basing diameter	0.32	1' 5.9"	
BR to trunnion	0.96	3' 1.7"	
Trunnion diameter	0.15	5.9"	
Bore	0.14	5.5"

Gun 6, a minion (c. 4lb shot)

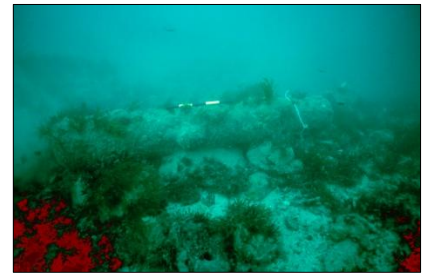
Fig 36 Gun 7

G7			
	Metric	Imperial	Comments
Length (BR to MF)	2.12	6' 11"	
Basing diameter	0.40	1' 3.7"	
BR to trunnion	0.91	2' 11.8"	
Trunnion diameter	0.16	6.3"	
Bore	0.07	2.7"	Heavily concreted

Gun 7, a minion (c. 4lb shot)
Lying upside-down on the seabed

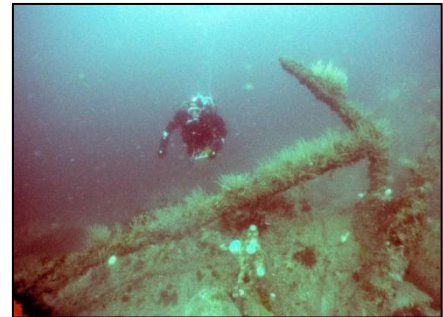
Fig 41 Anchor 1

A1			
	Metric	Imperial	Comments
Length (shank)	3.66	12' 0"	Anchor upright
Length (arm)	1.26	4' 1"	
Fluke to fluke	2.17	7' 1.4"	Upper fluke missing
Fluke (L x W)	0.77 x 0.54	2' 6" x 1' 9"	
Ring	0.69	2' 3.1"	Ring diameter
Shank section	0.15 x 0.16	6" x 6.3"

A bower was found in 2006 standing upright with one fluke buried in the seabed. Sadly, on our return to the site in 2007 it had fallen and now lies flat on the seabed. The iron anchor ring is intact. The upper fluke is missing from the anchor. This anchor is moderately concreted.

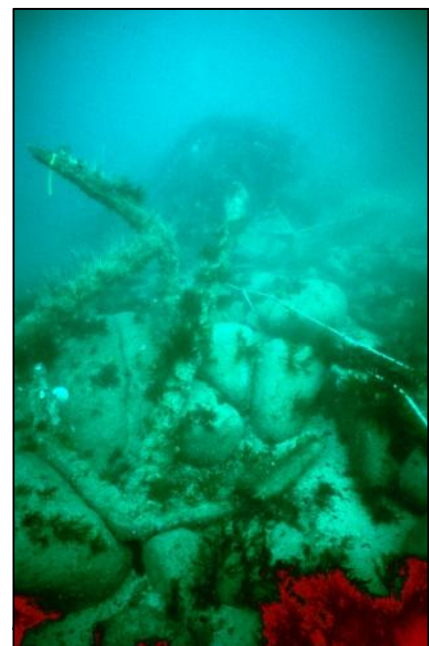
A2			
	Metric	Imperial	Comments
Length (shank)	3.72	12' 2"	
Length (arm)	1.50	4' 11"	
Fluke to fluke	2.10	6' 11"	
Fluke (L x W)	0.64 x 0.44	2' 1" x 1' 5"	
Ring	Missing	-	
Shank section	0.16 x 0.17	6.3" x 6.7"

A bower, or possibly the sheet anchor, lies flat on the seabed close to anchor 1. Both flukes are in place but the anchor ring is missing. This anchor is moderately concreted.

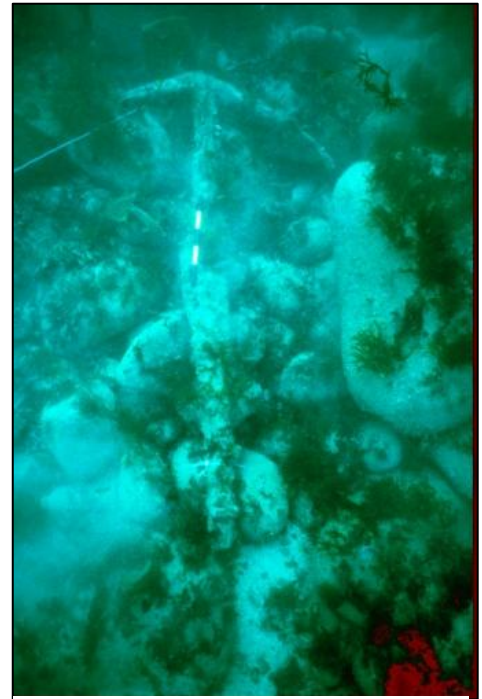
Fig 44 Anchor3

A3			
	Metric	Imperial	Comments
Length (shank)	2.49	8' 2"	
Length (arm)	0.86	2' 10"	
Fluke to fluke	1.37	4' 6"	One fluke missing
Fluke (L x W)	0.41 x 0.24	1' 4" x 9.4"	
Ring	Missing	-	
Shank section	0.15 x 0.15	6" x 6"

Probably the stream anchor, this lies flat on the seabed 11m to the southwest of the wreck. Only one fluke survives and the anchor ring is missing. This anchor is heavily concreted. The reason this anchor lies so far from the rest of the surviving wreckage is not clear. It is not shown in this position on the 1981 Morris plan, so may have been subsequently moved.

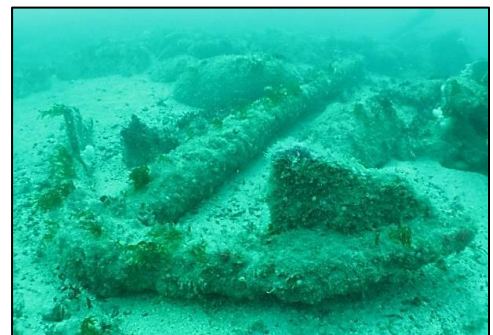
Fig 45 Anchor 4

A4			
	Metric	Imperial	Comments
Length (shank)	3.72	12' 2"	
Length (arm)	1.42	4' 8"	
Fluke to fluke	2.26	7' 5"	
Fluke (L x W)	0.72x0.54	2' 4" x 1' 9"	
Ring	Missing	-	Ring broken
Shank section	0.18 x 0.19	7" x 7.5"

A bower anchor, this lies flat on the seabed about 8m to the north of the postulated position of the bow of the wreck. Both flukes survive. The anchor ring is broken, probably when the ship's bell was recovered from under the anchor ring in 1981. This anchor is moderately concreted.

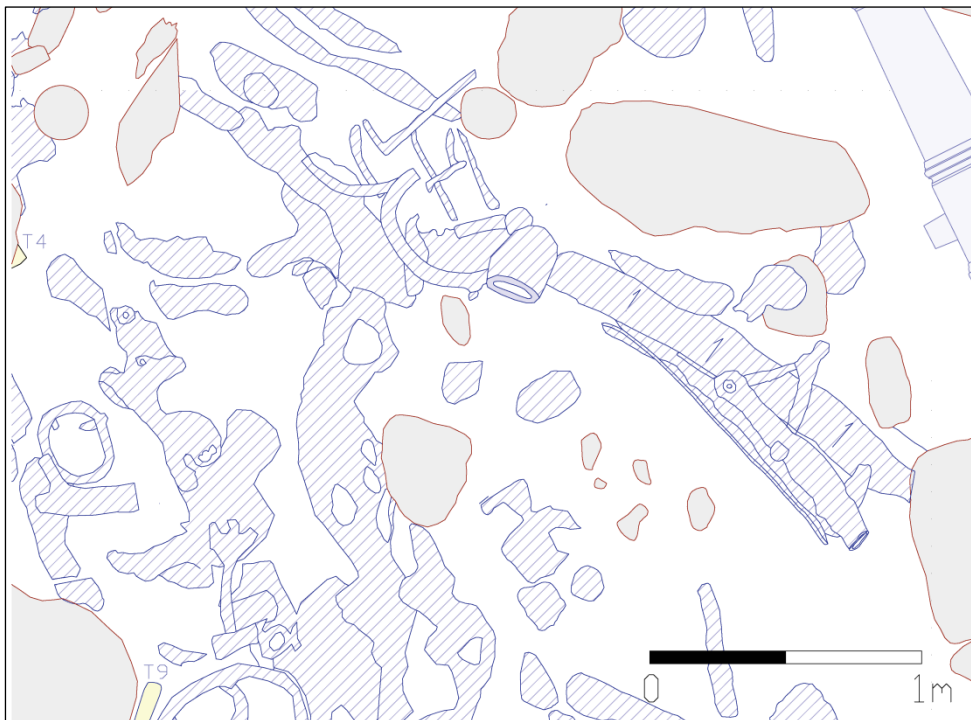
Fig. 59 Plan of the possible iron fire-trunk. Note the iron barrel hoops to the left of the 'fire-trunk'

The most likely component of a fireship which this iron feature could represent is one of the fire-trunks (see fig 9 above). The fire-trunks were usually made either of wood (Falconer, 1780) or of brass or copper (Coggeshall, 1997). However, it would seem from the surviving evidence that the fire-trunks on *Firebrand* may have been made of iron. The close proximity on the seabed of a number of iron barrel hoops may represent the remains of the fire-barrels which would have stood at the base of the fire-trunks. If this iron does indeed represent the fire-trunks then they are the rearmost pair, adjacent to the fire-room bulkhead – reference to figs 6 & 61 shows that this ironwork is in the position expected for the rear fire-trunks.

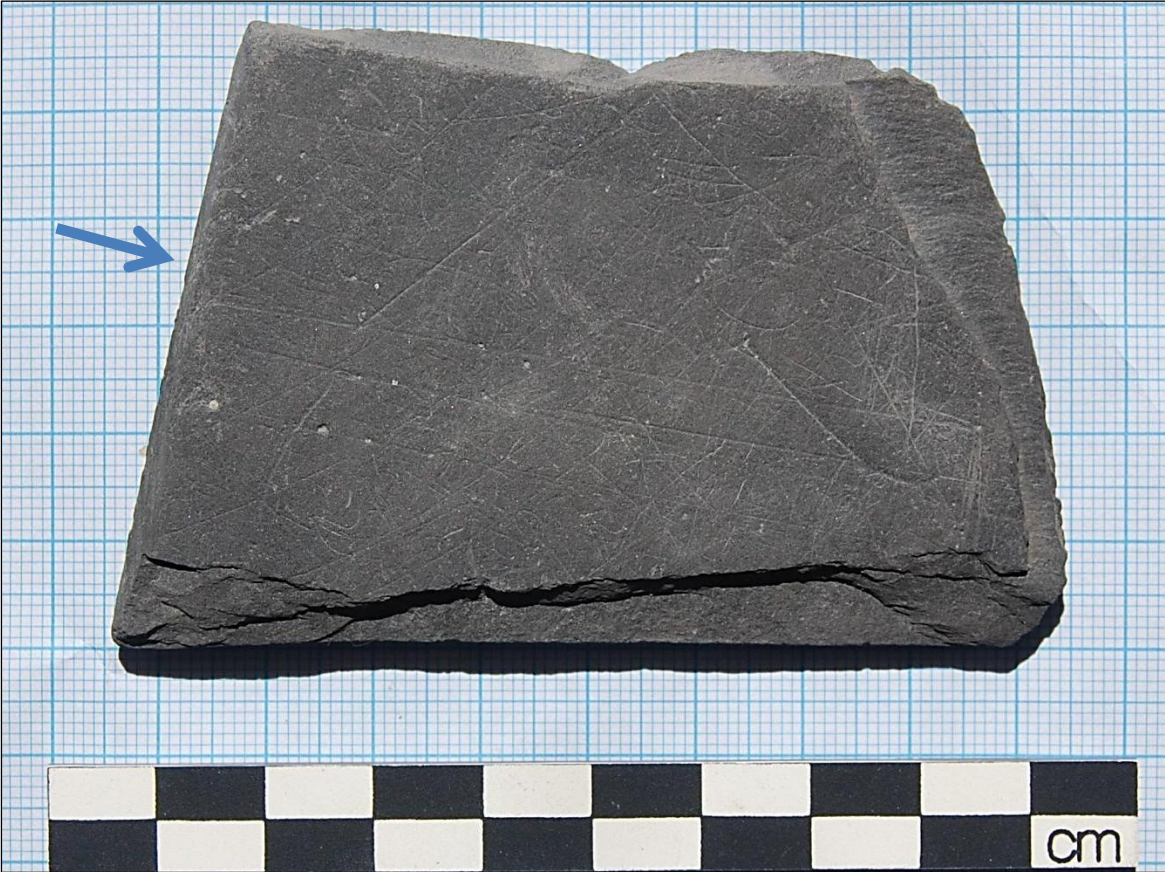
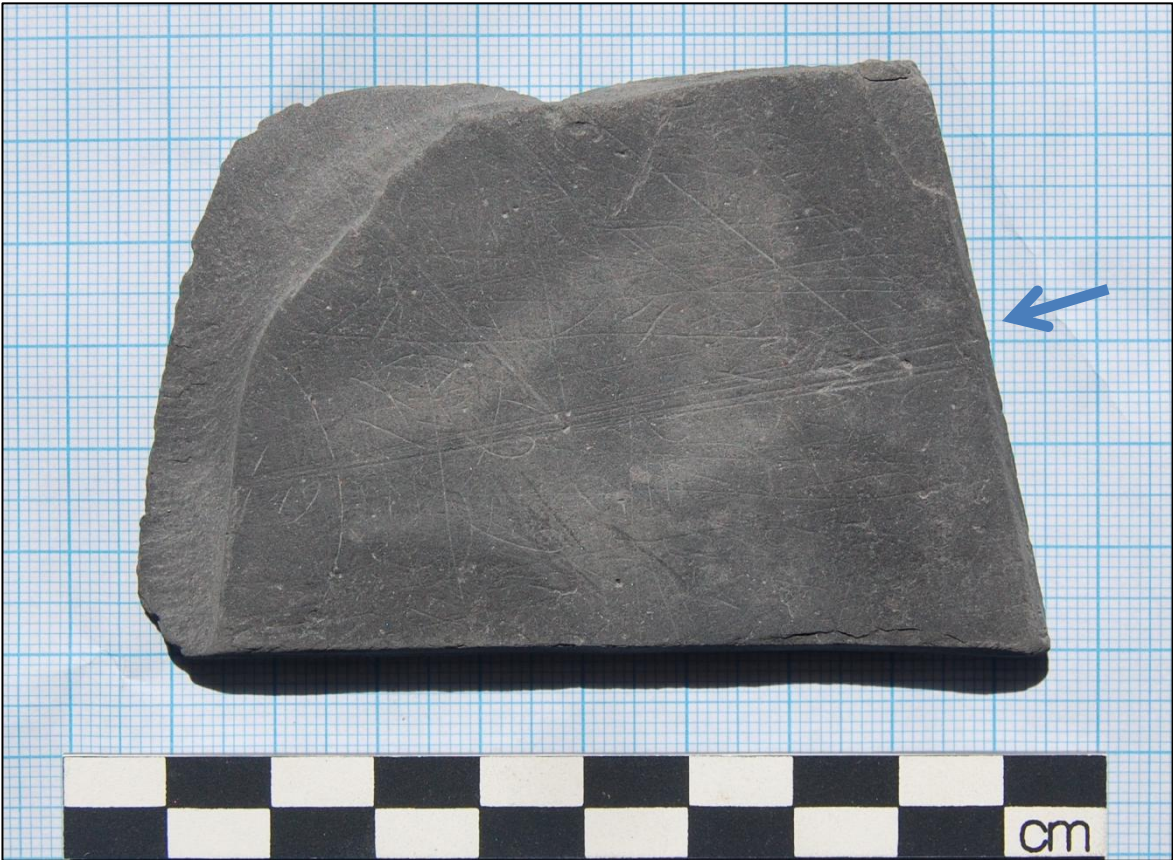
09A06 Fragment of Slate

This small fragment of slate has fine lines inscribed on each side; the lines are, on average, 0.2mm thick. There are also a number of small prick marks (average 0.5mm diameter) which often correspond with the ends or junctions of the inscribed lines. Many of these lines are 'drawn' over earlier lines. The slate is broken, the only original edge being the one shown arrowed in the photographs above.

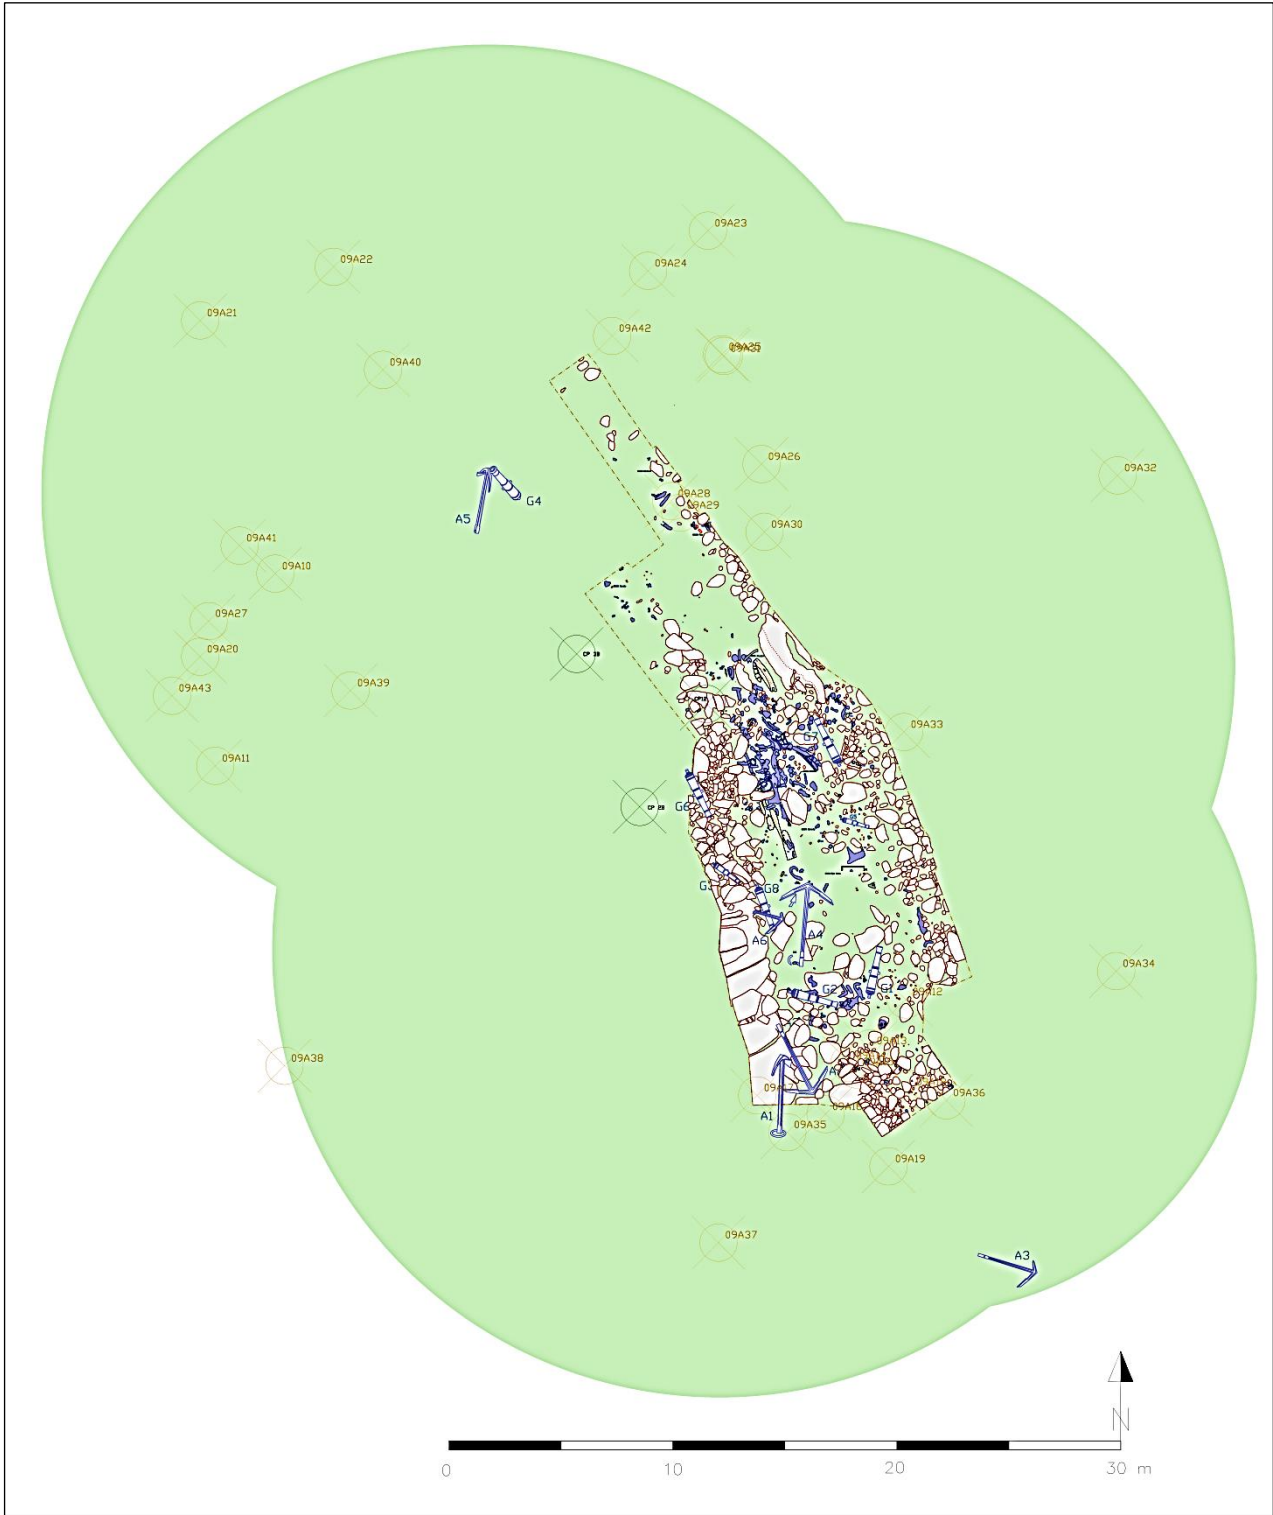
The area searched is shown shaded in light green on fig 69 below and the objects located by the green crosses (09A10 to 09A43). It is clear that relatively few objects were found to the south and east of the wreck while objects were more common to the north and west of the wreck. This is perhaps not surprising as the seabed slopes down (gets deeper) in these directions. What is clear is that only a relatively small number of objects have been dispersed from the main area of the wreck.

Fig 69
 Distribution plan of objects located in the area searches (green crosses). The area searched is shown shaded in light green.

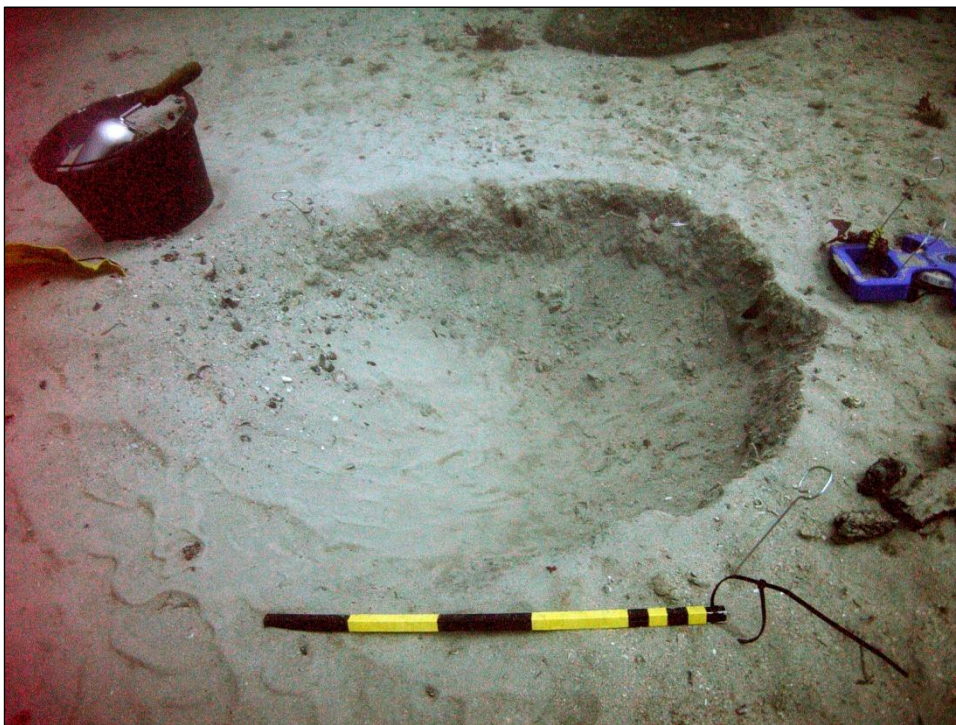
Fig 70

TP3 during excavation; note the trowel/scoop sat in the bucket. Scale = 0.5m
