St Anthony

Designated Historic Wreck Site

Desk-Based Assessment

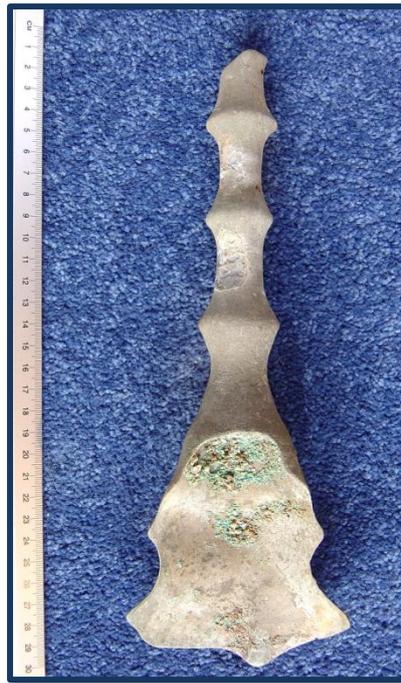
Cover photograph: SA277 Copper alloy candlestick base recovered from the site, now on display at Pengersick Castle.

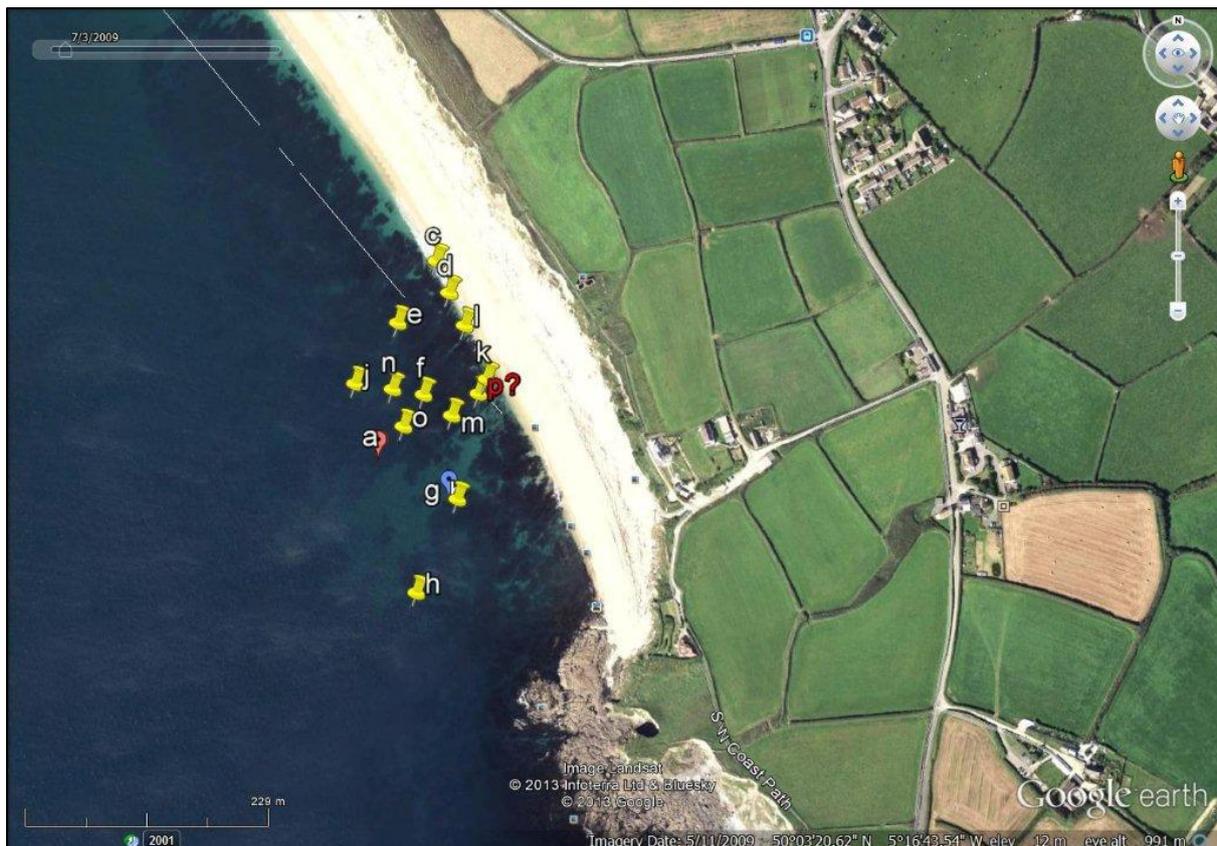
Fig 2

The licensee, David Roberts provided a Google earth image of the site with the approximate positions of the artefacts he has located to date. Each object is marked by a lower case letter, and an underwater photograph is included for each. These images all appear on the DVD.

b	Iron gun	J	Iron object
c	Iron ballast?	k	Iron anchor (part)?
d	Composite lead dice shot	k_2	Iron anchor [3]
e	Iron anchor [1]	l	Iron object
g	Iron object	m	Iron anchor [4]
h	Iron anchor [2]	o	Iron anchor [5]
l	Part of an iron gun?	p	Lead shot

Shows the approximate location of the artefacts located by David Roberts between 2007 and 2012

In recent years the licensee David Roberts (Visitor's licence since 2007) has undertaken a great deal of diving on the site. In consequence he has found a number of items on the site including an iron gun, part of another possible gun and no fewer than five anchors. Mr Roberts has supplied a Google Earth 'map' of the site with these finds marked on it (2013_1). The iron gun in particular looks to be contemporary with the wreck of the *St Anthony* and is probably the gun mentioned in the 1981 application for designation: 'no artefacts were showing and the single iron cannon known to be on site, and seen perhaps twice over the last few years remains buried'.

The guns and anchors recently found by the current licensee David Roberts should be recorded and an accurate GPS position for each taken. At the moment Mr Roberts only has a visitor licence for the site, and he would presumably need a survey licence to undertake this work.
