Her Majesty's Fire-Ship

Firebrand

Shipwreck Recording Project

Project Design 2009

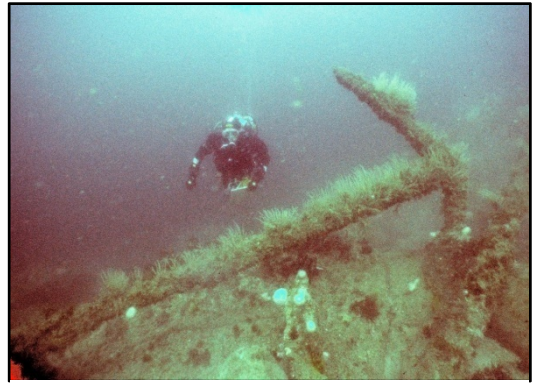
Fig 3 One of the Firebrand's four bower anchors – note the missing upper fluke.

Most of the wreckage appears to be *in situ*. A striking exception is the gun and bower anchor standing propped against each other at the northern end of the site (Fig 2). This gun and anchor are not shown in this position on the 1981 Morris sketch – they may have been moved there and used as a mooring by the Morris team.

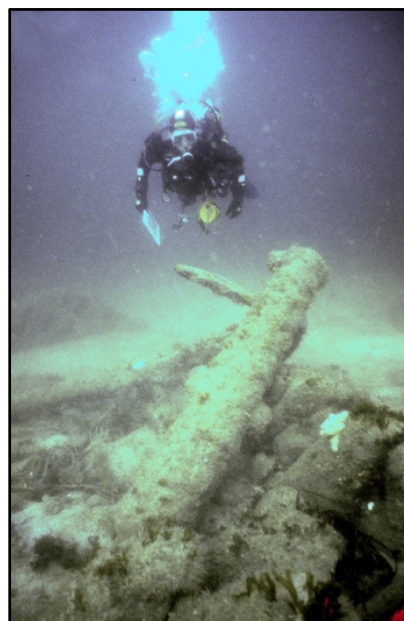
Fig 7 An iron gun, G4, propped against one of the bower anchors, A5
