# *COLOSSUS 2026*

## THE BREAKING POINT

### PROJECT REPORT

| Project number | 2026/C/2 |

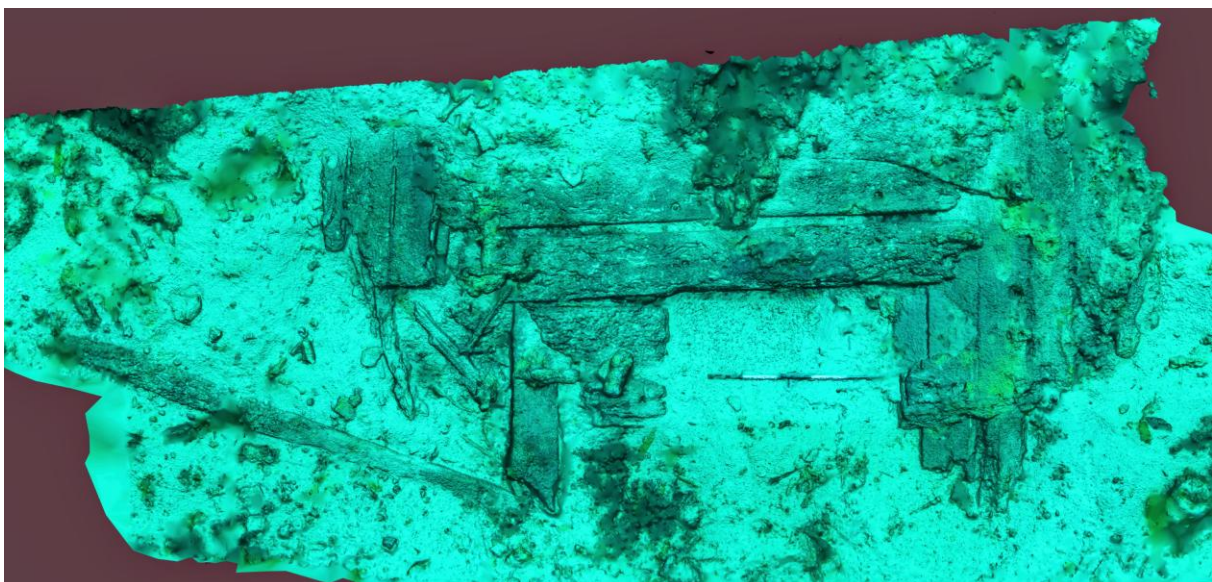
**Fig 11**  
Ortho image generated from the 3D SfM model of the timbers at the break

We then took a series of 128 overlapping photographs to enable a structure from motion 3D model to be constructed using Agisoft Metashape software. Many of the images would not align – mainly because of the numerous mobile weed clumps wandering past in the tide – but there were enough to make the ortho model below which was used to generate the outlines for the drawing of the timbers at the break. The annotated sketch was used to add in detail and to enable discrimination of the materials

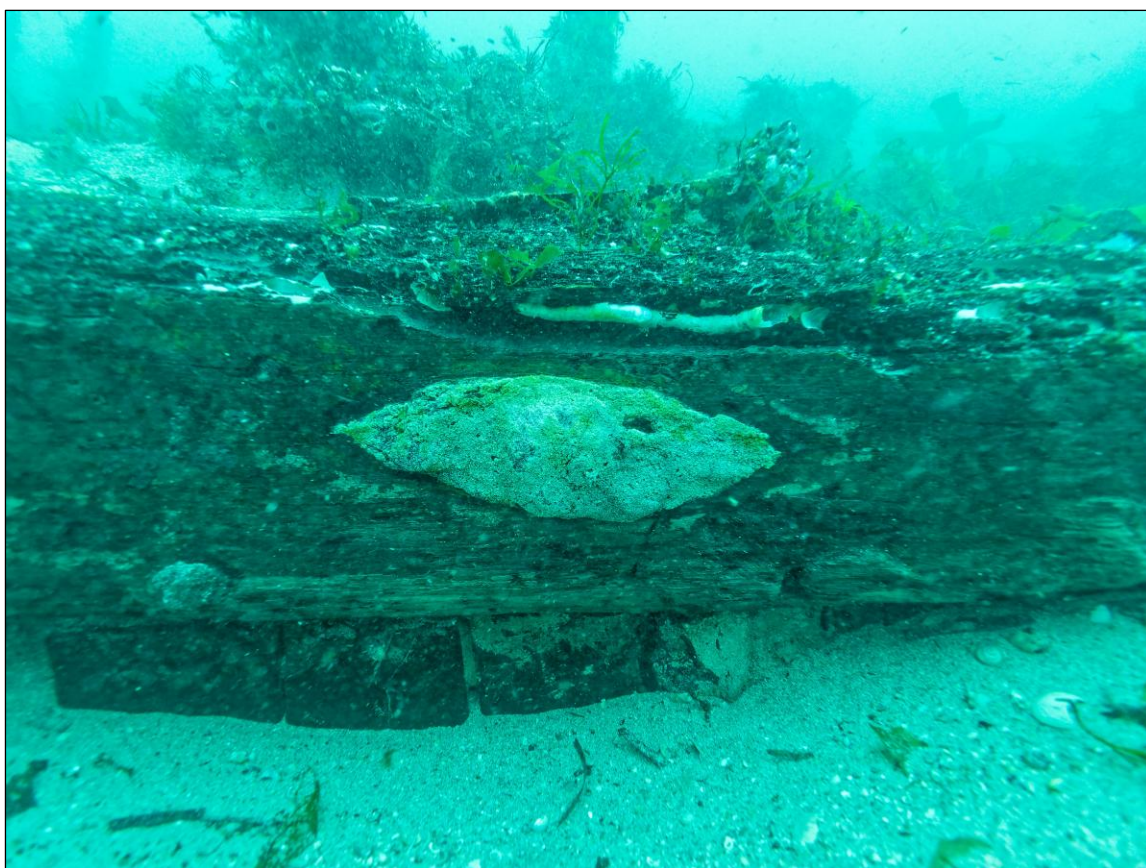
**Fig 16**

This shows one of the lozenge shaped patches of iron corrosion on the frame timber where the iron bolt holds the two futtocks together. Below the frame timber can be seen the ends of the hull planking where they abut the gun port edge. On the top of the frame can be seen the shipworm tunnels bored into the frame.

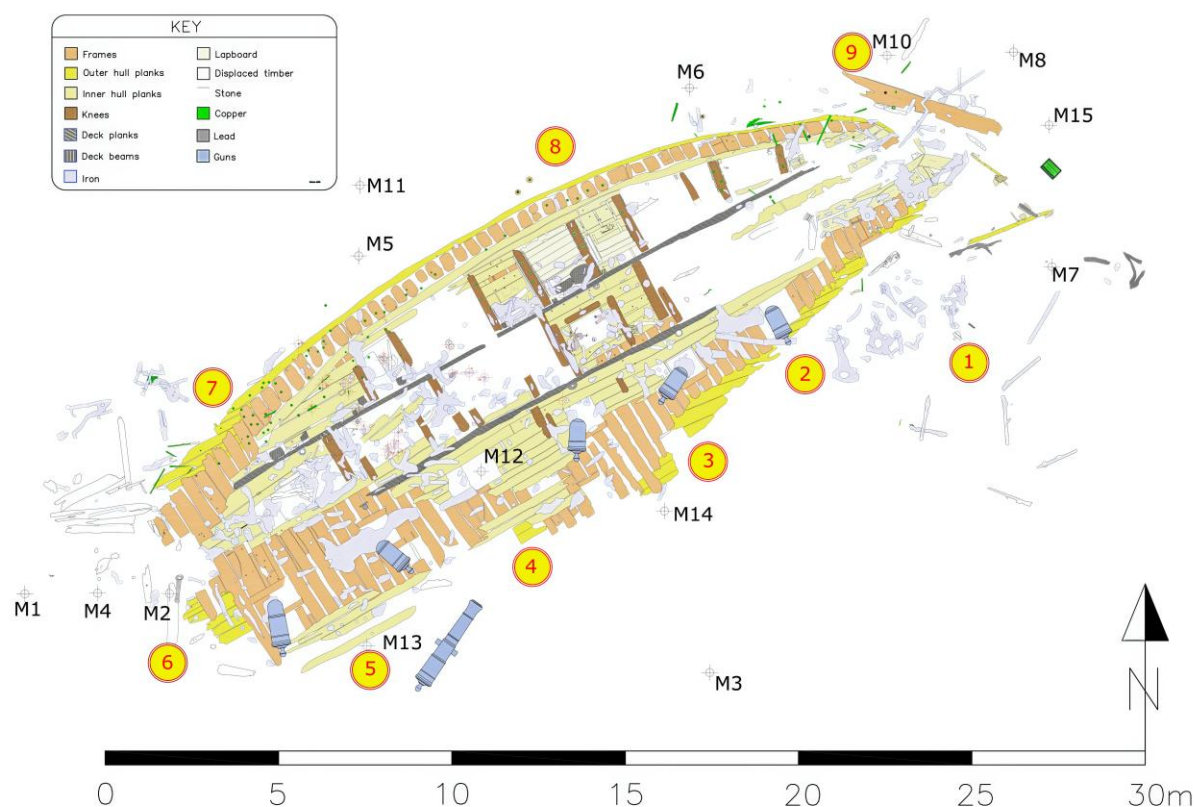
**Fig 18**  
Location of the sediment monitoring points

The plan above shows the distribution of the 14 sediment monitoring points around the wreck site. The positions of the monitoring points were slightly altered when the points were renewed in September 2025 to make them easier to locate. The table below lists the readings taken this year: note these are the actual measured length of exposed rod, not the differences since last measured. For historic reasons there has never been an M9 monitoring point.

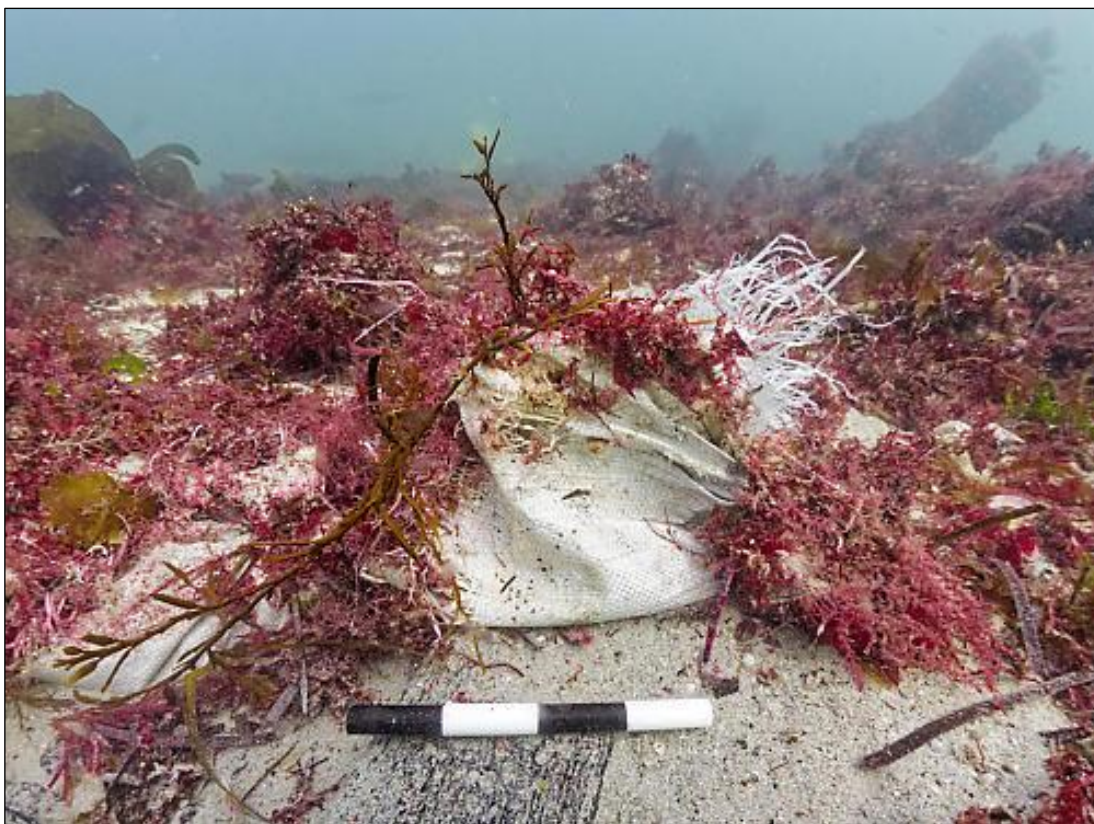
**Fig 19**  
One of the exposed sandbags

In several places around the site geotextile sheets have been used to help stabilise the sediment and wreck on the site. This geotextile is held in place with rows of sandbags. This September it was noticed that several of these sandbags have been exposed (probably by the falling sediment levels) and have begun to unravel. The sandbags are made of a woven plastic (probably polypropylene), and given recent concerns about plastics in the sea, it would probably be best if these exposed sandbags were replaced with sandbags made from a natural fibre such as hessian. Furthermore, it would probably be desirable to compile a list of materials which have been used on protected wreck sites, the level of risk they pose, and where appropriate suitable alternatives.

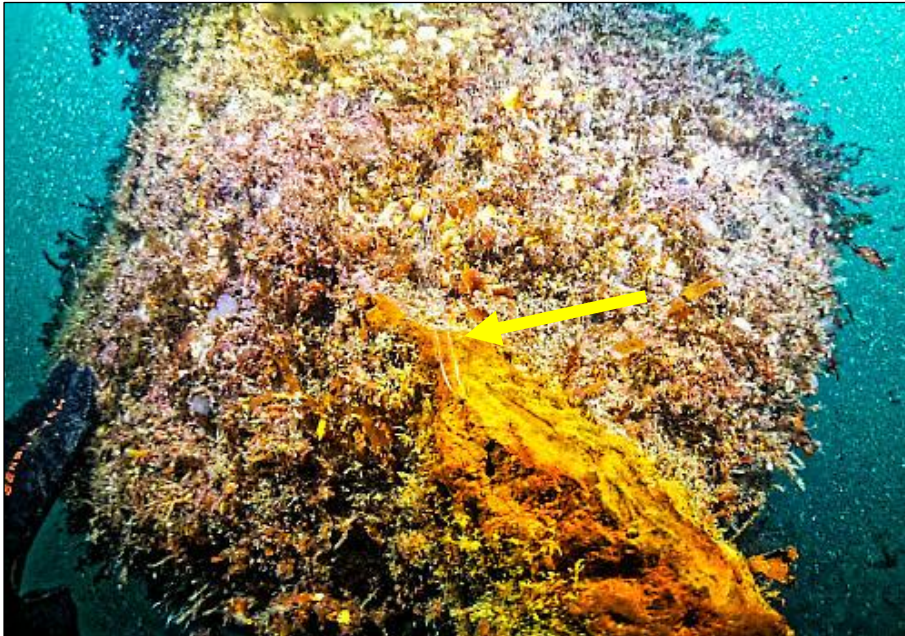
**Fig 20**

The arrow indicates the stream of tiny bubbles emanating from the cast-iron gun barrel

Occasionally effervescence is noticed emanating from the iron guns on site; this is probably a sign of active iron corrosion. In the past, Gun 1 has exhibited this, but this year it was observed on Gun 4, close to where there is a corrosion-generated 'fin' near the cascabel base ring.

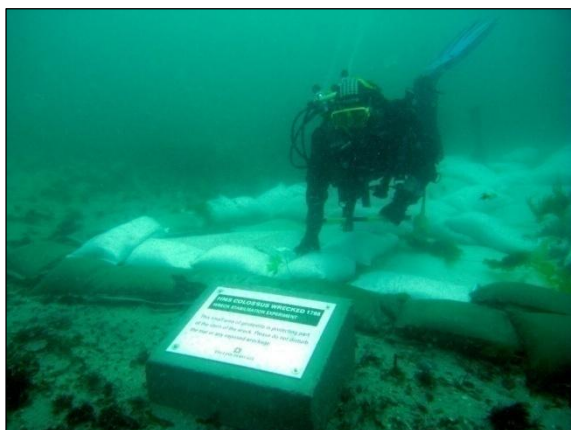
**Fig 21**  
The original sign in 2008

The seabed sign was originally installed in 2008 as part of the limited site stabilisation project. The sign face has been renewed three times since then, using a variety of different materials. The sign is attached to a concrete base which weighs in the region of 120kg. The sign became the start point of the dive trail when that was installed in 2009 and has remained at the start of the trail ever since.

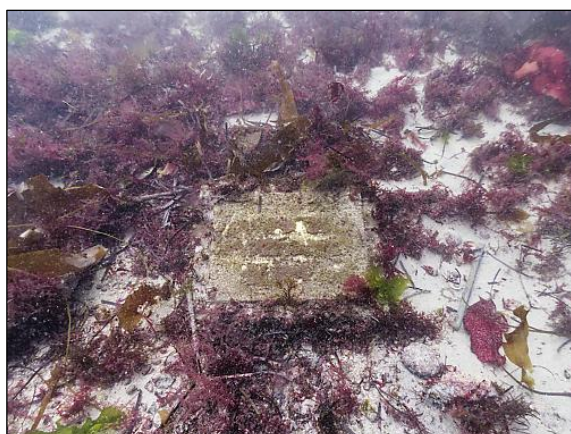
**Fig 22**  
The sign in 2026 before cleaning

The sign is probably reaching the end of its useful life; it also features the English Heritage logo which is no longer appropriate. As the start of the dive trail the tatty, almost illegible sign gives a poor first impression. What we need is a new sign, probably in stainless steel with cutout lettering to enable simple cleaning. Ease of cleaning and robustness is important as visiting divers often try to clean the sign using their dive knives, which has caused damage to the plastic sign in the past.

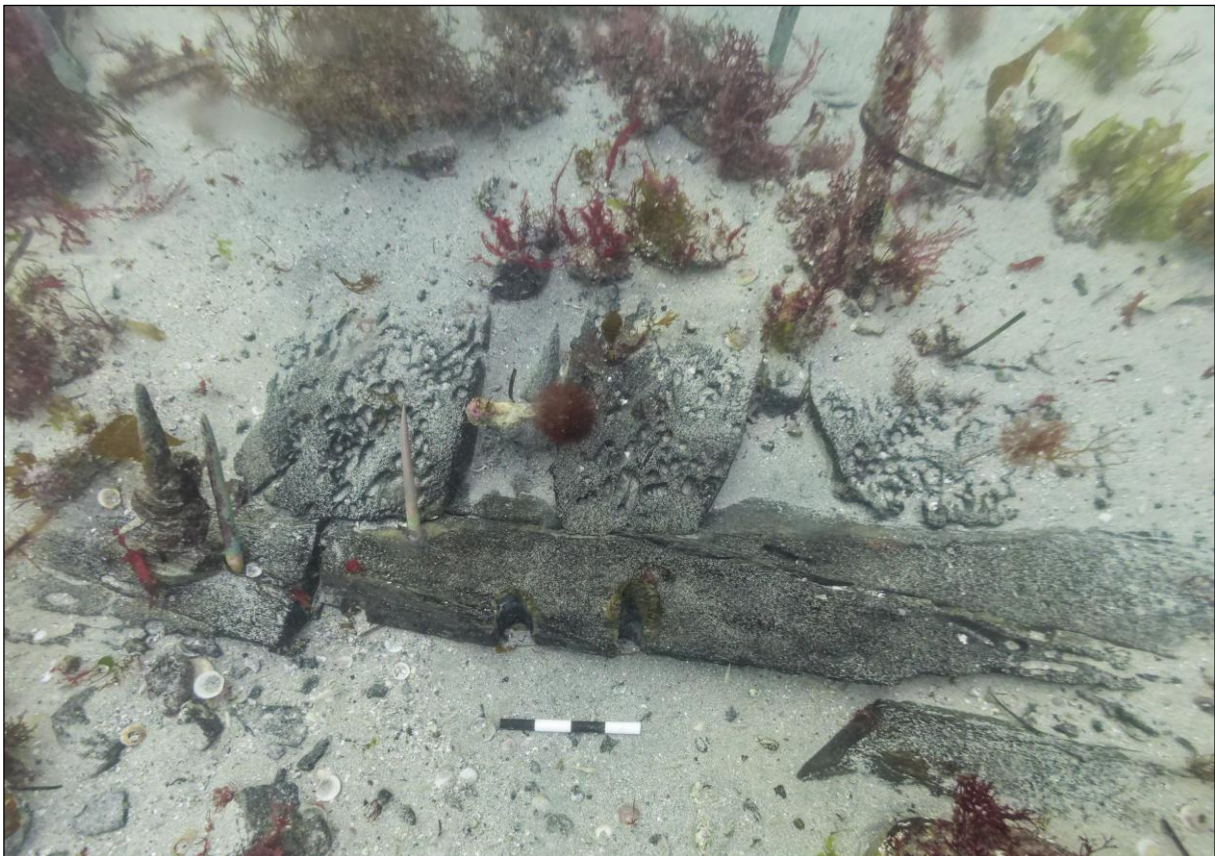
**Fig 24**

Hull timbers on the north west side of the wreck, frames running vertically and outer planking horizontally. The two heavily corroded iron bolts are just above the scale bar and are surrounded by copper bolts.

The bolts themselves have largely rotted away, but the crust of iron corrosion products remain. This could be an important discovery which might help to explain why *Colossus* was such a leaky ship, as these bolts passed right through the hull and once corroded by their proximity to the nearby copper bolts and sheathing would have leaked continuously.
