# ***Royal Anne Galley*** **Marine Environmental Assessment** **The Lizard, Cornwall**

## **Phase 4: Inspection and Monitoring**

| <b>Report Number</b> | <b>2014R052</b> |
| <b>Date</b> | <b>17 September 2014</b> |

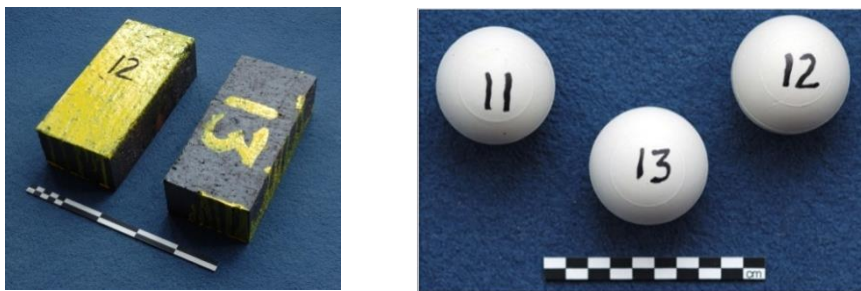
Fig 6 Numbered bricks and steatite spheres, 20 of each were deployed on the site in 2009

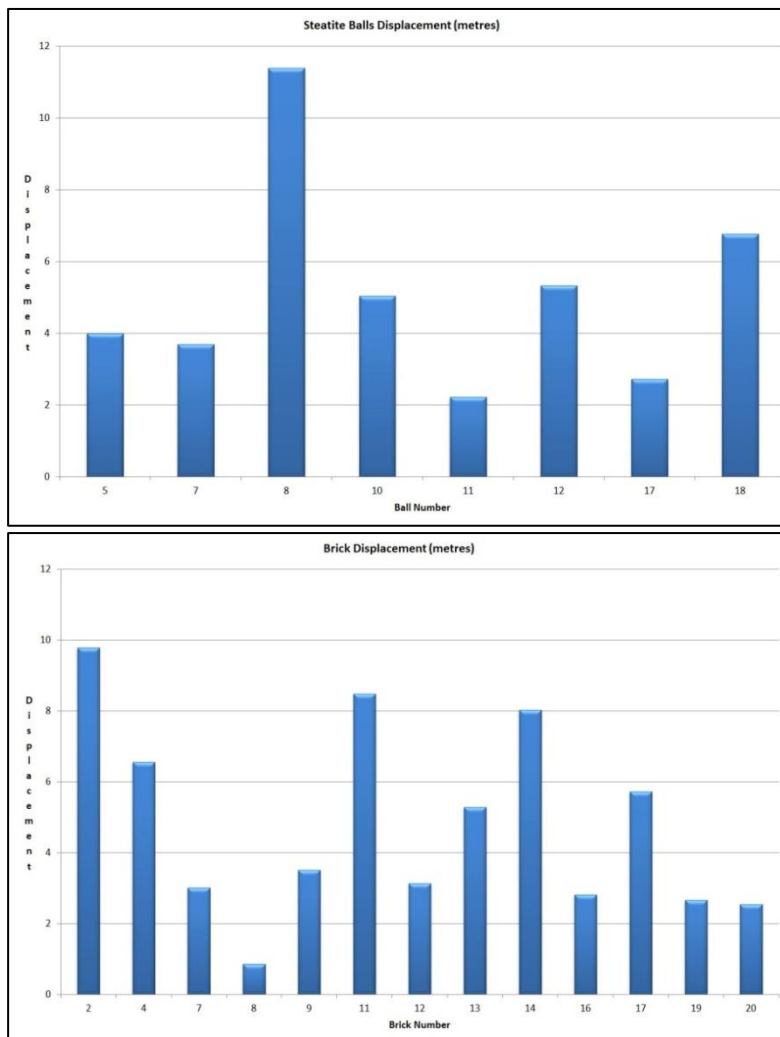
What is remarkable for such a high-energy site is the high percentage of the dispersal objects relocated within 10m of their starting position (Fig 7). Those who know this site all predicted that most—if not all—of the dispersal objects would be lost. What is even more surprising is the distribution of the dispersal objects as recorded in October 2010 (Figs 9 and 10 below). With the single exception of sphere 8, the objects had been sorted into two distinct areas; the bricks had all been moved to the east while the spheres have all been moved to the west of their original positions (Fig 12). This 'sorting' of the dispersal objects was a most unexpected result. As the two types of object have similar densities (2408kg/m<sup>3</sup> and 2735kg/ m<sup>3</sup>) the differentiation was likely to be due to their different size and shape. This theory was bolstered by the fact that the granite block SS1 measuring 0.2mx0.35mx0.25m and weighing 30kg was moved by 5m to the east between deployment and recovery—thus behaving in the same way as the bricks. Why the smaller spheres had been moved in a different direction is not clear. The following comments were received from Jon Rees, principal oceanographer at Cefas:

*I think these results are incredibly good – two very distinct groups. The consistency of the results is also very strong – no "outliers". In terms of analysis, the distributions are also explainable – several different solutions are possible (1) depth variation over tidal cycle – at low tide particles move inshore or high tide offshore (2) different size/density/shape objects will move according to the stress applied to them (the 'bed shear stress' – combination of wave and tidal current components and also depth related) and the critical "movement stress" for that object. I don't know the specific densities of brick or spheres but one group could have been moved north-east during a south-west storm at low tide whilst the other group moved south-west on the same storm at high tide (undertow). Conversely, during a single storm event and with increasing bed shear stress applied to each group could of lead to different transport paths. As well as analysing the 'found' objects the difference in 'lost' objects may give useful information.*

*Fig 7 Charts showing the distance of each brick and sphere from their starting point (October 2010)*

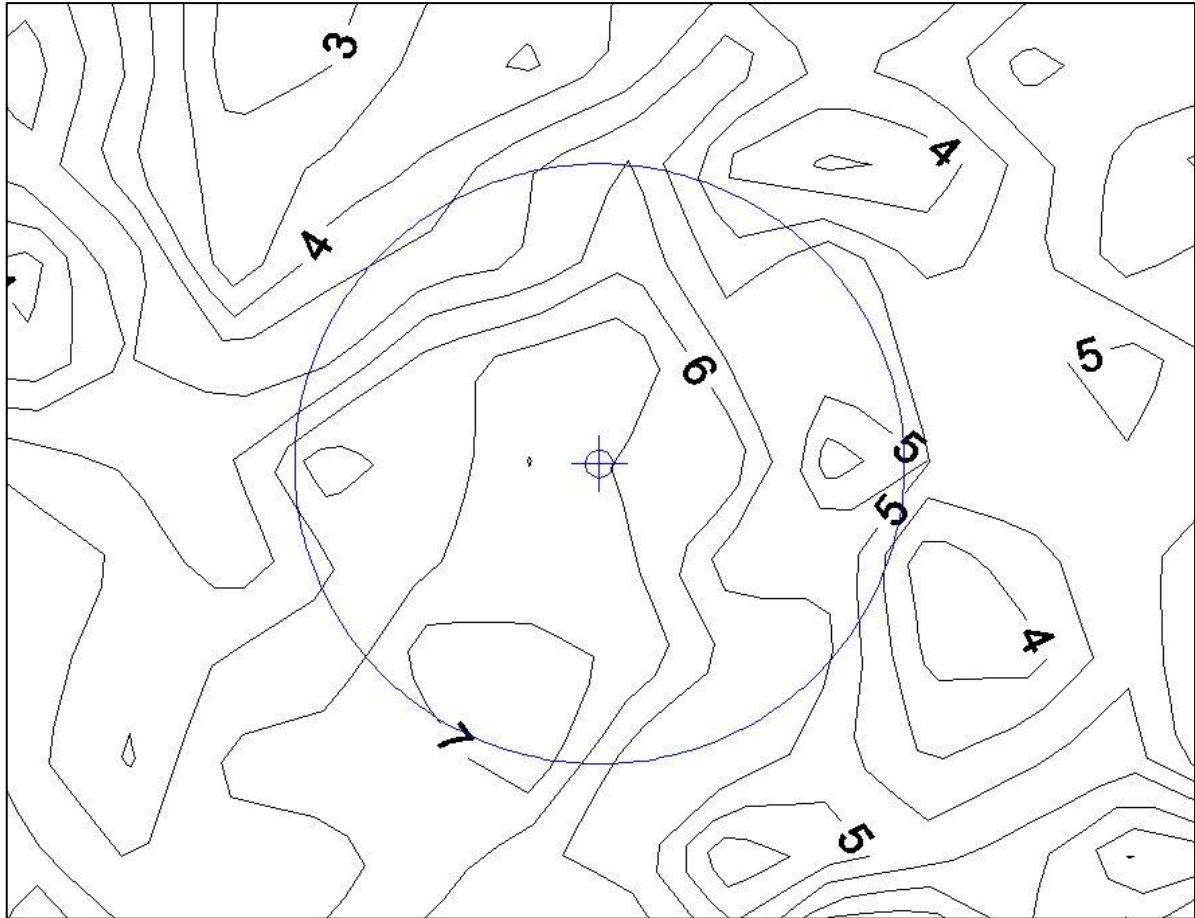
*Fig 8 Contour plot of the area around the dispersal trial. The blue circle has a radius of 10m and is centred on the dispersal objects origin. The heights are in metres below chart datum. The contour vertical interval is 0.5m. Derived from Seastar bathymetric data collected September 2009 (RAG MEA stage II).*

It has been suggested (EH comments on first draft report) that the differential movement of the two types of object (bricks and spheres) may have been caused by the spheres rolling downhill, while the bricks have reacted to water movements. This is an interesting idea. The impression given to the diver of the seabed in the area of the dispersal trial is that of a flat bottomed gulley. However, reference to the contour plot of the area (Fig 8) shows that the area where the majority of the spheres were observed in 2010 is in fact a shallow depression, while the majority of the bricks have 'travelled' uphill. This may account for the differentiation seen in 2010. By 2014 the spheres had all left the shallow depression and were all found (albeit only three of them) on higher parts of the seabed. We should perhaps be careful not to speculate too much on matters which are clearly the province of an oceanographer. It may be worth undertaking a small study of the data in collaboration with someone with expertise in the area of seabed sediment transport.
