COLOSSUS 2024

PROJECT REPORT

CISMAS

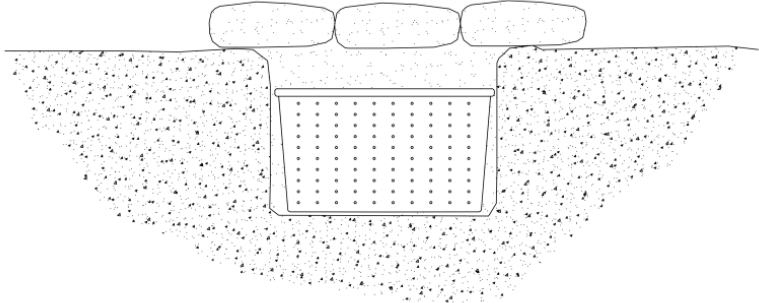
When the 10-year finds were retrieved in 2022 it was noticeable that the tops of the plastic reburial crates were visible on the seabed – due to falling sediment levels on the site. As a temporary measure, extra sandbags were placed over the 25-year repository to help protect it.

Fig 10
Schematic section showing one of the reburial crates buried beneath the seabed and covered with sandbags

The first task CISMAS undertook in 2024 was to place a two-metre square of geotextile (Terram 4000) over the 25-year repository to protect it from falling sediment levels. The Terram was held in place by sandbags, placed in a continuous line around the edges of the Terram.¹⁰ This method has been used elsewhere on the site and has proved very effective at protecting elements of the wreck from falling sediment levels. Previously, the Terram and sandbags have been quickly colonised by seaweed and a layer of sand quickly accumulates over the geotextile.

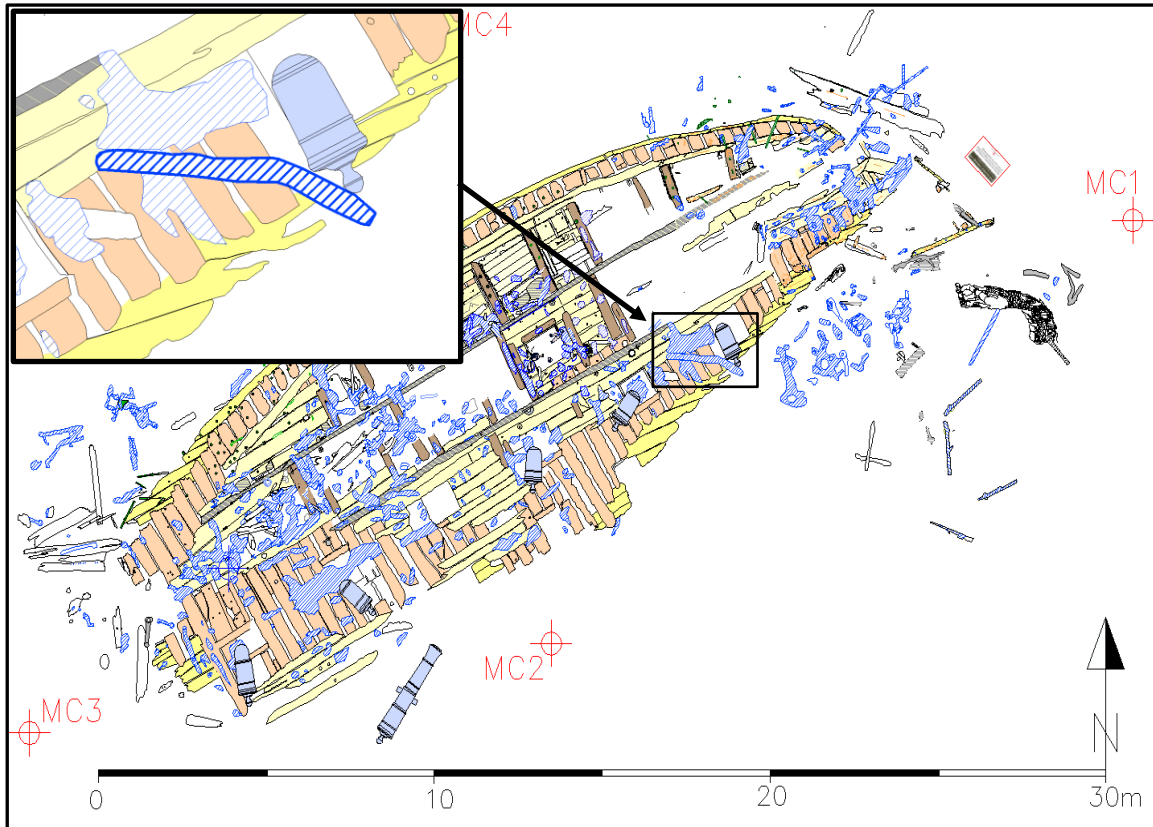
Fig 13

The position of the mystery iron object (shown hatched in bold on the inset) close to G1, the most easterly of the five upstanding 18-pound guns

The mobile kelp was first removed from around Gun 1 and then the fine 'seaweed' was carefully detached from the surface of the iron. It became immediately apparent that this object closely resembled the broken and twisted shank of an angle-crown anchor with the arms and crown broken off. Close examination revealed 'fibrous' strands of iron under the concretion indicating that it is made of wrought iron.

The iron consists of a bar 2.35 metres long, square sectioned at its southern end (0.17 x 0.17m) and roughly circular in section for the rest of the bar (0.14m \varnothing average). It is slightly bent and appears to be twisted as well. This is a substantial piece of iron and considerable force would have been needed to bend it. We initially speculated that the anchor had become fast on the seabed and the shank was bent and broken when attempting recovery of the anchor.

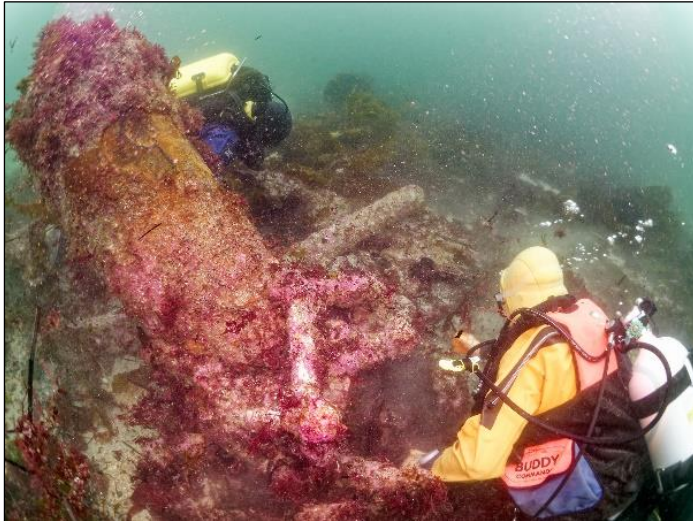
Fig 15

Divers removing 'scaffs' and fine weed from the concreted iron around gun 1. The iron bars visible in the foreground are the remains of the iron bolts which fastened the wooden gun carriage, still attached to gun 1

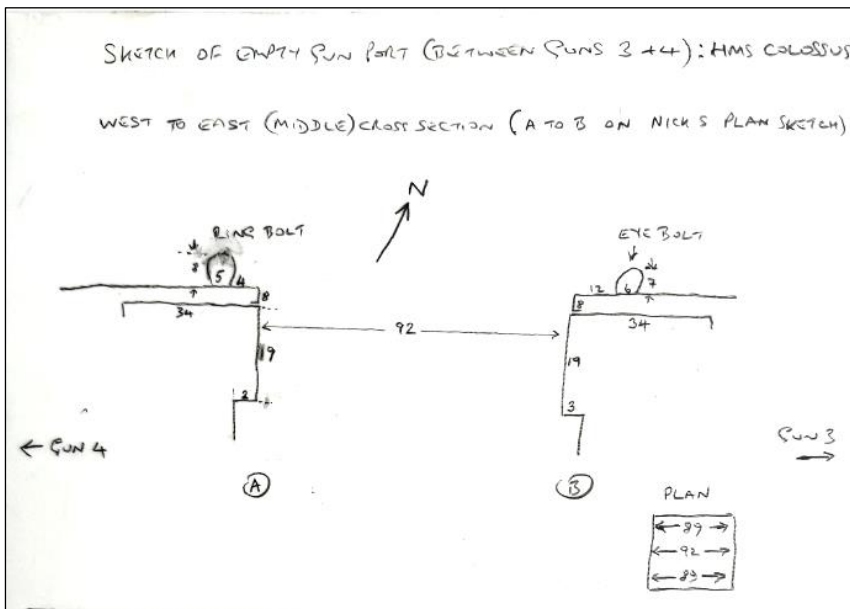
Fig 19

An east-west profile sketch of the gunport drawn in September 2024 by Jez Davies

Referring to figs 17, 18 and 20 it is clear that a great deal of timber shown on the 2001 plan no longer exists. Much of the inner hull planking has now gone - exposing the gun port lintel, sill beams and many more of the hull frame timbers. The inner hull planking was constructed of substantial strakes of around 12 inches wide by 3 inches thick, which were in near-perfect condition when first seen in 2001. It has only taken a little over twenty years for these to largely disappear from around the gunport. Similarly, the deck planking of the upper gun deck shown in fig 17 is, sadly, no longer with us.

It is now also possible to see damage to the gun-port lintel (the timber along the south side of the port), in the form of a missing central curved section. This was probably caused by the upper part of the gun muzzle striking the lintel on recoil (which could be particularly violent when the gun was hot). To reduce this type of damage, naval guns have flared muzzles while garrison guns often have a ring at the muzzle. There is a similar piece missing from one end of the gun port sill.¹⁵

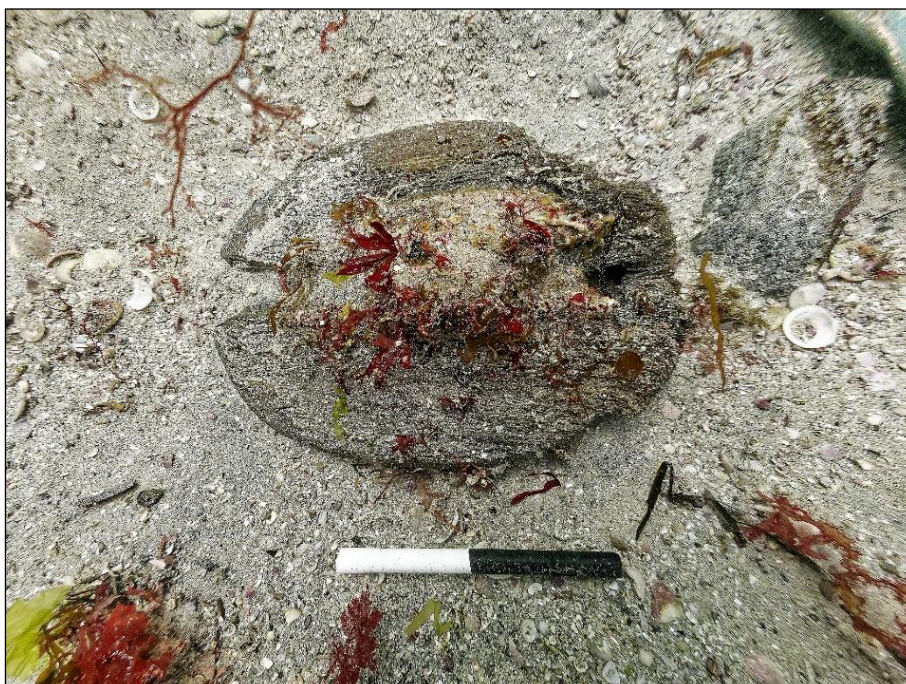
This year we made the decision to revisit the remains we had found in 2005. The search did not get far – almost as soon as we reached the seabed, we started finding wreckage: a substantial timber single-pulley block (0.35 x 0.25 x 0.15m) which lay close to a folded sheet of copper sheathing, only partly exposed but confirmed by metal detector to be over 1.2m long. The sheathing had a row of regularly spaced nail-holes along the uppermost (exposed) edge.

Fig 23
The pulley block
Scale = 0.2m

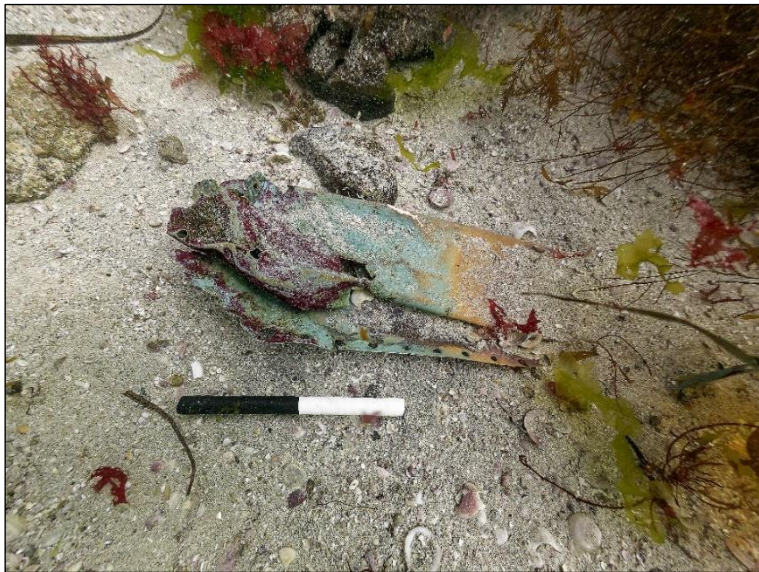
Fig 24
The folded copper sheathing
Scale = 0.2m

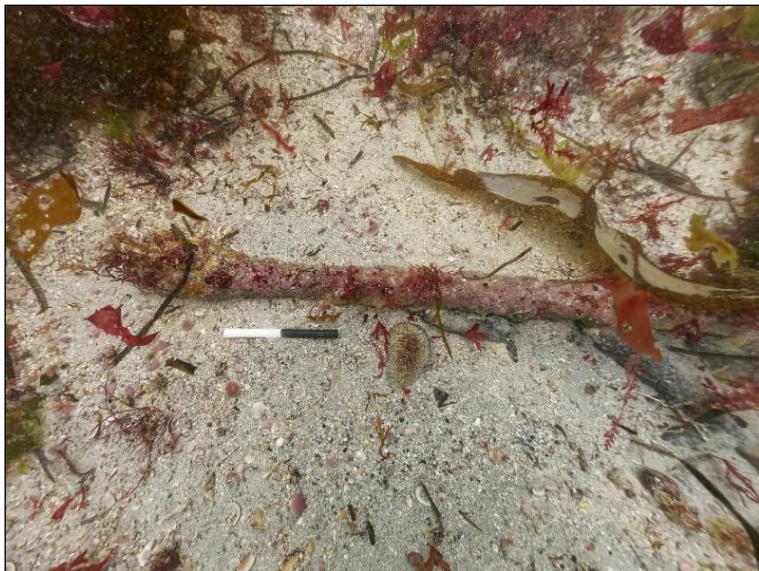
Fig 25
The iron bolt
Scale = 0.2m

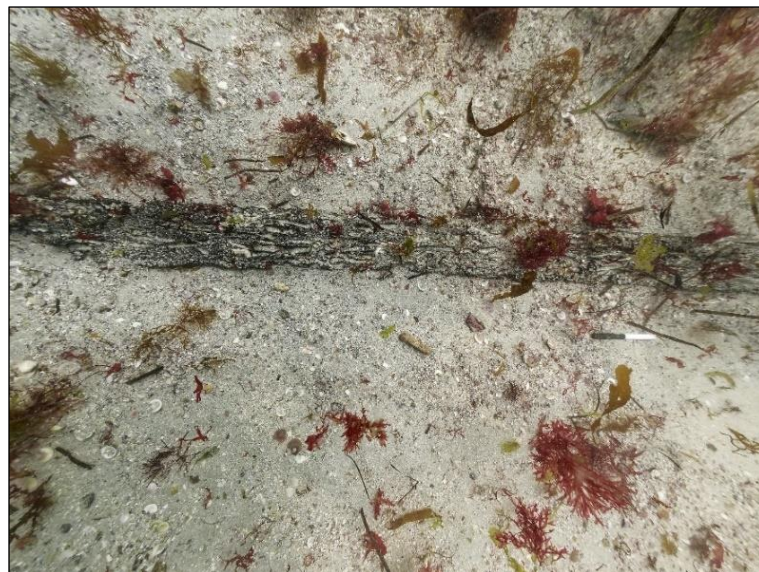
Fig 26
Plank 2
Scale = 0.2m

Not far from these there was a piece of planking (2.85 x 0.20 x 0.075m) which showed signs of attack by wood boring organisms. This lay over another piece of timber, thicker than the planking so possibly structural (frame or deck beam timber 1.10 x 0.25 x 0.11m). Close to this was a second section of planking (2.30 x 0.20m), and finally, a substantial iron bolt (1.60 x 0.08Ø m). Only a very small area was searched and it seemed that everywhere we looked there was wreckage. This area should be recorded properly and its true extent determined. As all the timber observed was showing evidence of attack by wood boring organisms, this needs to happen fairly soon.

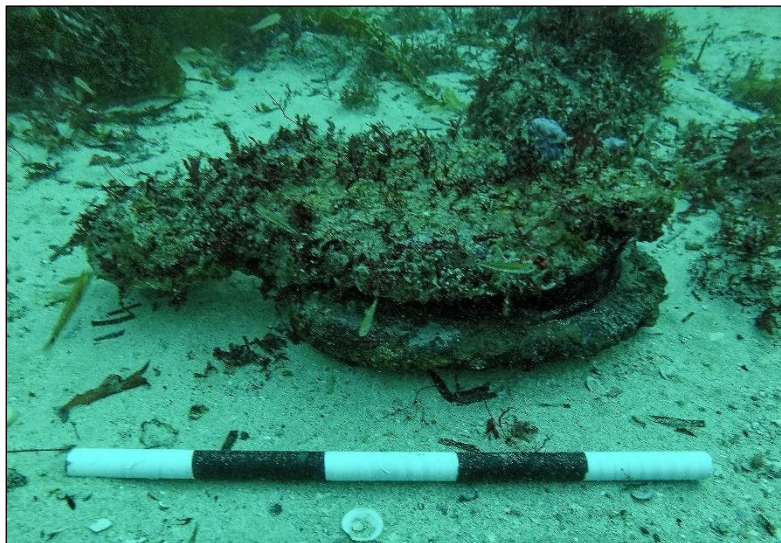
Below: what was found on the seabed at that location – a timber pulley block with iron concretions

What was found at the location specified was a large pulley block with attached iron concretion 0.60 x 0.35 x 0.13m. It seems unlikely that this block would have caused the linear features observed on the sidescan imagery, but nothing else was visible at that location.

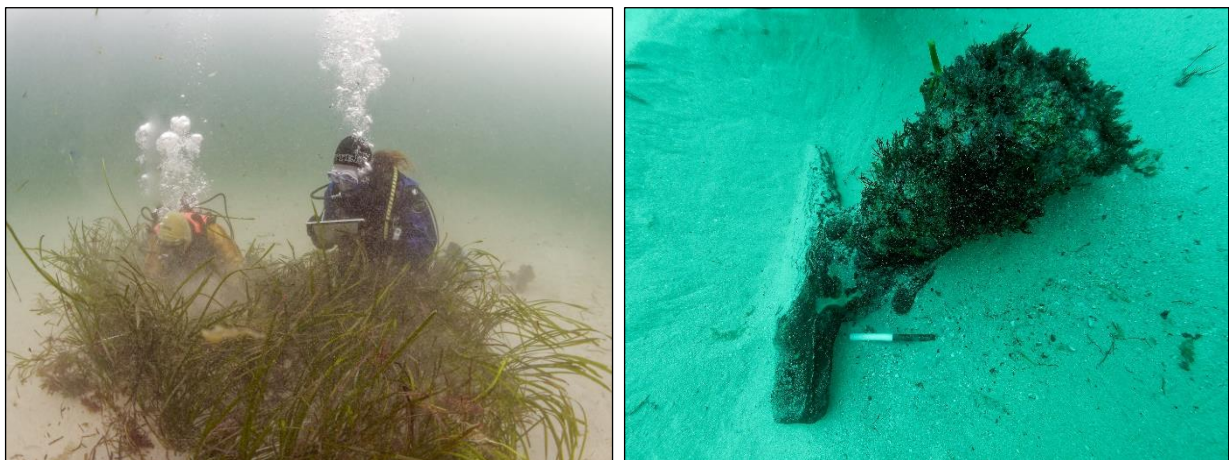
Fig 32

This target was searched for a radius of 20m around the sidescan target position. Two anomalies were located, a fragment from a large iron anchor and a small raised mound of eelgrass 0.15m high and 3m in diameter. The mound of eelgrass is the only possible cause of the object shown on the sidescan image (fig XX) – the rest of the area searched was flat, featureless sand. The small mound was found 16m to the west of the shot line. We also found part of a large broken iron anchor partly buried in the sand some 8m to the west of the shot line (fig 32). This consisted of the broken off end of one arm, with the palm partly buried in the sand. The arm of the anchor is 0.22m square in section at the point it has broken, and the palm is 0.6m at its widest point. Not enough of the anchor was exposed to determine its age – but it is possibly 18-20th century. This area has been used as an anchorage for centuries, and anchors are a fairly common find.

Left: the shallow mound covered in eelgrass. Right: the broken arm of an iron anchor with part of the palm visible; the bill of the anchor was not exposed. Scale = 0.2m

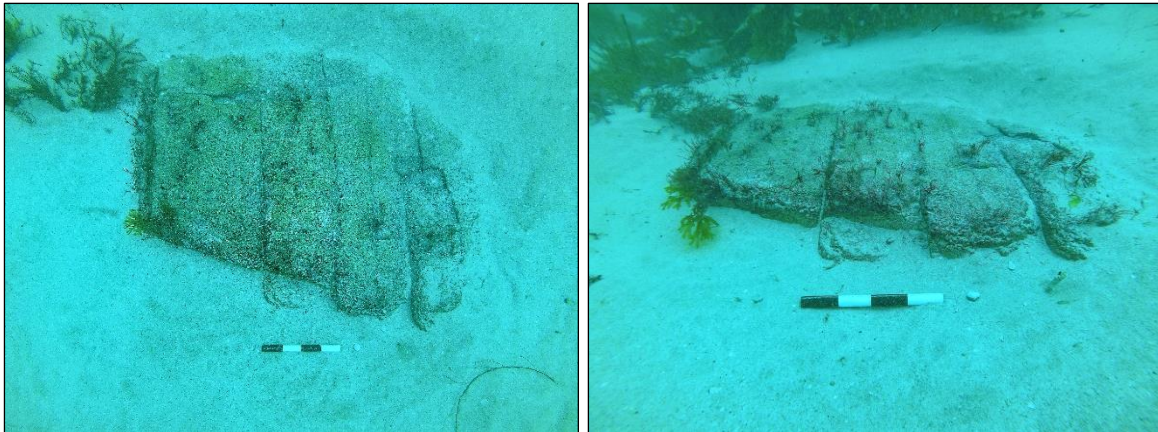
Fig 35

The area around this target was searched to a diameter of 40m. A number of areas of exposed rock were found, all with tabular fissures so that the rock had a superficial resemblance to a laid pavement. No doubt natural formations like this are what gives rise to the persistent rumours of a paved road underwater between the islands of St Mary's and St Martin's. As no iron objects were observed, the origin of the three magnetic anomalies remains a mystery.

Two examples of the exposed tabular rock encountered in this search. These are thought to be natural formations. The scale is 0.2m long

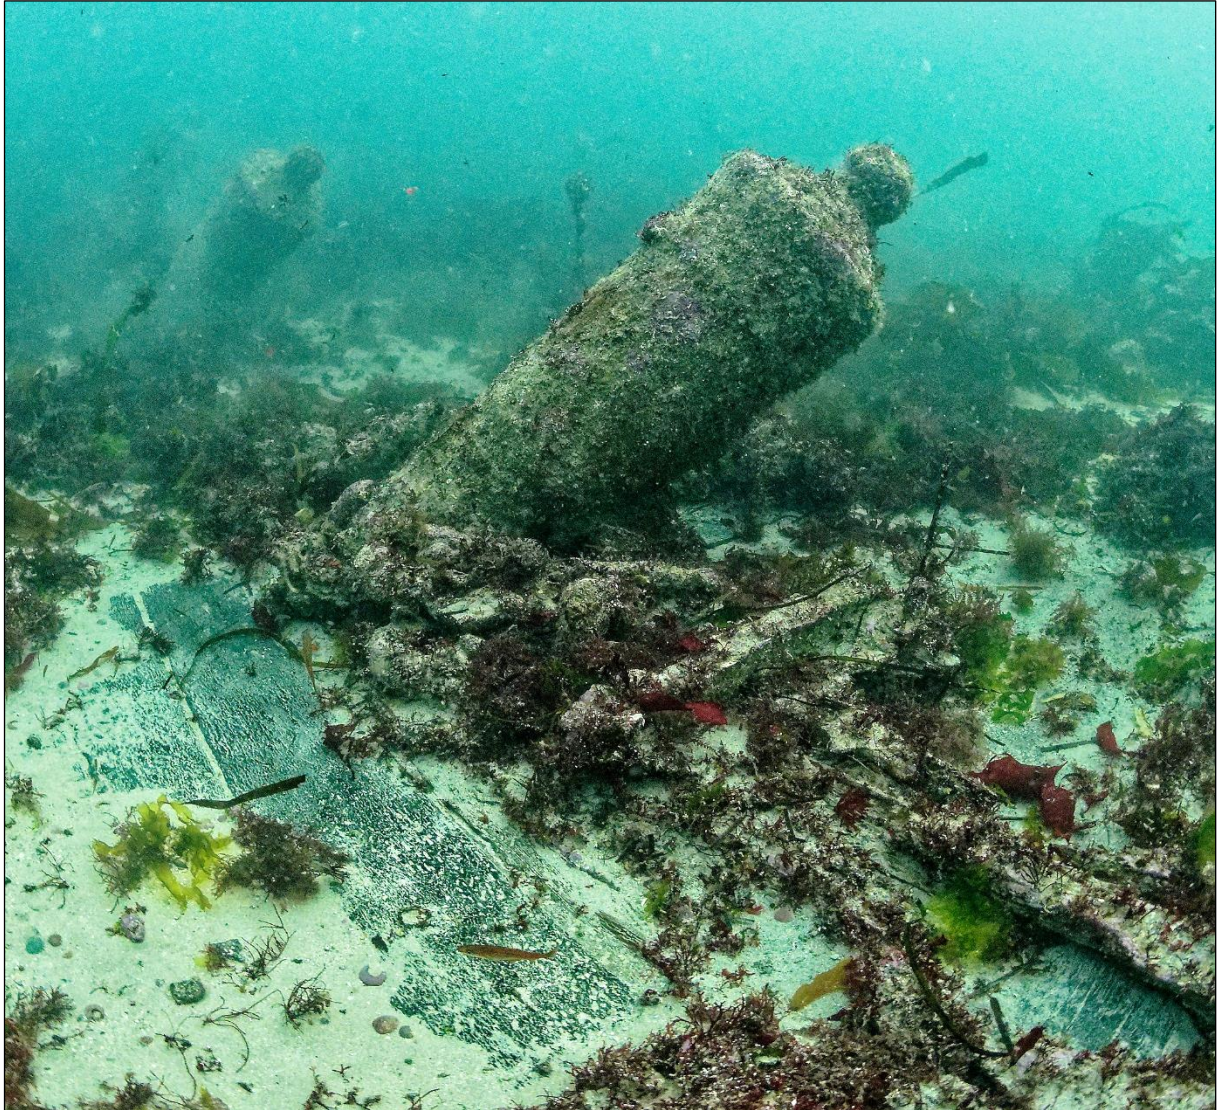
Fig 43

The same guns when the weed had been cleared in 2021. Note the inner hull planking in the foreground

These examples demonstrate how much survives under the cover of the mobile kelp. Clearing the weed usually keeps the site 'presentable' for several weeks or until the next storm. One possibility would be to occasionally clear the weed in advance of an advertised site open day/week, possibly timed to coincide with a field school in practical archaeology.

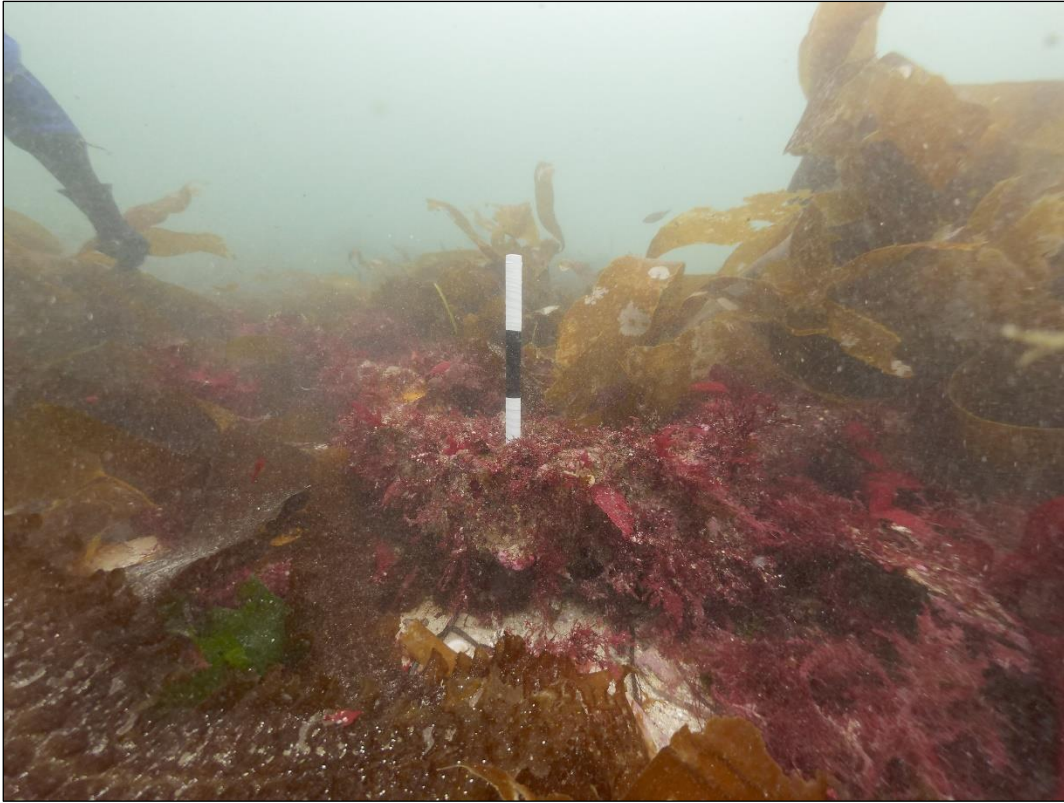
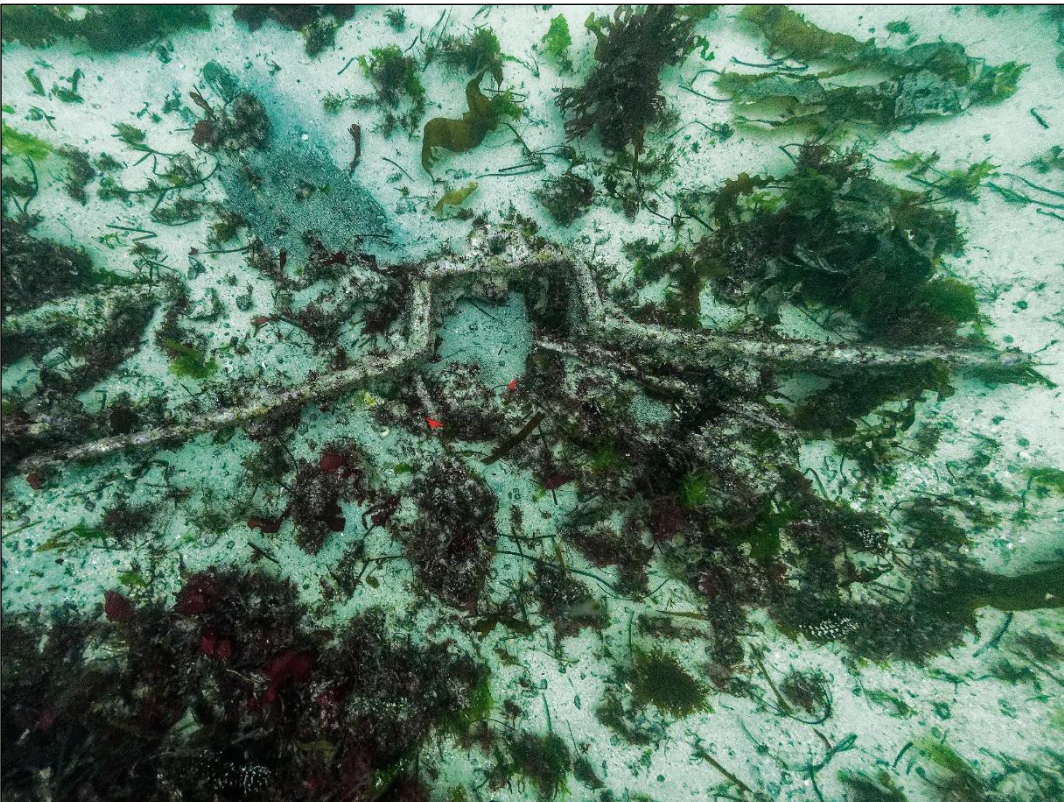
Fig 44

Above: the rudder gudgeon strap in September 2024 – the scale is inside the gudgeon pivot hole

Below: the gudgeon after de-weeding in 2021. The gudgeon is 3.3m from end to end

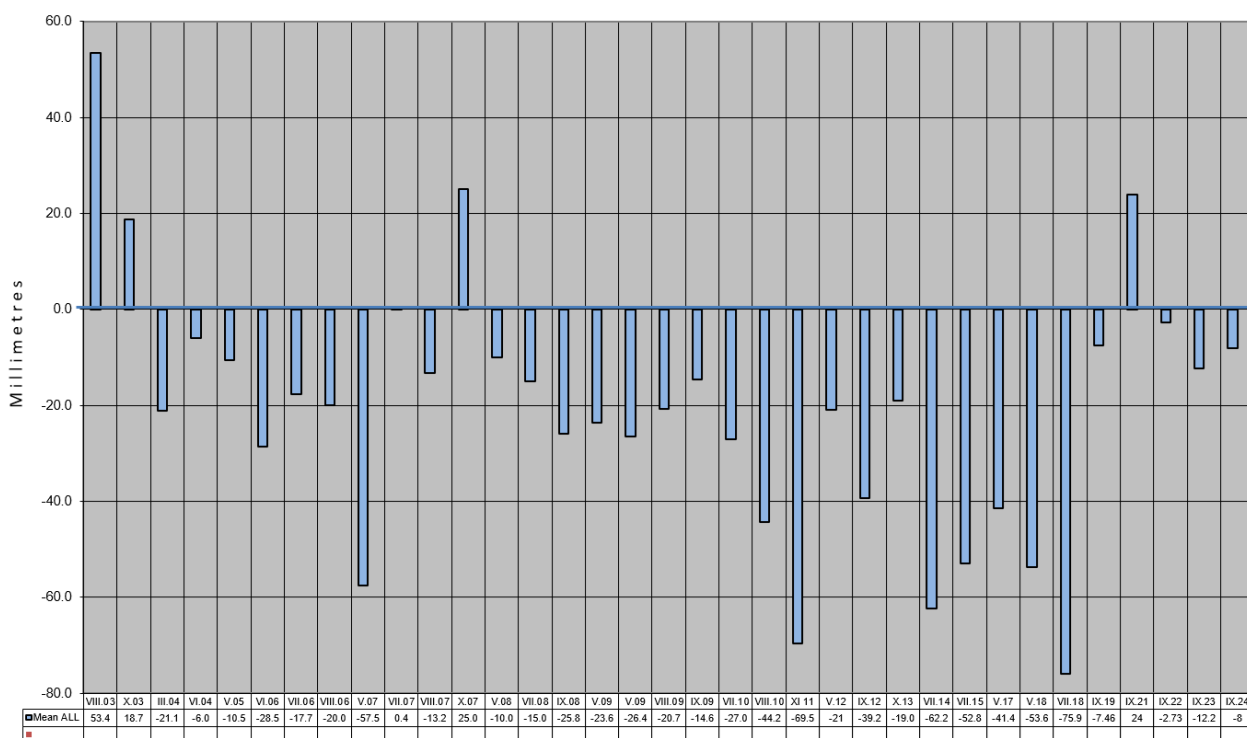
Fig 46

The overall mean sediment change for the 11 remaining monitoring points is a fall of 19mm since September 2023 (fig 46). This clearly demonstrates that the sediment levels on site continue to fall, putting the buried wreckage at risk.

Bar chart showing the mean sediment change over all sediment monitoring points since September 2023.

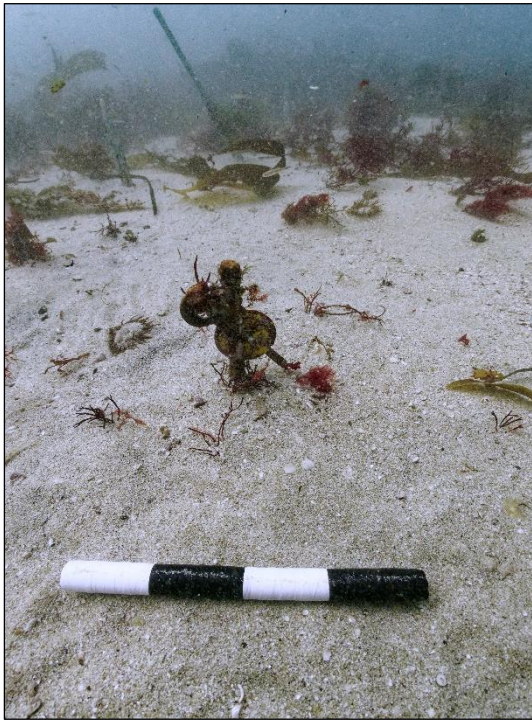
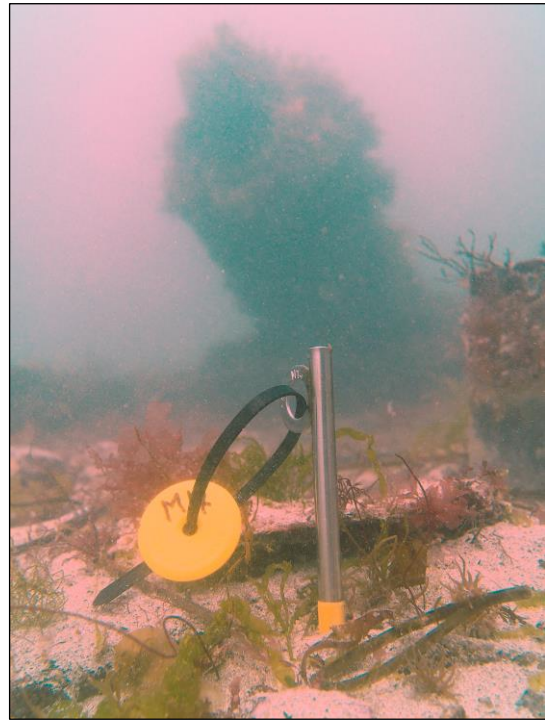
Fig 48

Left: A point after one year on the seabed - the 'weed' growth gets much worse after 2-3 years on the seabed.
Right: Sediment monitoring point when first installed.

Unless the sediment monitoring points are overhauled and the missing points replaced, the sediment monitoring at this site will come to an end.

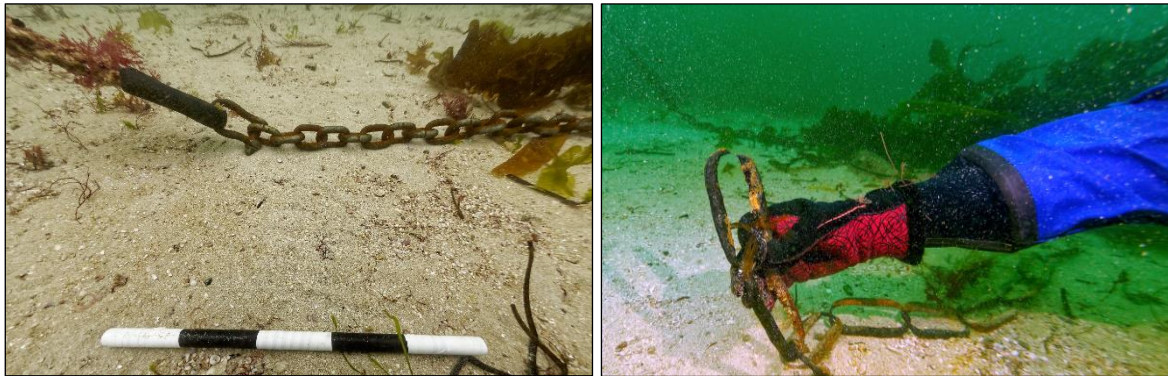
Fig 49

Access to the site is by a permanent mooring buoy situated 22 metres to the north-east of the site. The buoy is attached to a concrete block by a rope and chain – these are sturdy enough to allow the dive charter boats to moor to the buoy. The buoy, rope and chain need to be replaced periodically. This replacement has been undertaken by Tim Allsop (previous dive charter boat skipper) in the past – but this might not be the case in the future.

Left: the mooring chain in September 2024 (recently replaced) Right: the previous mooring chain

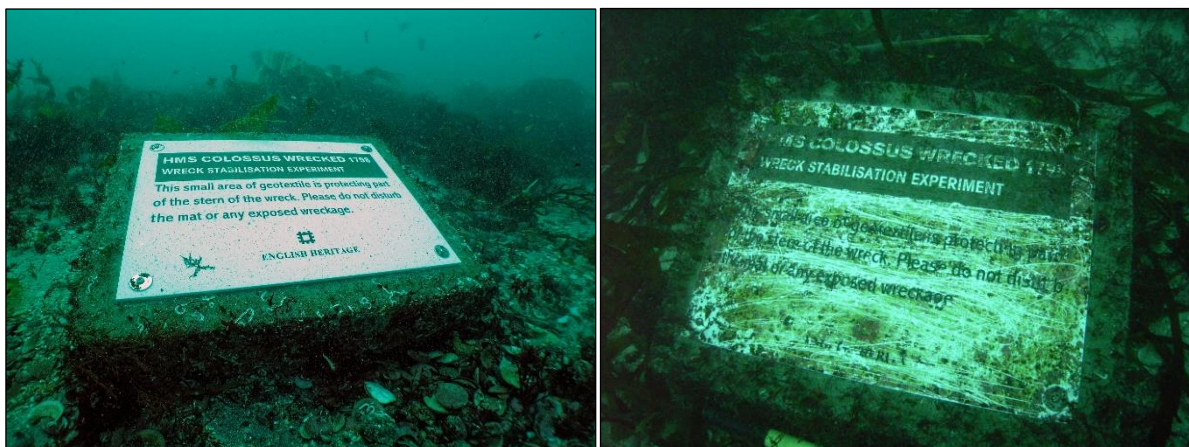
Fig 50

Left: the original seabed sign installed in 2008 Right: the same sign after two years on the seabed

This sign was made using commercial cut vinyl signage attached to a white A3 polycarbonate board. It was replaced with a similar one after the original was damaged by well-meaning visiting divers attempting to clean the flora from the sign using a dive knife. This type of sign quickly becomes illegible through marine growth over the face. For a while it can be successfully cleaned using nylon pan-scouring pads, but after about five years becomes scratched and is no longer cleanable.

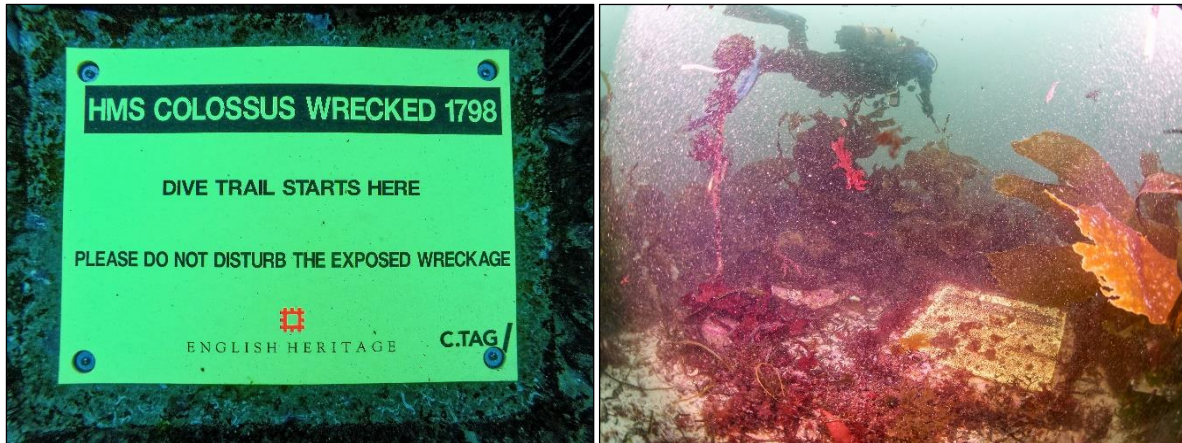
Fig 51

Left: The C-Tag sign shortly after installation in 2015 Right: The same sign in September 2024 (after some cleaning)

In 2015 we installed a new seabed sign made by a local company, C-Tag. They specialised in providing seabed signage for oyster fisheries, and these signs were resistant to fouling by marine growth for about five years, after which the marine growth started to colonise the material of the sign itself so it could no longer be successfully cleaned. C-Tag were still in business in 2022, but have since been taken over. As the new owners were quoting a price well beyond our means, the sign has not been replaced since 2015. It is now just about legible, but is unlikely to be for much longer.

If the dive trail is to continue, we need to consider installing a more permanent sign. We should perhaps take some advice from English Heritage who use a variety of different materials in their outside signage. Laser-etched copper or stainless steel would probably make a good underwater sign which could be easily cleaned.

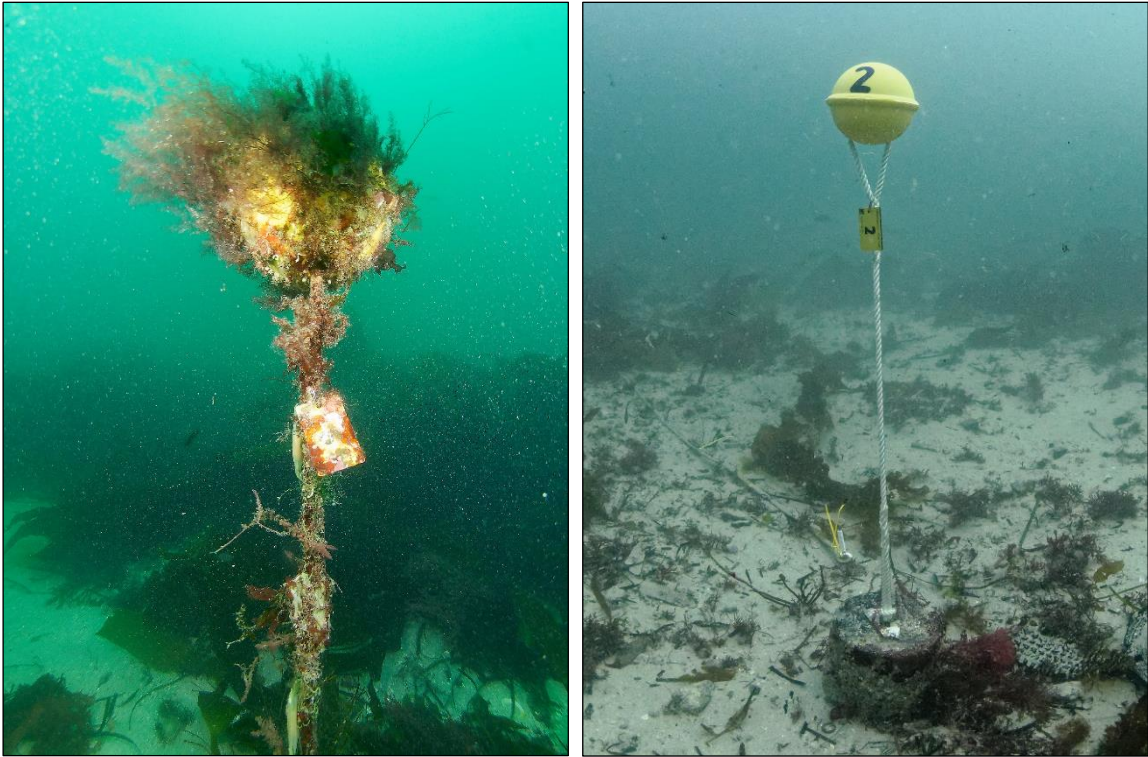
Fig 55

Left: one of the station markers as they are now, the numbers completely obscured by marine growth
 Right: in 2015 when the buoys were replaced and embossed numbered tags installed

A solution to this problem would be to mark the stations using a system which would work even when covered in marine growth. One possibility is outlined in fig 56 below. New underwater guide slates would need to be made to correspond with the new station markers.

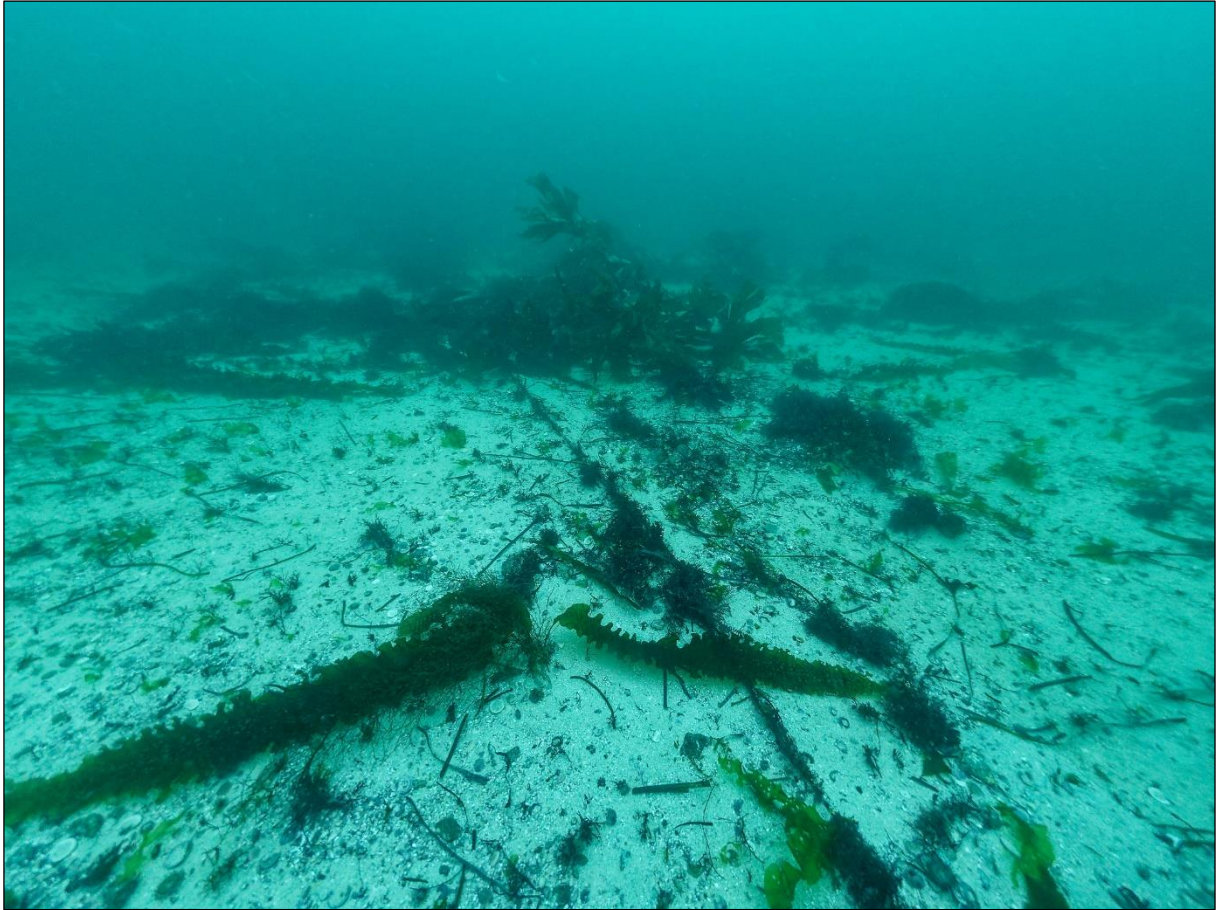
Fig 57

The bottom line used to guide divers to the outlying features at stations 10-12. This line can collect large tangles of kelp and be dragged off the site by the flood tide – but without it, many divers lose their way
