HMS *Colossus*

Reburial Trial – First Retrieval

Interim Project Report

CISMAS

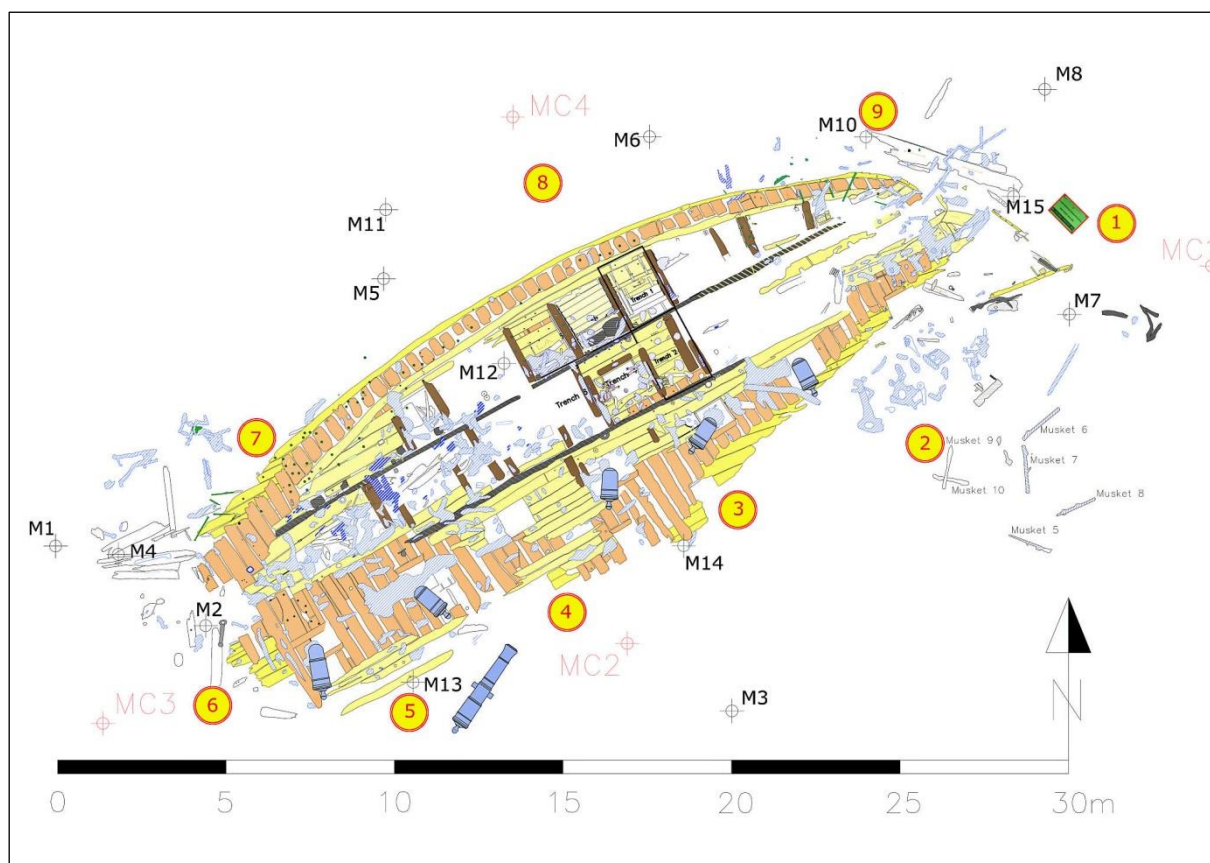
Fig 13

The location of the fourteen sediment monitoring points M1-M8 and M10-M15. Note there is no M9

However, reference to Fig 14 below demonstrates that the levels have fallen most on the north side of the wreck, which probably accounts for the newly-exposed material observed to the north of the wreck. This is best demonstrated by looking at the largest fall, monitor points M5 and M6, which are both on the north side of the wreck - while the largest increase of sediment level was at monitoring point M13, which is on the south-west corner of the wreck.

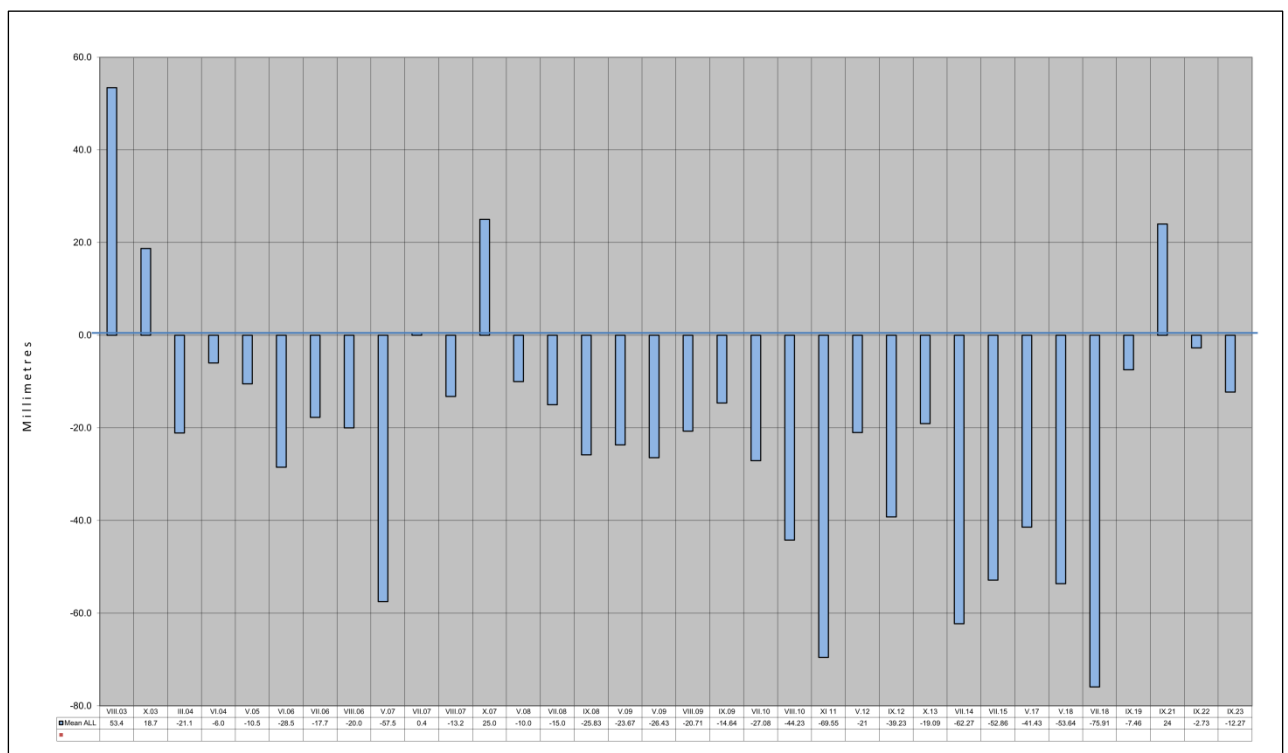
The mean sediment levels on the site were 2.7mm lower than they were in September 2021. When measured again in September 2023 they had fallen by a further 12.2mm. The trend of the mean level change can be seen in Fig 15 and appears to show a steady fall over the last two years.

Fig 15
Chart showing the mean sediment level change on the site relative to the sediment levels in 2003 when monitoring began – this is represented by the horizontal zero line in the centre of the chart. These values are the mean of all 14 readings. Note how the plot for 2019-2023 seems to repeat the pattern recorded in 2007-2008

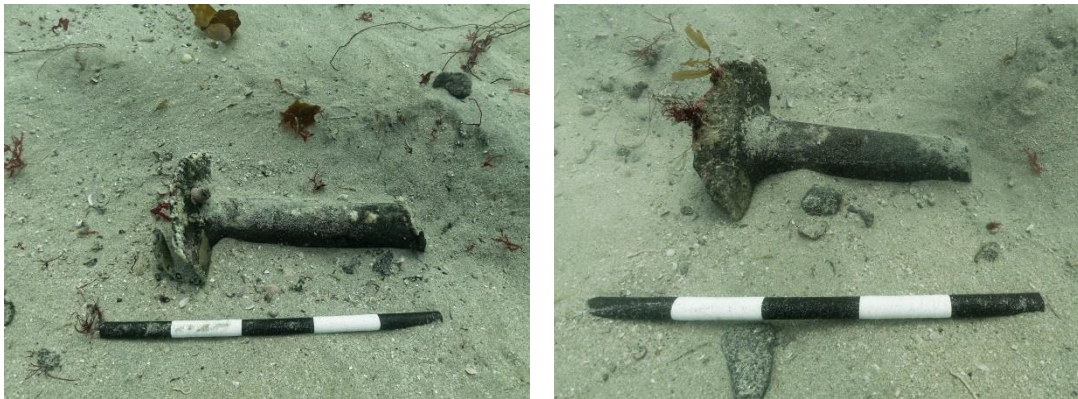
Two lead scupper pipes were also found (scupper 1 & scupper 2 on fig 16); these were part of the drainage system on the gun decks.

Fig 19 - Lead scupper pipes. Scale = 0.5m

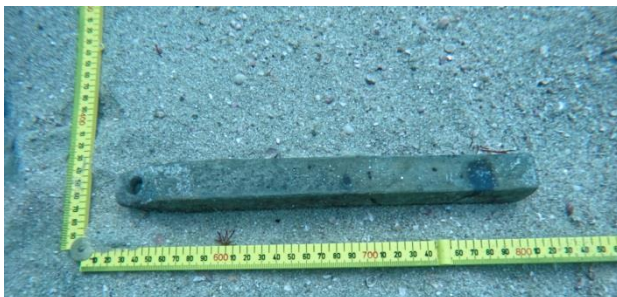
A lead sash weight was also seen. This would have been a counter-weight for one of the sash windows at the stern of the ship, either in the captain's cabin or one deck lower down in the wardroom.

Fig 20
Lead sash weight. Several of these have been seen on the site in the past.

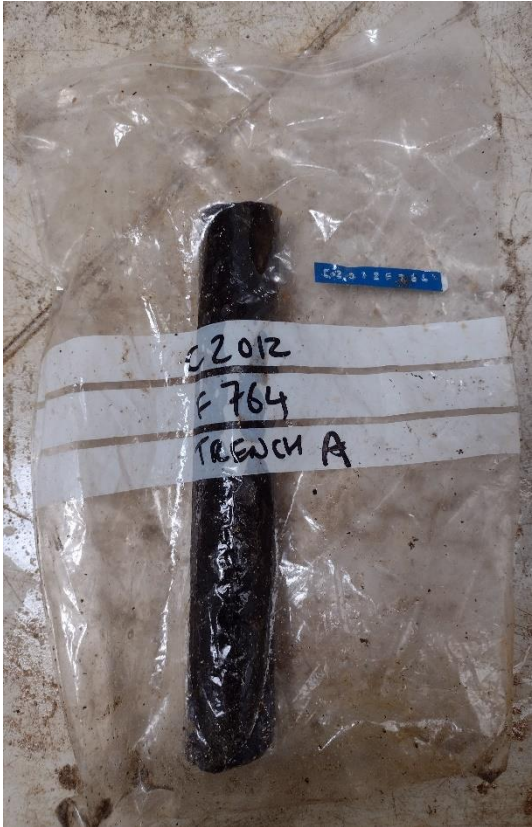
The resealable polythene bags that each artefact had been buried in were found to be intact and little affected by the ten years under the seabed. The majority of bags were unstained, although the bags containing the concretions were stained from rusty iron corrosion, and/or black deposits and the Dymo™ labels were also intact and well preserved, and remained legible in all cases (Figures 1 and 2).

Fig 34: the majority of bags were unstained.

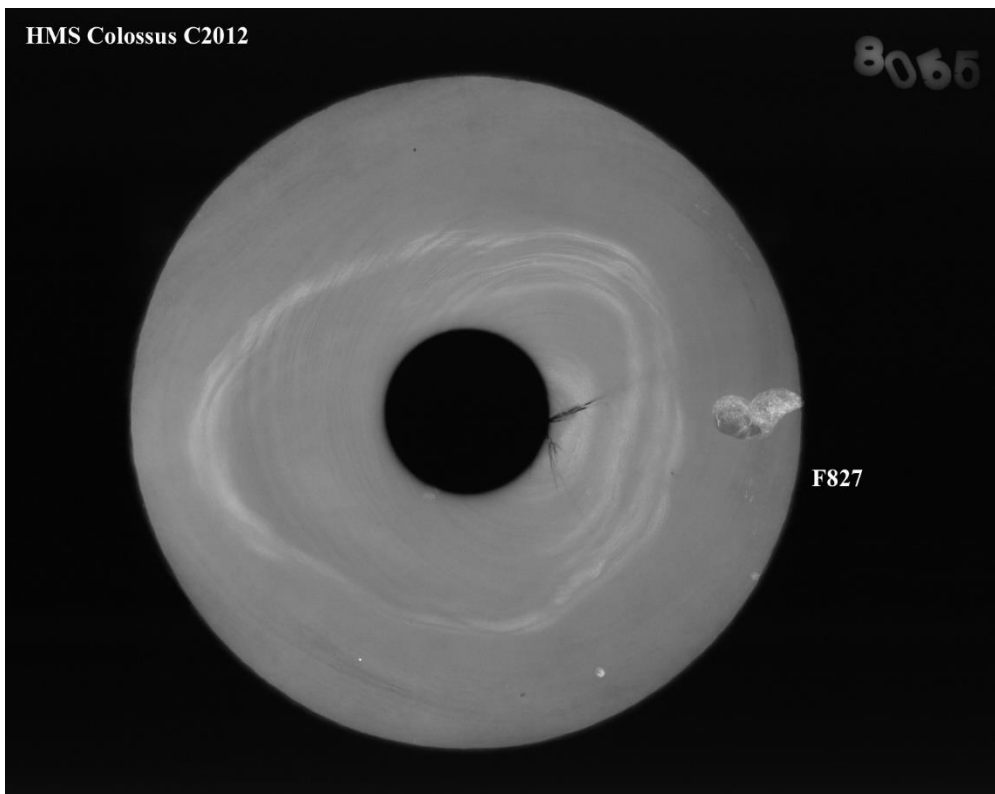
All four wooden artefacts remain well preserved and there is no evidence for ongoing shipworm activity following reburial. There has been no increase in shipworm activity observed in sheave F827 (Figures 5 and 6) and handle F764 in 2012, and both remain classified Grade 1 under EN275 (British Standard, 1992).

Fig 38: X-ray of F827, 2012, prior to reburial

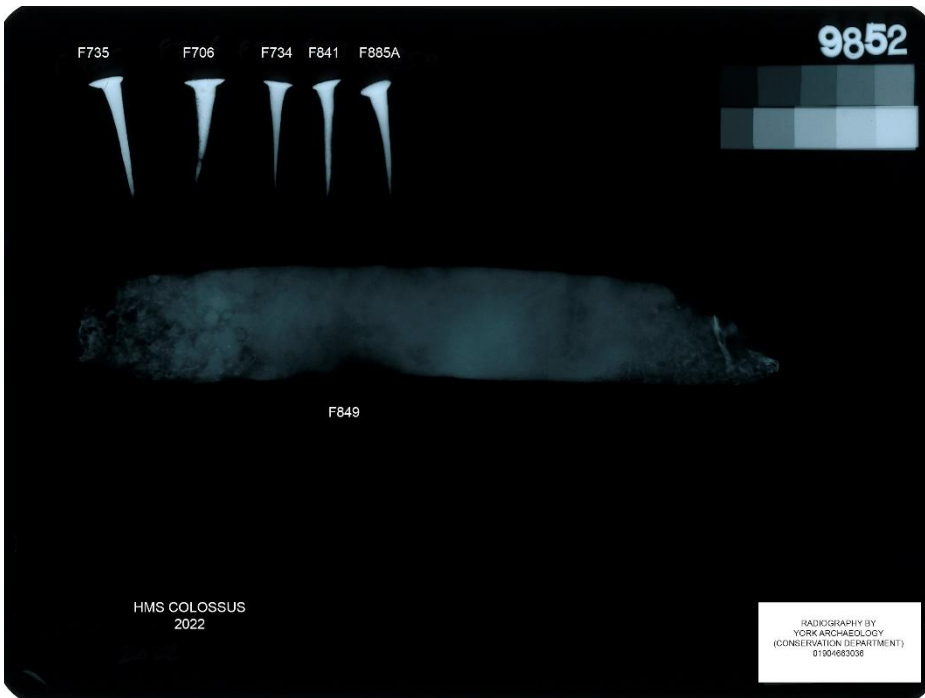
The small tacks/nails are very well preserved, show no signs of active corrosion, nor any physical changes from when recorded in 2012 (Figures 7 and 8). The X-radiography suggests less than 5% of the metal has been mineralised.

Fig 39: X-ray of copper alloy artefacts, 2022
