HMS Colossus

Monitoring & Investigation 2012

Project Report

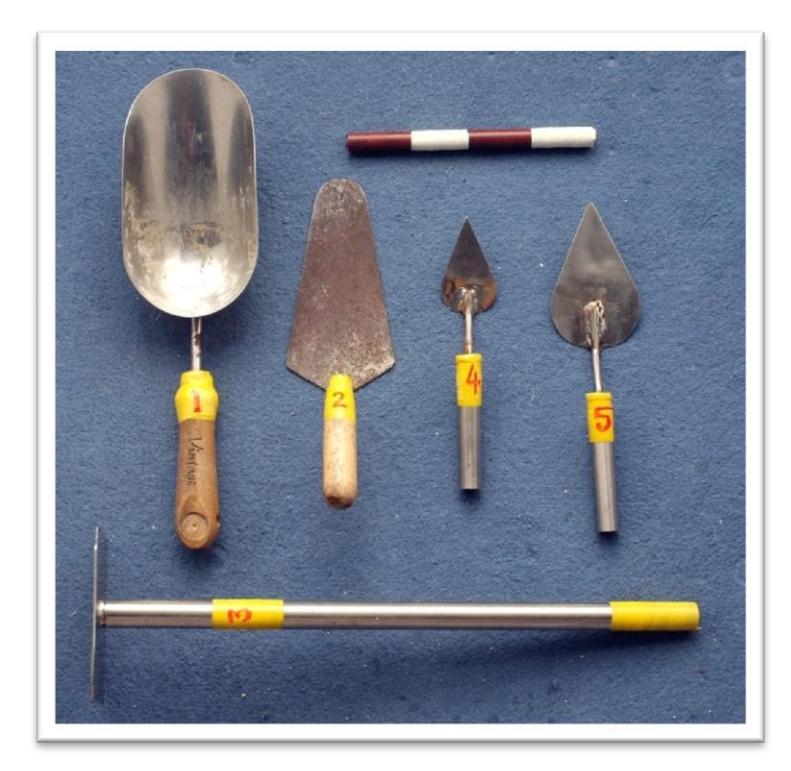
Fig 3 Tools used for the excavation Scale 0.20m

Although most of the tools were used in the excavation the most popular by far was the pointing trowel (number 5 in fig 3 above). This was fabricated from welded stainless steel. Although the standard archaeological trowel would be just as effective, the wooden handle would split and become loose after use underwater. For very delicate work – excavating fragile objects such as rope and fabric – it was found that gentle hand fanning and the use of fingers was the best method of excavating. For bulk movement of sediment (such as filling sandbags) the grain scoop (number 1 in fig 3) was found to be very effective.

Several different excavation strategies were tried during the excavation. A variety of hand tools was made available to excavators during the excavation (fig. 3). Each excavator was required to fill out a log sheet detailing which tools were used and how effective they were. The tools were used to excavate, and the reaction dredge was employed to remove sediment from the excavation to a spoil heap. The spoil was contained by placing the reaction dredge outlet pipe under an area of polypropylene scaffold mesh, secured to the seabed using sandbags. The reaction dredge was powered using a petrol driven 3" Honda fire pump, which was situated in an inflatable boat on the surface. The water outlet of the pump was connected to the dredge using 20m of flexible fire hose (fig. 4).

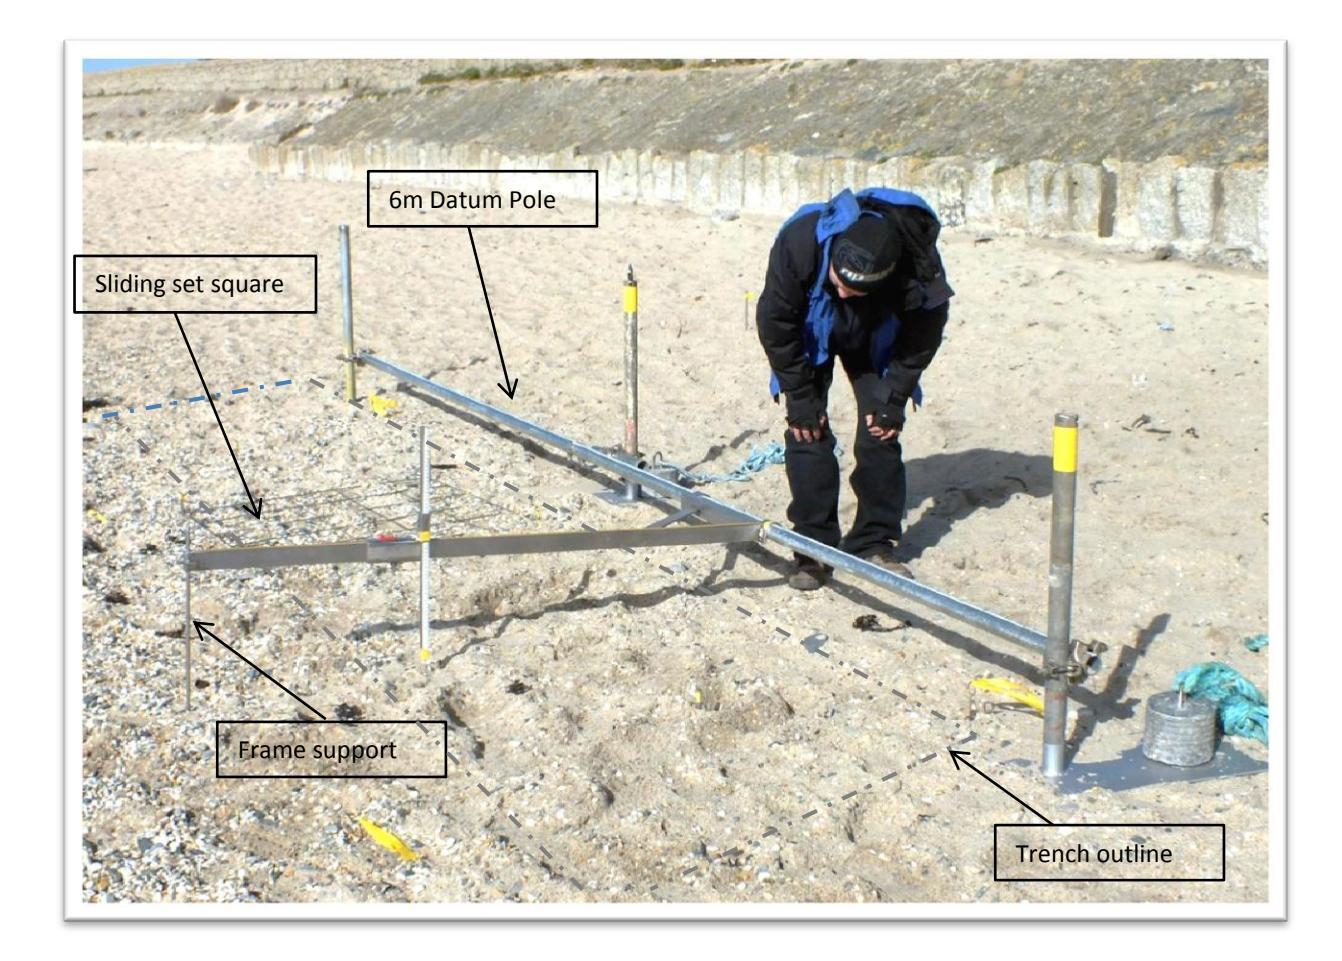
Fig 7 The frame offset device for measuring finds positions seen here during the recording trials on the beach.

The frame offset device consists of a stainless steel set square which slides along the 6m scaffold pole datum. It also has an adjustable rod attached to measure depths. Scales have been attached to the frame using epoxy adhesive. The six 'finds' positions were measured in two minutes using this device. Three measurements were recorded to fix each 'find': these are termed datum, offset and down.

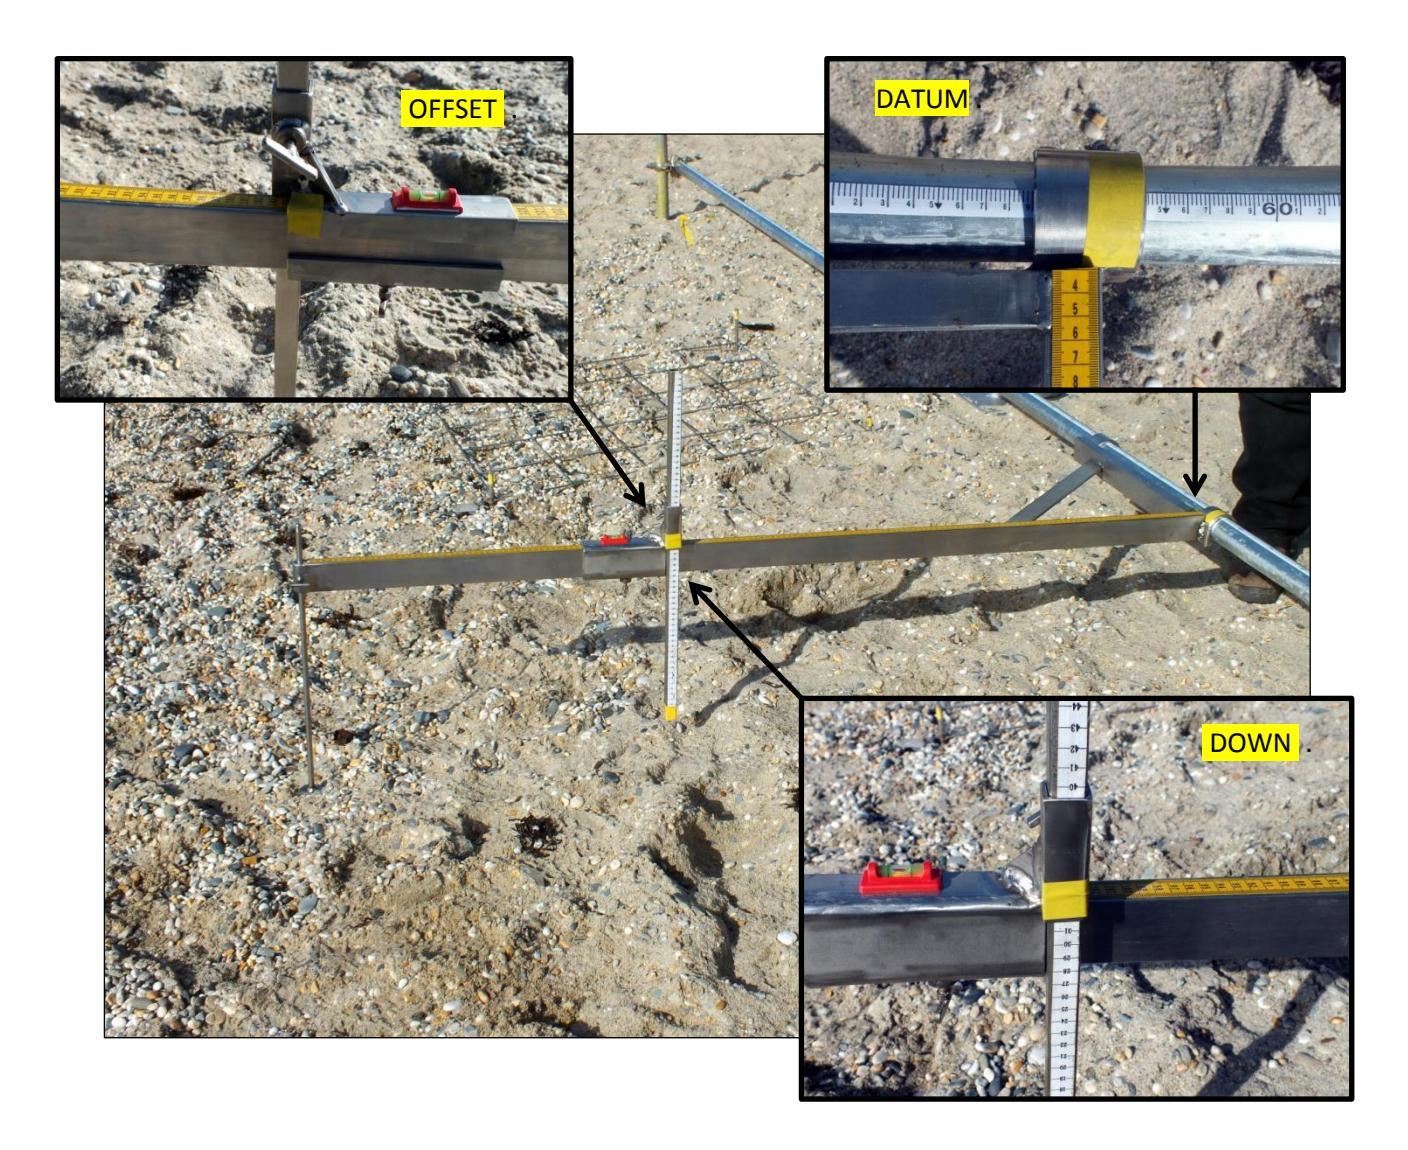
Fig 8 Details of the recording frame showing the datum, offset and down measuring points. In each case the point to read the measurement from is marked with yellow tape.

The offset frame is fitted with a spirit level to allow it to be set horizontally (using the adjustable frame support leg) - see fig 3 above. Measurements are read directly from the device as tapes have been fixed to the frame and scaffold pole using epoxy resin (see fig 4 below). All readings were taken to the nearest centimetre.

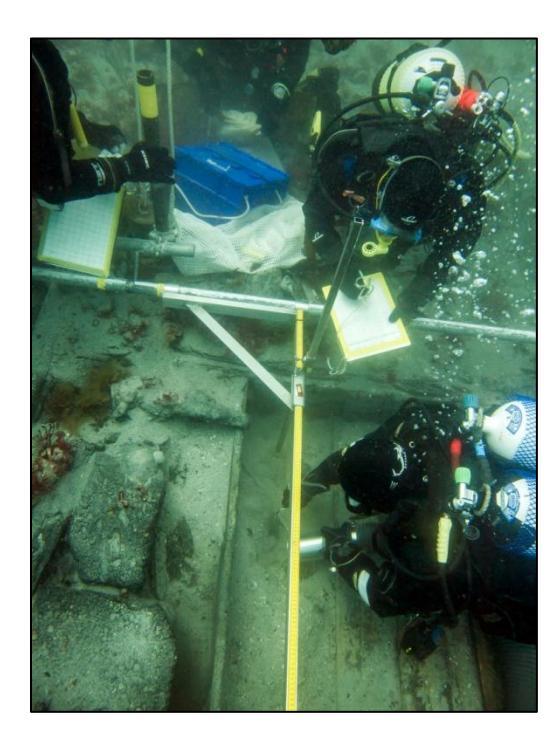
Fig 9 The offset measuring frame in use underwater

It is clear from the results that the most accurate method of the three trialled is DSM survey. However, it is also the slowest of the three methods (seven minutes for the six 'finds') and also causes the most disruption to others working in the area (in this case the excavators) because of the deployment of tapes from four different directions. The offset frame constructed for the excavation proved to be the quickest in use, taking only two minutes to record the six 'finds'. The accuracy was only slightly worse than with DSM, and in practice is a great improvement on traditional (freestyle) offset recording. The traditional offset recording was clearly the least accurate of the three methods trialled and it took twice as long to record the six 'finds' as the offset frame, although it was quicker than DSM. In consequence of the above trials, the offset frame is the method which was used to record the finds on the *Colossus excavation* in 2012.

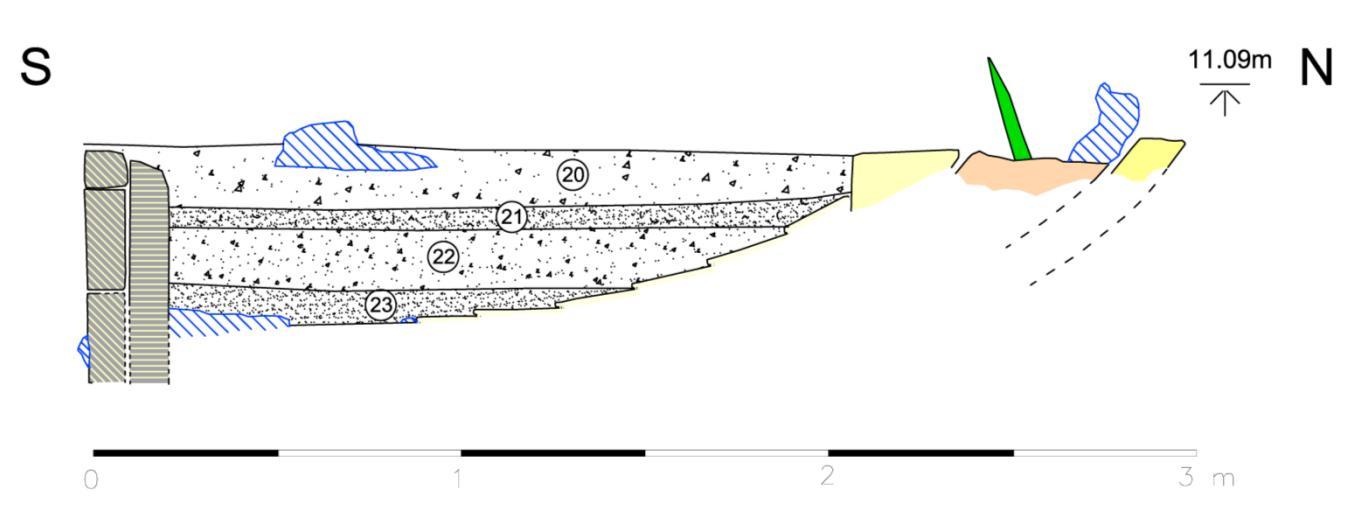
Fig 14

A total of four layers were excavated within trench 3, as shown in fig 14. Clearly, all these sediments accumulated within the hull once it had come to rest on its starboard side. Whether the stern section of wreckage is still in the place where *Colossus* foundered is not certain. Either the bow or stern (which lie over 300m apart) must have broken off and been moved by the action of the sea. The fact that the stern (the subject of this project) is largely intact, while the bows are almost completely broken up, would perhaps suggest that the bows travelled farthest from the position of foundering.

TRENCH 3 STRATIGRAPHY					
Layer	Description	Compaction	Depth(m)	Finds		
L20	Light grey coarse sand with shell	Loose	0.16	17		
	flecks and granite chips.					
L21	Very light grey coarse silty sand with	Fairly loose	0.07	4		
	some shell flecks					
L22	Light grey silty sand with shells and	Loose to	0.16	6		
	granite chips	medium				
L23	Very light grey fine silty sand	Firm	0.11	0		
	No inclusions

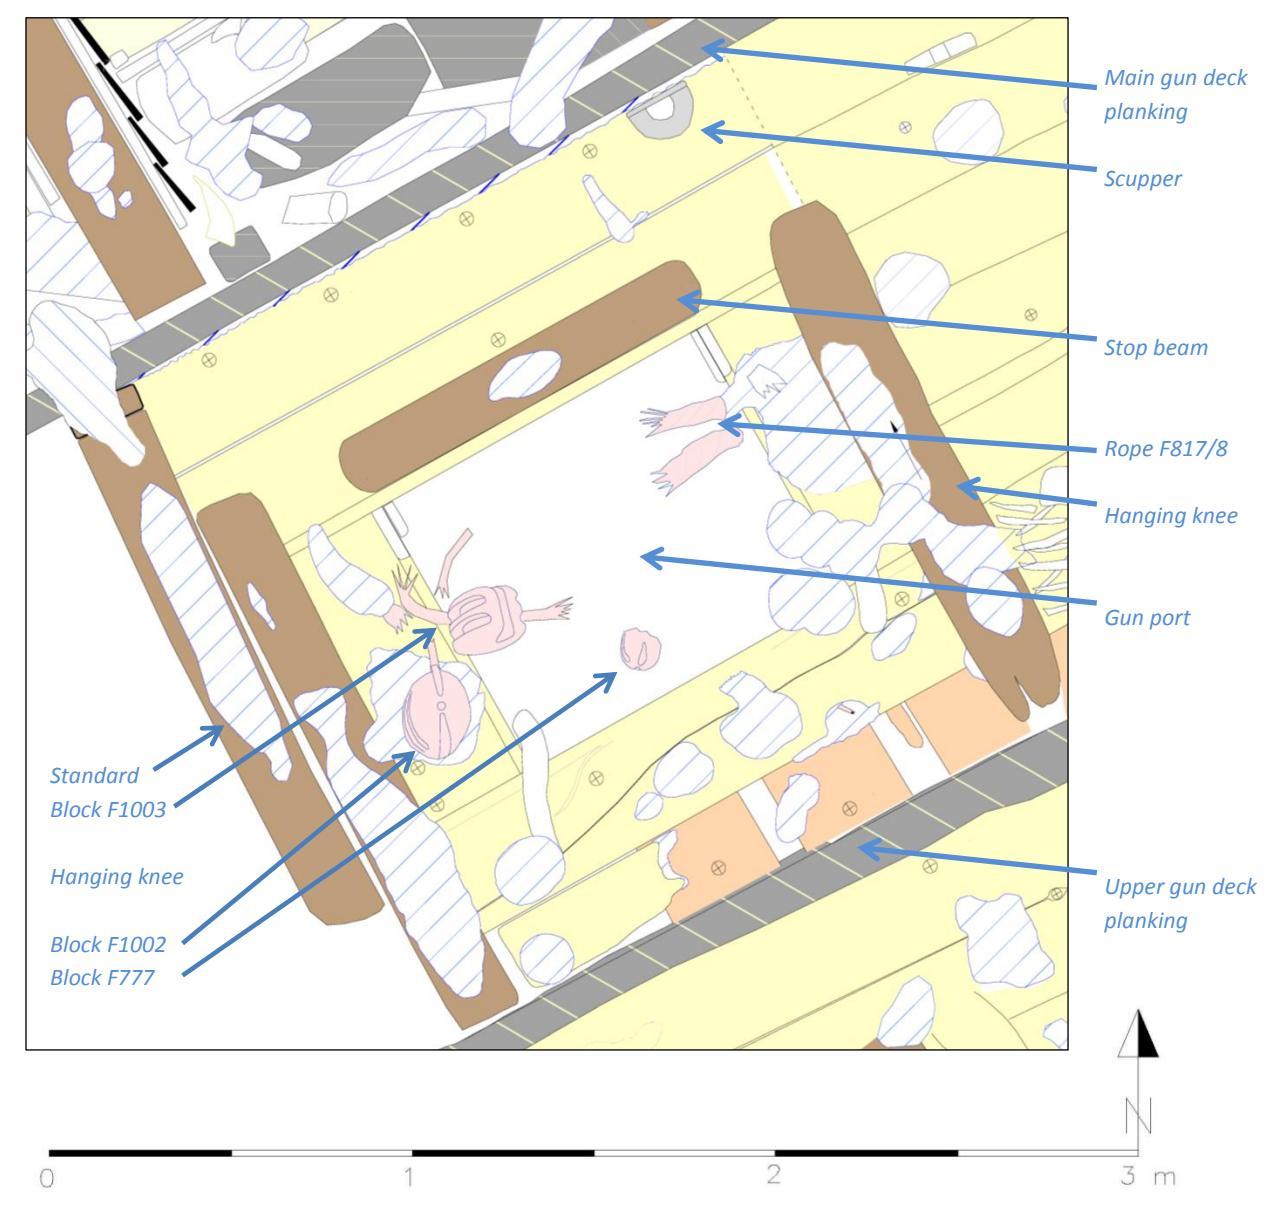
Fig 22 Plan of Trench 4 – Main Gun Deck (MGD)

The inside face of the hull was lined with planks (inner hull planking) 0.30m wide and 0.10 - 0.12m thick. These were fastened to the frames of the vessel using trenails 0.035m in diameter – fig 22.

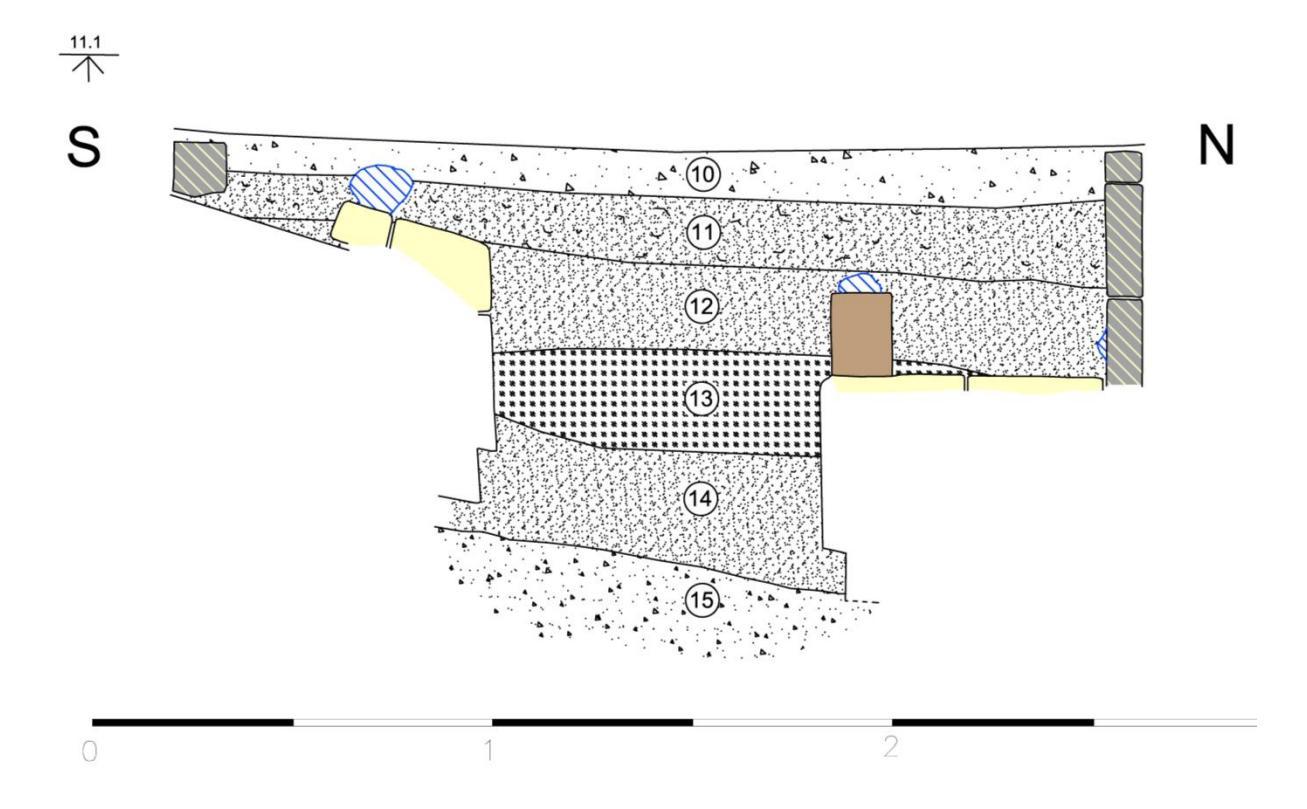
Fig 23 North-south section through Trench 4 showing the stratigraphy

TRENCH 4 STRATIGRAPHY					
Layer	Description	Compaction	Depth(m)	Finds		
L10	Light grey coarse sand with shell	Loose	0.16	22		
	flecks and granite chips/cobbles					
L11	Grey silty sand with small shell flecks	Fairly loose	0.20	20		
L12	Light grey silty sand with some shells	Loose to	0.23	18		
		medium				
L13	Light greyish brown silty sand with	Medium to	0.25	1		
	lenses of darker organic material –	firm				
	mostly inside gunport but also over					
	parts of the inner planking					
L14	Very light grey fine sandy silt	Firm	0.31	0		
	No inclusions					
L15	Very light grey fine sandy silt with	Firm	Not	0		
	many granite chippings and some		excavated			
	shell – only in gunport under hull

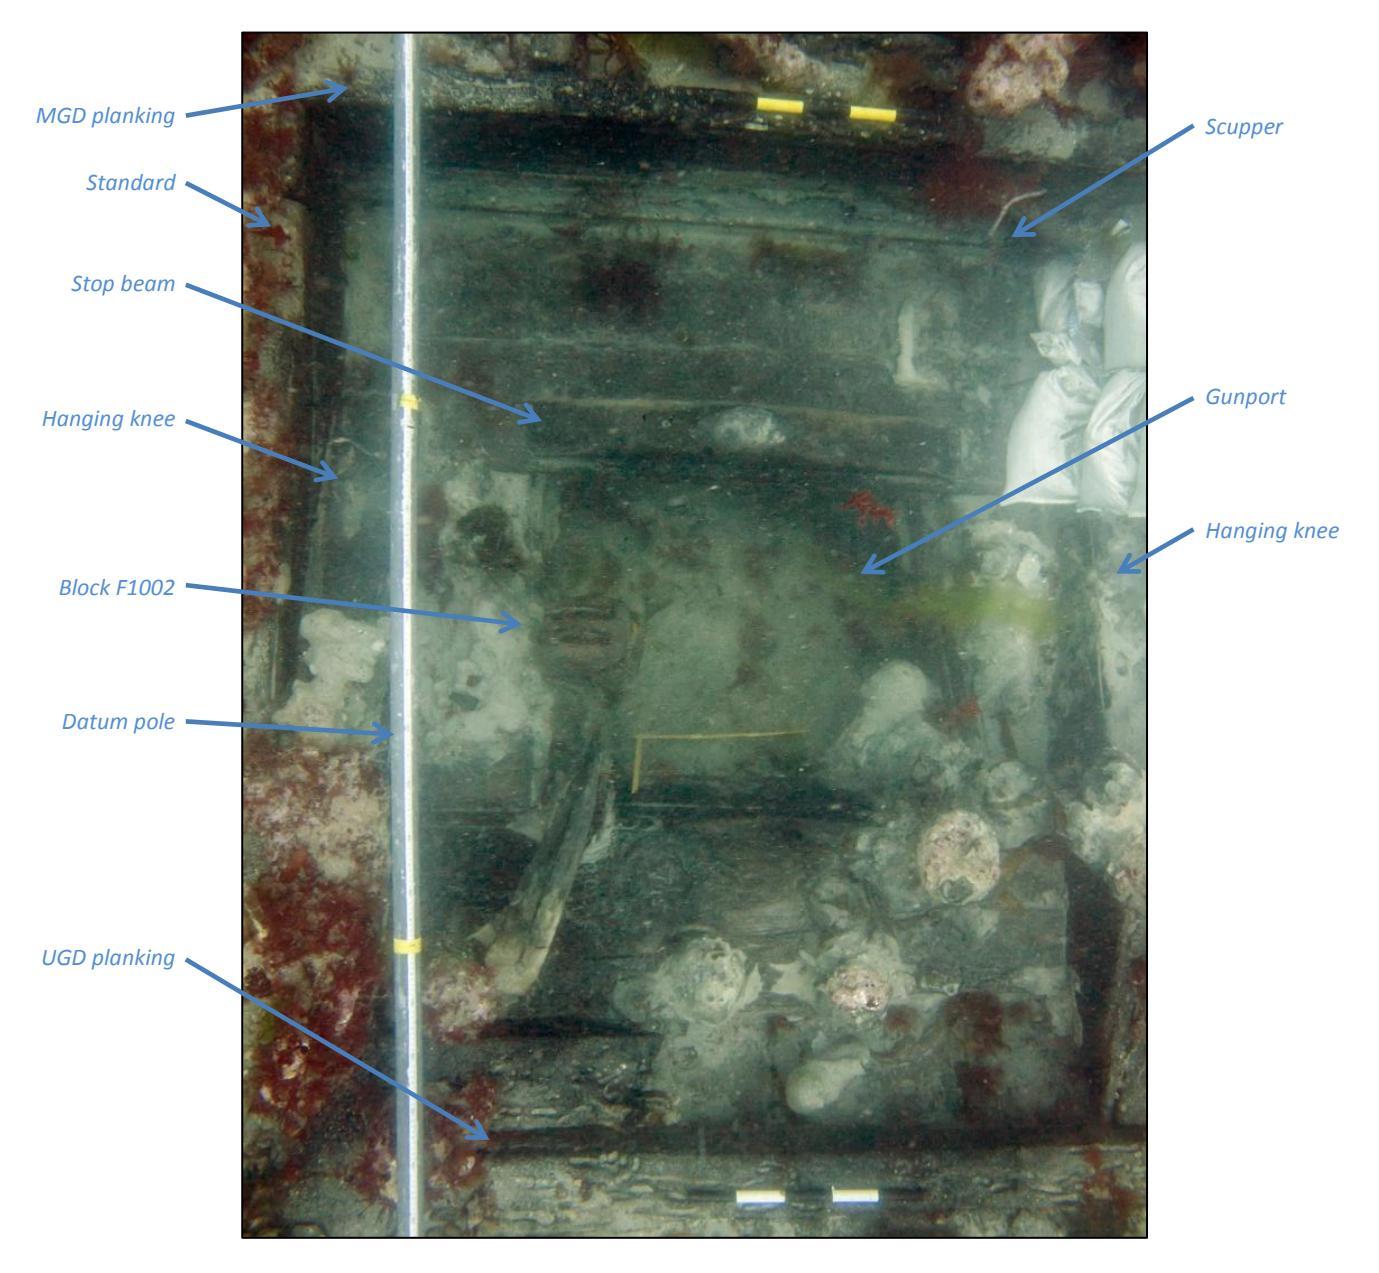
Fig 24 Trench 4 from above. Scales 0.50m – north is approximately upwards

The main feature located in trench 4 was a main deck gun port. The port was 1.05m wide, 0.85m high and 0.60m deep (through the thickness of the hull). On the outer edge of the hull there was a rebate to take the port lid, this was 0.16m deep and 0.06m wide – which would mean that the port lid would have been approximately 1.10m wide and 0.90m high – the port lid, hinges and the gun were missing. The MGD armament consisted of 32lb Blomefield pattern guns, which were 2.9m (9' 6") long and weighed 2.8 tonnes (56cwt) (Caruana, 1994). Three of these MGD guns - guns 8, 9 and 10 - have been found in the *Colossus* debris field (Camidge, 2005), but to date none have been found on the wreck itself. This raises an interesting question – why when the six upper gun deck 18lb guns are all still in place on the site are none of the MGD 32lb guns still on the wreck? Certainly, in the case of the gun port in trench 4 it would seem that the gun probably exited through the gunport, removing the port lid and hinges as it did so – few other scenarios would account for the missing port lid.

Just below the gun port a curved timber beam was fastened to the side of the hull, over the inner hull planking (figs 24, 25 & 31). This timber has been assigned the name 'stop beam' and its likely function was for the gun carriage to bump against when the gun was pulled up into the firing position - rather than bumping against the inner hull planking. I have been unable to find any concordances for this structural element in any of the literature on ships of the period (or indeed on any sailing vessels). However, a similar wooden beam is known in 19th century terrestrial gun emplacements where it is called a hurter. The stated function of the hurter was to protect the parapet from the wheels of the gun carriage (OED). The stop beam is 1.40m long, 0.16m wide and 0.26m thick at its widest point. The surface of the beam is curved, presumably to facilitate aiming of the gun forward or astern of the beam. The stop beam is fastened to the hull using iron fastenings and trenails. On the underside of this beam (now facing north) were a number of incised lines, one of which consists of three parallel lines, resembling a Roman numeral 'III' (fig 32). These may represent builder's marks – and would have been very difficult to see or access when the ship was upright. Incidentally, this is the third MGD port on the starboard side counting from the stern. The function of this piece of wood was presumably to protect the side of the ship from the impact of the gun carriage when pulled up into the firing position (fig 31). Whether stop beams are a peculiarity of Colossus or merely absent from the literature is not at this stage known – but I suspect the former case is more likely.

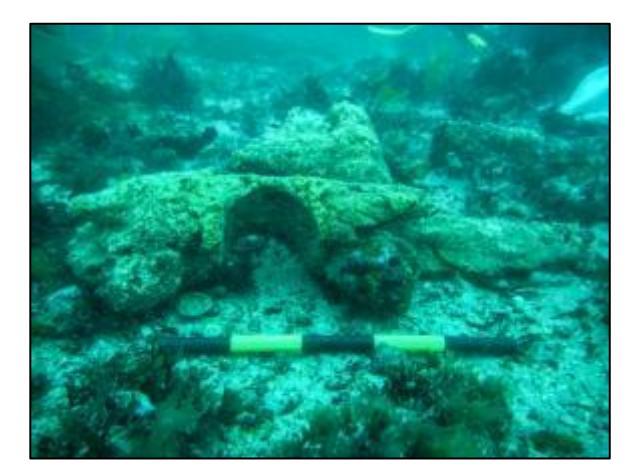
Fig 33 Part of a gun carriage F1001 – scale 0.50m

There is no way to be certain which gun port these fragments of gun carriage were originally associated with. However, given their proximity to trench 4 it would seem likely that they are parts of the gun carriage for the now missing gun from trench 4. The presence of weed and algae on the surface of these timber fragments suggests that they have been exposed on the seabed for some time.

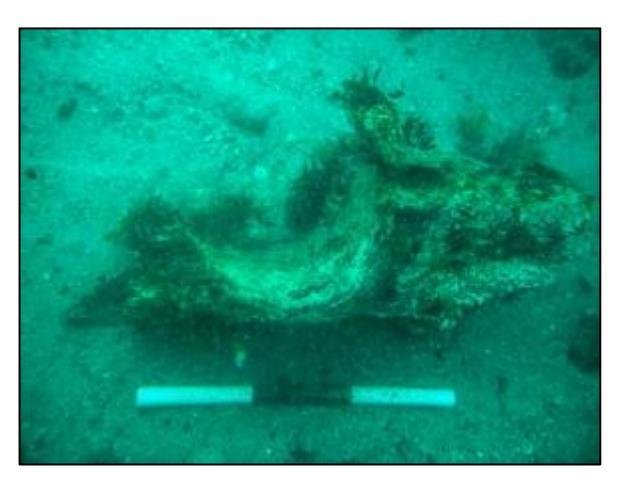
Fig 34 Gun carriage part F1000 - scale 0.30m

A fragment of a timber gun carriage (F1000) was found on the seabed surface above trench 4 (fig 34). This consisted of timber, some 0.40m long, with iron fastenings. It had a characteristic semicircular cut-out which was circa 150mm in diameter – this is where the trunnion of the gun would have sat. Part of the iron cap square which would have secured the trunnion to the carriage was also in place. About 1m to the west of this, another fragment of gun carriage was also found on the seabed (fig 33). It had a similar circular cut-out, also of 150mm diameter, and this fragment was 0.85m in length. Iron concretions marked where the iron bolts securing the cap square were still in place.

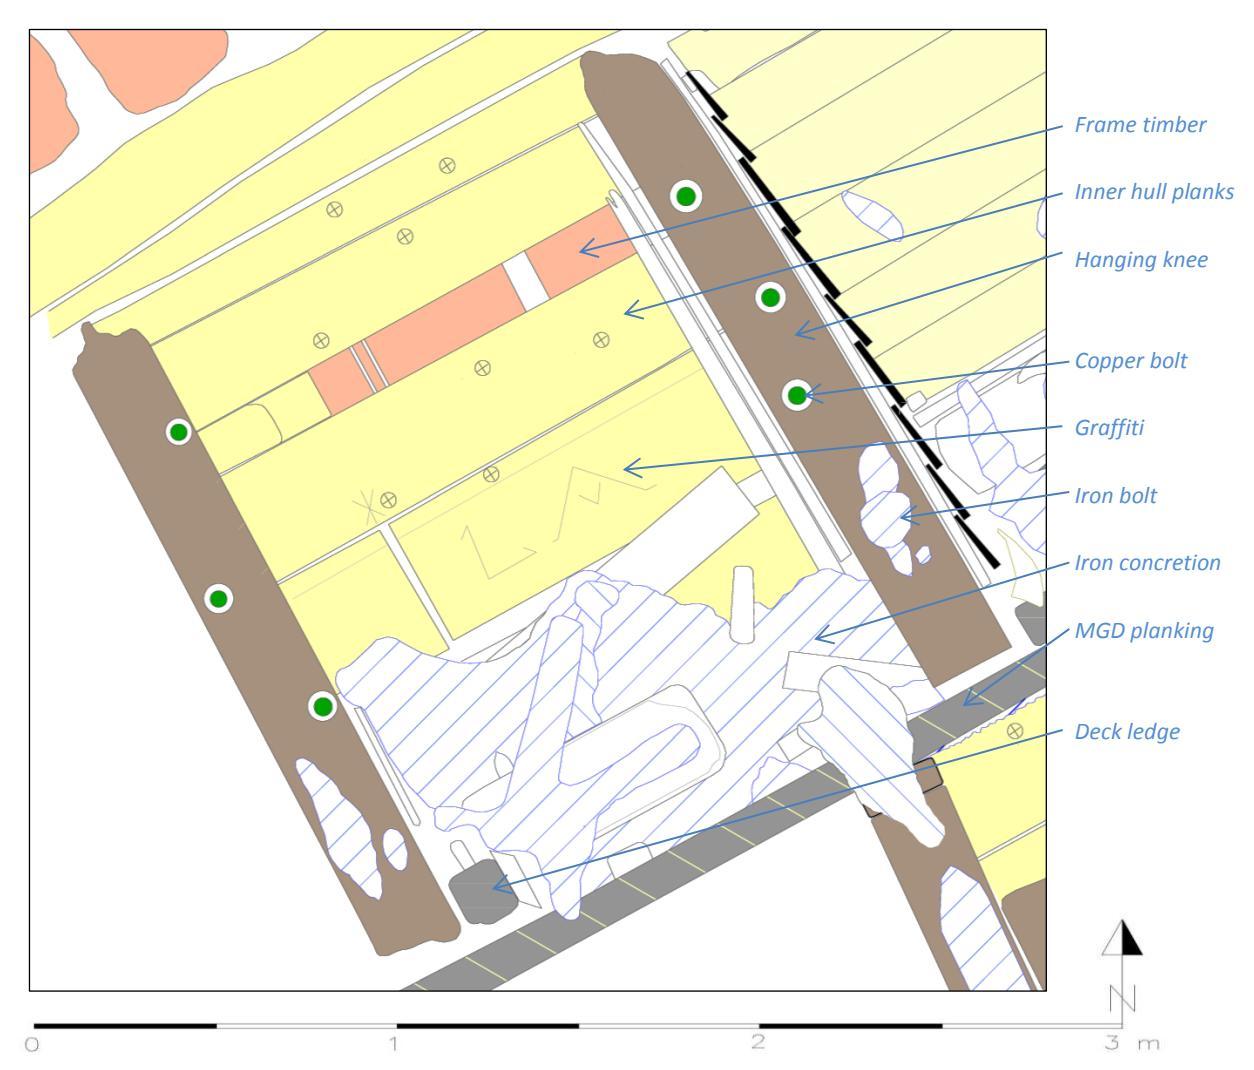
Fig 35 Plan of trench 5

The inner hull planks varied in width from 0.23m to 0.33m and were fixed to the hull frames with trenails of 0.035m diameter (fig 35). One of the inner hull planks was joined with a straight butt joint (figs 35 and 39). Several of the inner hull planks had simple shapes incised onto their outer faces, and similar graffiti were observed on the inner hull planking in trench 1 when excavated in 2002. The graffiti took the form of simple geometric shapes (figs 35 and 41) and were possibly builder's marks as those seen in trench 1 were behind the lapboard lining. Similar marks have also been observed on the Swash Channel wreck (pers comm with Dave Parham). Graffiti was also noted on the western face of the eastern hanging knee in this trench (figs 37 and 40).

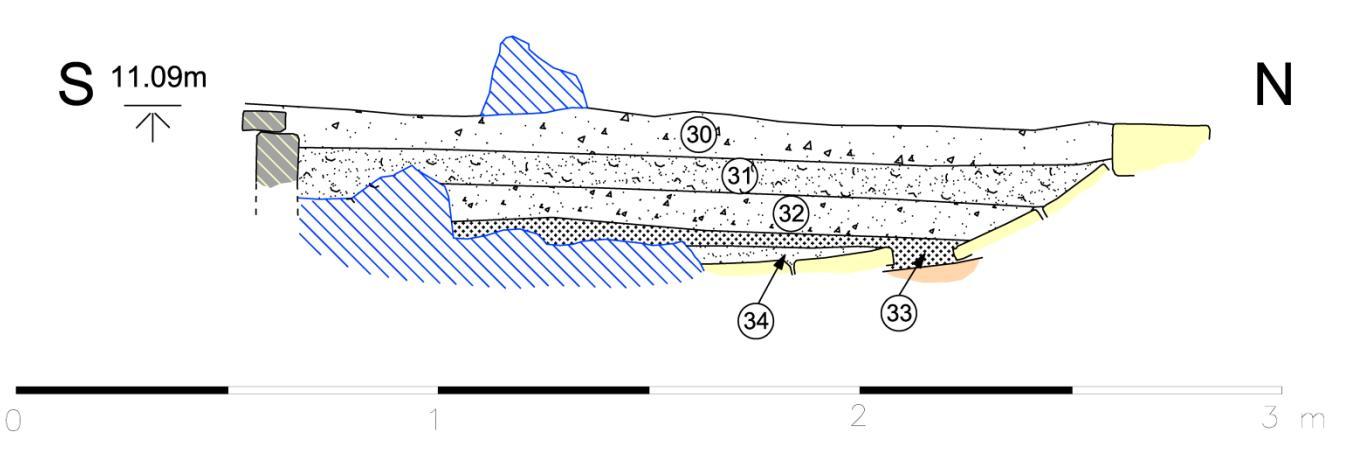
Fig 36 Trench 5 stratigraphy

TRENCH 5 STRATIGRAPHY								
Layer	Description	Compaction	Depth(m)	Finds				
L30	Light grey coarse sand with shell	Loose	0.11	6				
	fragments and granite chippings							
L31	Light greyish-brown silty sand with	Loose	0.09	18				
	broken shell							
L32	Grey coarse sand with shell	Loose to	0.08	26				
		medium						
L33	Very dark grey/black sand and iron	hard	0.06	1				
	concretion							
L34	Light yellowish brown fine silty sand	Firm	0.05	0				
	No inclusions

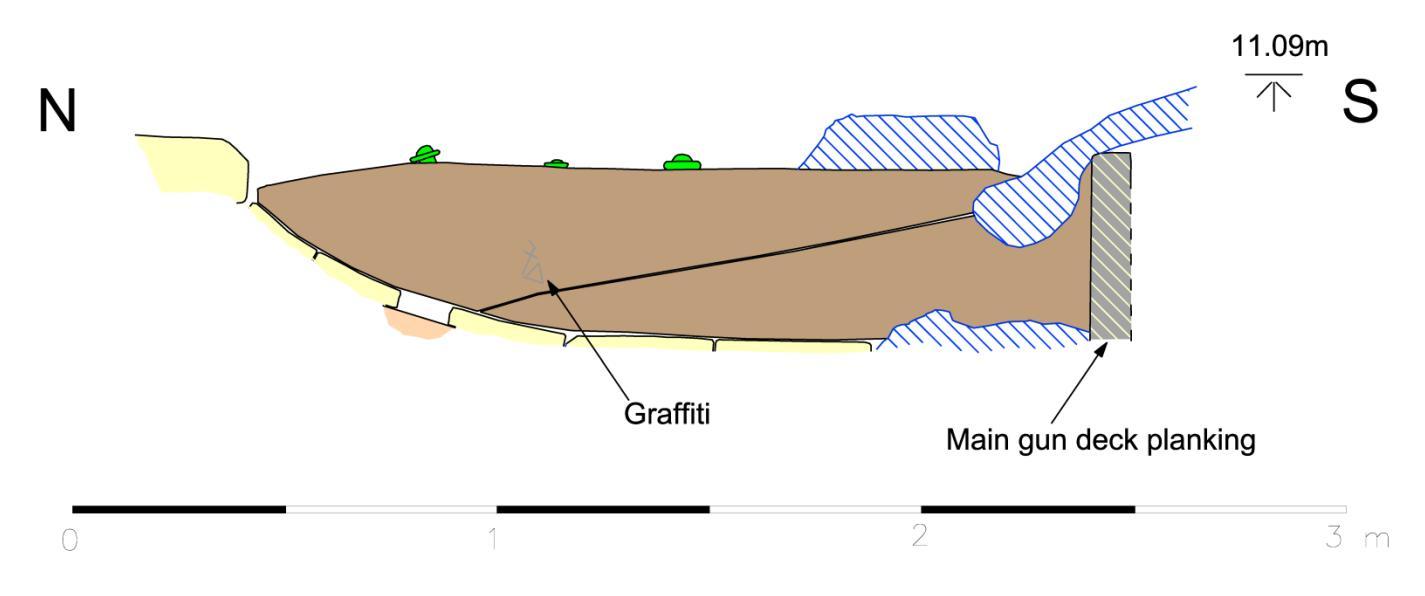
Fig 37 North-south profile along the eastern edge of trench 5 – note that the hanging knee is formed from two separate pieces of timber

Trench 5 was bounded to the east and west by hanging knees. These both had the shorter arms of the knee eroded away, leaving only the longer arm of the bracket intact. These knees would have been connected to the side of the ship (long arms) and to the underside of the MGD planking and beams (shorter arms). The eastern knee was 1.87m long, 0.23m wide (sided) and 0.41m deep (moulded). The western knee was 1.85m long, 0.22m wide (sided) and 0.38m deep (sided). Both of these knees were evidently fabricated from two separate pieces of timber, held together by the copper bolts fastening the knees to the hull of the vessel – figs 37 and 38. These copper bolts were secured by copper roves and were of a similar diameter to those observed in trench 3 (30mm). The knee on the western side of the trench has obviously been partially eroded, as evidenced by the protruding copper bolts (fig 38).

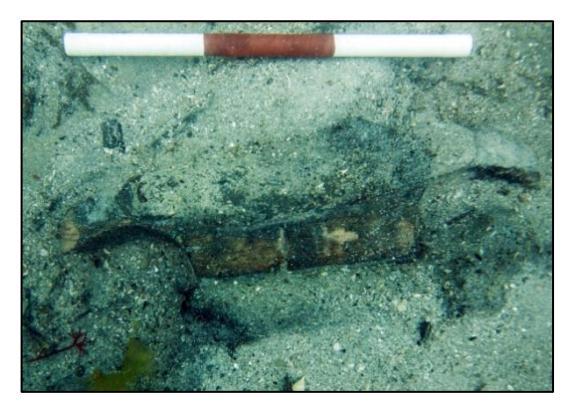
Fig 42 Wooden tool F779, a draw plane or spoke shave found in (L32) trench 5 – scale 0.3m

Perhaps the most interesting of the objects recovered from trench 5 were several objects relating to tools, perhaps pertaining to carpentry. The most notable of these was F779, a wooden draw plane or spoke shave found in layer (L32). Also from this layer came a pewter vessel possibly containing the remains of a brush – perhaps a glue pot. Both these objects are undergoing conservation and investigation at York Archaeological Trust (YAT) and will eventually go on display at the Isles of Scilly museum. Two wooden handles - F881 and F882 - were found in (L31), and these are probably the remains of tools. Further details of these and all the other objects recovered are presented in the finds database which appears in full on the DVDROM which accompanies this report, and in abbreviated form in appendix II. These objects may indicate the use of this part of the orlop deck as a carpenter's store.

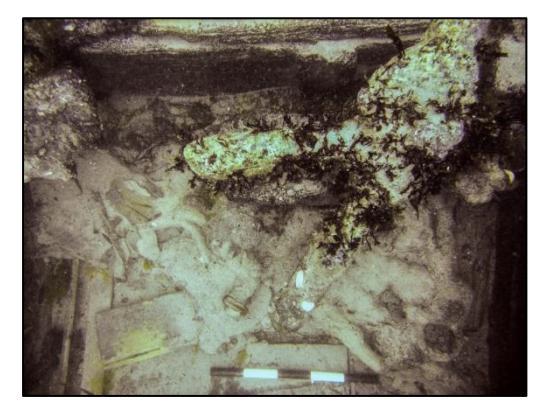
Fig 43 Complex iron concretion at the south end of trench 5 – scale 0.5m

The most numerous find type from trench 5 was fragments of iron concretion, of which 15 were found. This is not surprising given the mass of iron concretion located within the southern end of this trench. The next most numerous type was ceramics, which has been amongst the most numerous find types in each of the trenches excavated – see separate section below on the ceramics recovered.

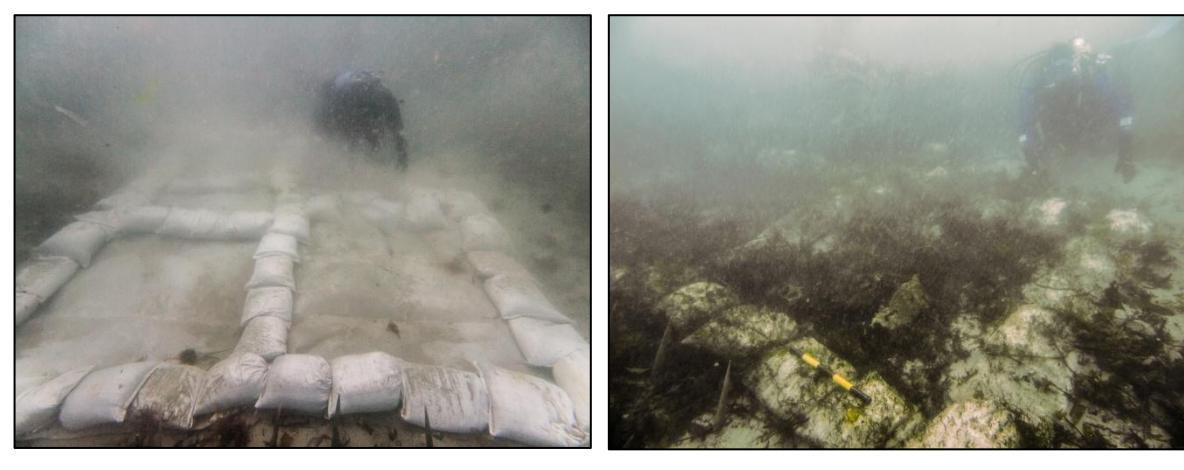
Fig 46 The Terram and sandbags after installation in June 2012

The spoil was moved back into the trenches using the reaction dredge (fig 4), and the scaffolding mesh was placed over the trenches and weighted down with sandbags to ensure that the spoil stayed in the trenches. The backfilling took 1.5 days to complete.

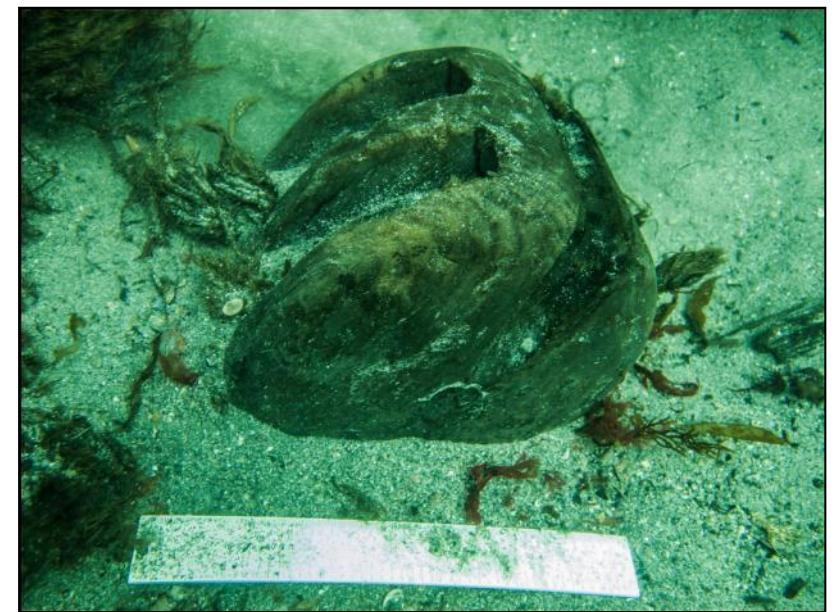
Fig 51 Block 1 in situ with frayed remains of the rope fall visible on the left

Pulley block 1 is a double block that was found in situ, concreted to the fixing (eye bolt?) attached to the side of the ship on the west (forward) side of the gun port in Trench 4. The block was initially visible in Layer 10, found partially eroded on its upper side, with the bottom of the block facing upwards, with only fragments of the falls and strop in place. On one cheek is marked 'RS' and '10' either side of the pin, perhaps as this block is 10 inches in size.

Remains of the strop were found with the block. This was F725, found on the south side of the block in (L12), and rope F770 on the north side of the block (L12) along with sections of the tackle around the sheaves, these being F771 and F772 (part of F771). The upper parts of the strop and ropes were missing and the upper part of the block itself is abraded, suggesting that this part of the block had been at seabed level at some point.

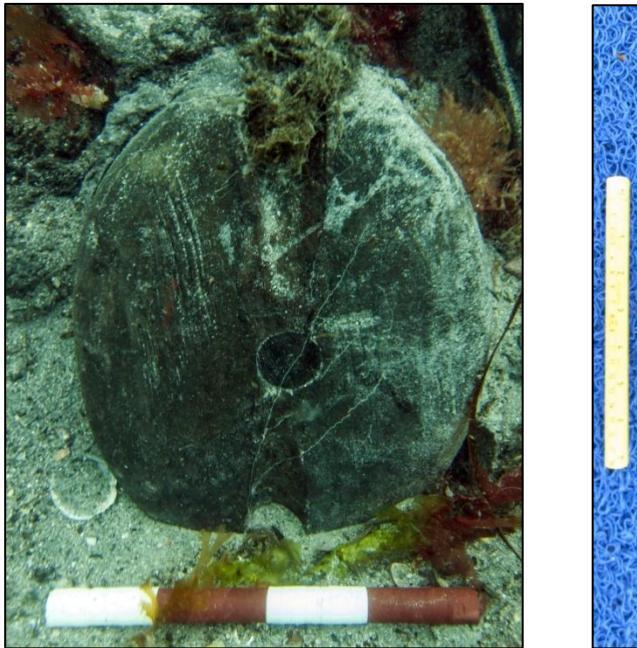
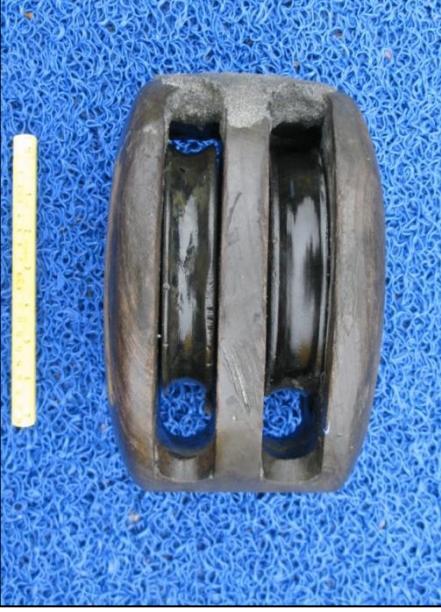
Fig 55 Block F1003, left on the seabed and right after recovery. Scale 20cm

Pulley block 2 is a double block found loose up against the knee on the west side of Trench 4 with bottom of the block uppermost. This block appears to be the same size and type as Block 1. Some of the rope strop remained on the bottom of the block as it was held in place by concreted sand. The block was recovered and recorded using the DS block form, along with detailed recording which was used to create an engineering drawing. This block was recovered for conservation.

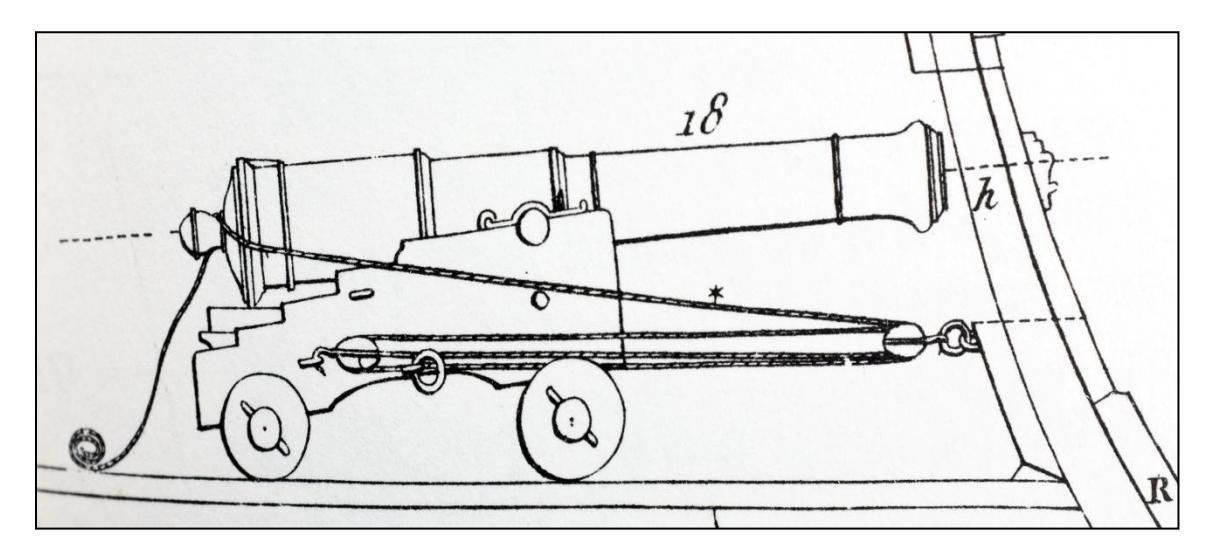
Fig 64 The arrangement of the running out tackle for a 32lb gun. The double block is attached to the hull and the single block to the gun carriage. (Falconer, 1780)

The running out tackle was used to pull the gun into the firing position. It consisted of a pair of blocks: one double block attached to the hull at the side of the gun port, and a single block hooked to the side of the gun carriage. This arrangement was repeated at each side of the gun, making two double blocks and two single blocks in total for a set of running out tackle (Caruana, 1994, p.386). If this is the case, we are missing the two single blocks of the running out tackle, originally attached to
